# Roof Inspection Report

Bellevue Elementary  
12001 Timberridge Drive  
Papillion, NE 68133

Date	Inspection Type	Inspecting Company	Inspector
Mar 28, 2017	Phase 1 Roof Inspection	Roofing Solutions, Inc.	Garry Hendrickson

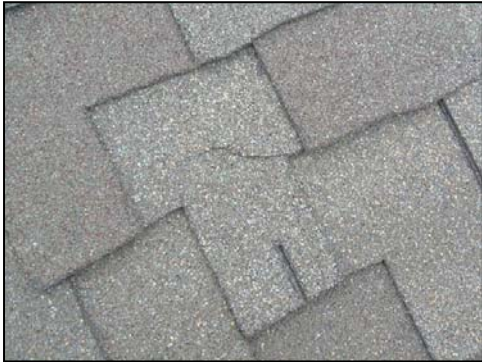
<b>Defect Code:</b>	<b>6</b>	<b>Quantity:</b>	<b>Random</b>	<b>Priority:</b>	<b>First Year</b>
Description: Split in membrane.					
Repair: Cut out splits and repair membrane with similar membrane material. Extend repair material a minimum of 6" in all directions past repair areas.

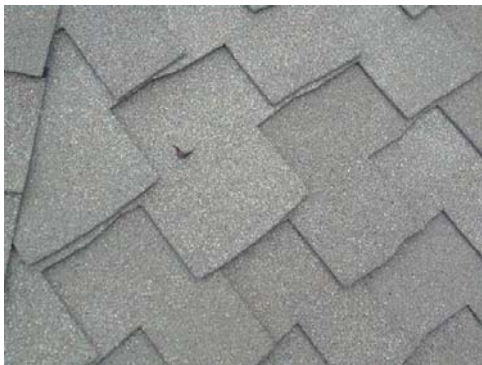
<b>Defect Code:</b>	<b>10</b>	<b>Quantity:</b>	<b>Random</b>	<b>Priority:</b>	<b>First Year</b>
Description: Tented membrane at fastener.					
Repair: Remove fasteners that are loose or not flush with the substrate. Remove underlying substrate materials including insulation and coverboard and replace with matching materials of similar thicknesses to provide for a smooth flush surface.. Install new fasteners and plates per manufacturer's recommendations for system type and apply new membrane repair materials of similar type, gauge, and plies as existing roof system.

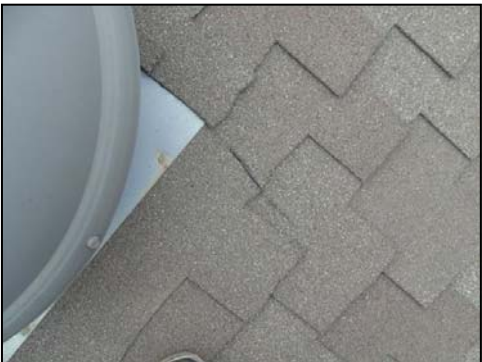
<b>Defect Code:</b>	<b>23</b>	<b>Quantity:</b>	<b>1</b>	<b>Priority:</b>	<b>Monitor</b>
Description: Physical damage to membrane including cuts, holes, tears, scrapes, scuffs, or abrasions.					
Repair: Apply repair membrane over damaged area, extending repair material a minimum 6" past damage.

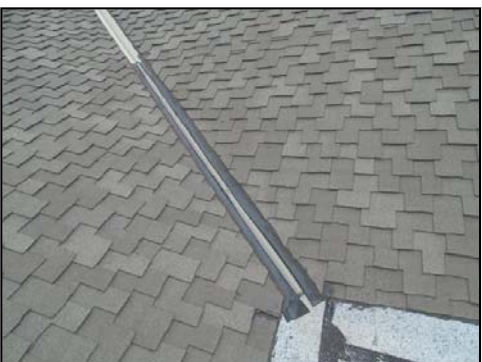
<b>Defect Code:</b>	<b>24</b>	<b>Quantity:</b>	<b>Random</b>	<b>Priority:</b>	<b>Monitor</b>
Description: Evidence of past problem and previous repair.					
Repair: Investigate for chronic leak problems and repair any areas that are suspect.

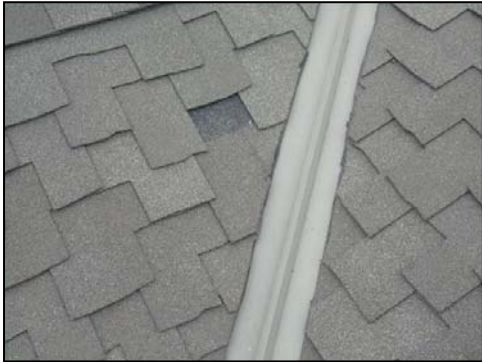
<b>Defect Code:</b>	<b>29</b>	<b>Quantity:</b>	<b>5</b>	<b>Priority:</b>	<b>Monitor</b>
Description: Missing, loose, or broken shingles					
Repair: Remove all damaged shingles and replace all damaged and missing shingles with shingles of like kind and color.

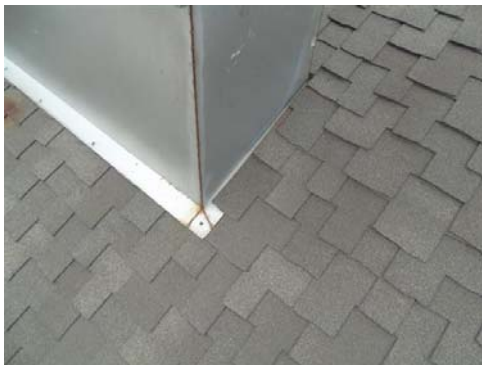
<b>Defect Code:</b>	<b>58</b>	<b>Quantity:</b>	<b>Random</b>	<b>Priority:</b>	<b>Monitor</b>
Description: Inadequate, incomplete, nonconforming membrane flashings or flashing details.					
Repair: Complete membrane flashing repairs in accordance with NRCA recommendations and good roofing practices. Follow manufacturer requirements on warranted systems.

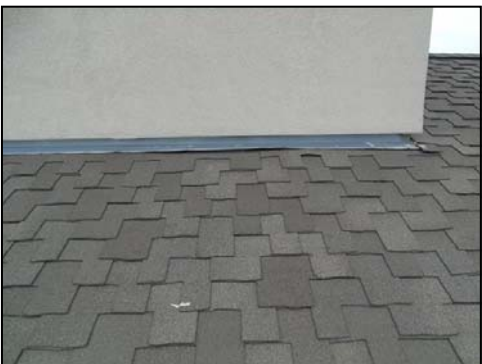
<b>Defect Code:</b>	<b>75</b>	<b>Quantity:</b>	<b>Under 10 LF</b>	<b>Priority:</b>	<b>First Year</b>
Description: Inadequate attachment of metal flashings.					
Repair: Reattach metal flashings a maximum of two EPDM washered fasteners per side of curb or attach a maximum of 12" O.C for flashings more than 24 " in length.

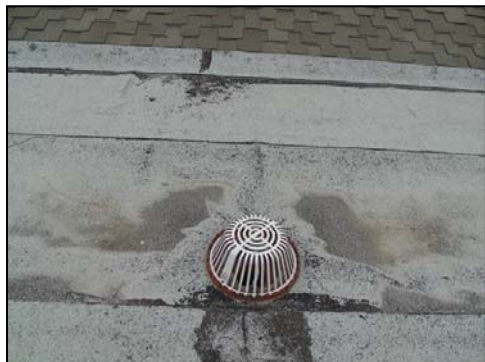
<b>Defect Code:</b>	<b>3</b>	<b>Quantity:</b>	<b>Random</b>	<b>Priority:</b>	<b>First Year</b>
Description: Open lap in field membrane.					
Repair: Clean lap of all dirt and close seam. Overlay edge of affected seam with strip-in of new membrane of like material. Extend a minimum of 4" in all directions past seam edges and repair areas.

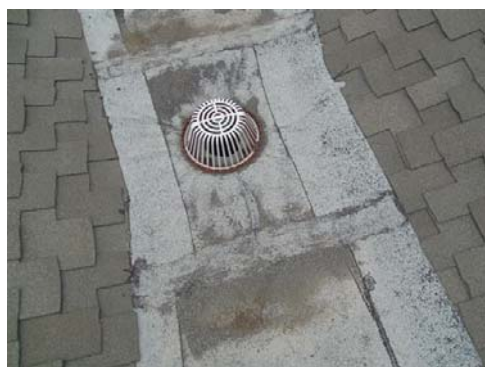
<b>Defect Code:</b>	<b>7</b>	<b>Quantity:</b>	<b>Widespread</b>	<b>Priority:</b>	<b>First Year</b>
Description: Wrinkle in membrane.					
Repair: Cut out wrinkles and loose membrane. Apply new membrane of like material and plies to cover cuts and extend repairs a minimum of 6" in all directions past cut out areas.

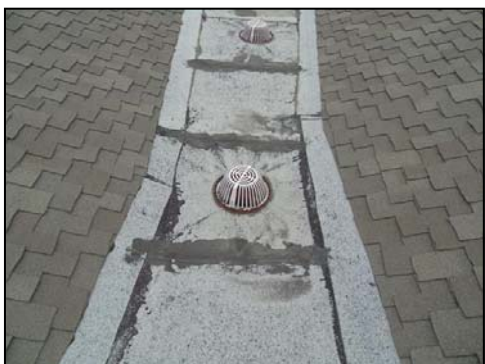
<b>Defect Code:</b>	<b>24</b>	<b>Quantity:</b>	<b>1</b>	<b>Priority:</b>	<b>First Year</b>
Description: Evidence of past problem and previous repair.					
Repair: Investigate for chronic leak problems and repair any areas that are suspect.

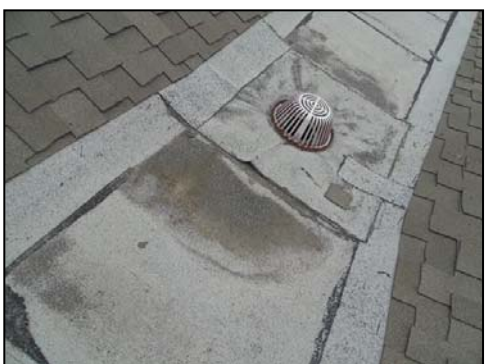
<b>Defect Code:</b>	<b>45</b>	<b>Quantity:</b>	<b>Widespread</b>	<b>Priority:</b>	<b>First Year</b>
Description: Open flashing lap					
Repair: Open loose lap area and clean thoroughly. Prime and reseam or reweld lap per the manufacturer's requirements. Strip-in defective lap with mimum 6" wide membrane on single ply systems or 6" wide fabric and mastic three-course application on asphalt systems. Regranulate or coat flashing repairs.

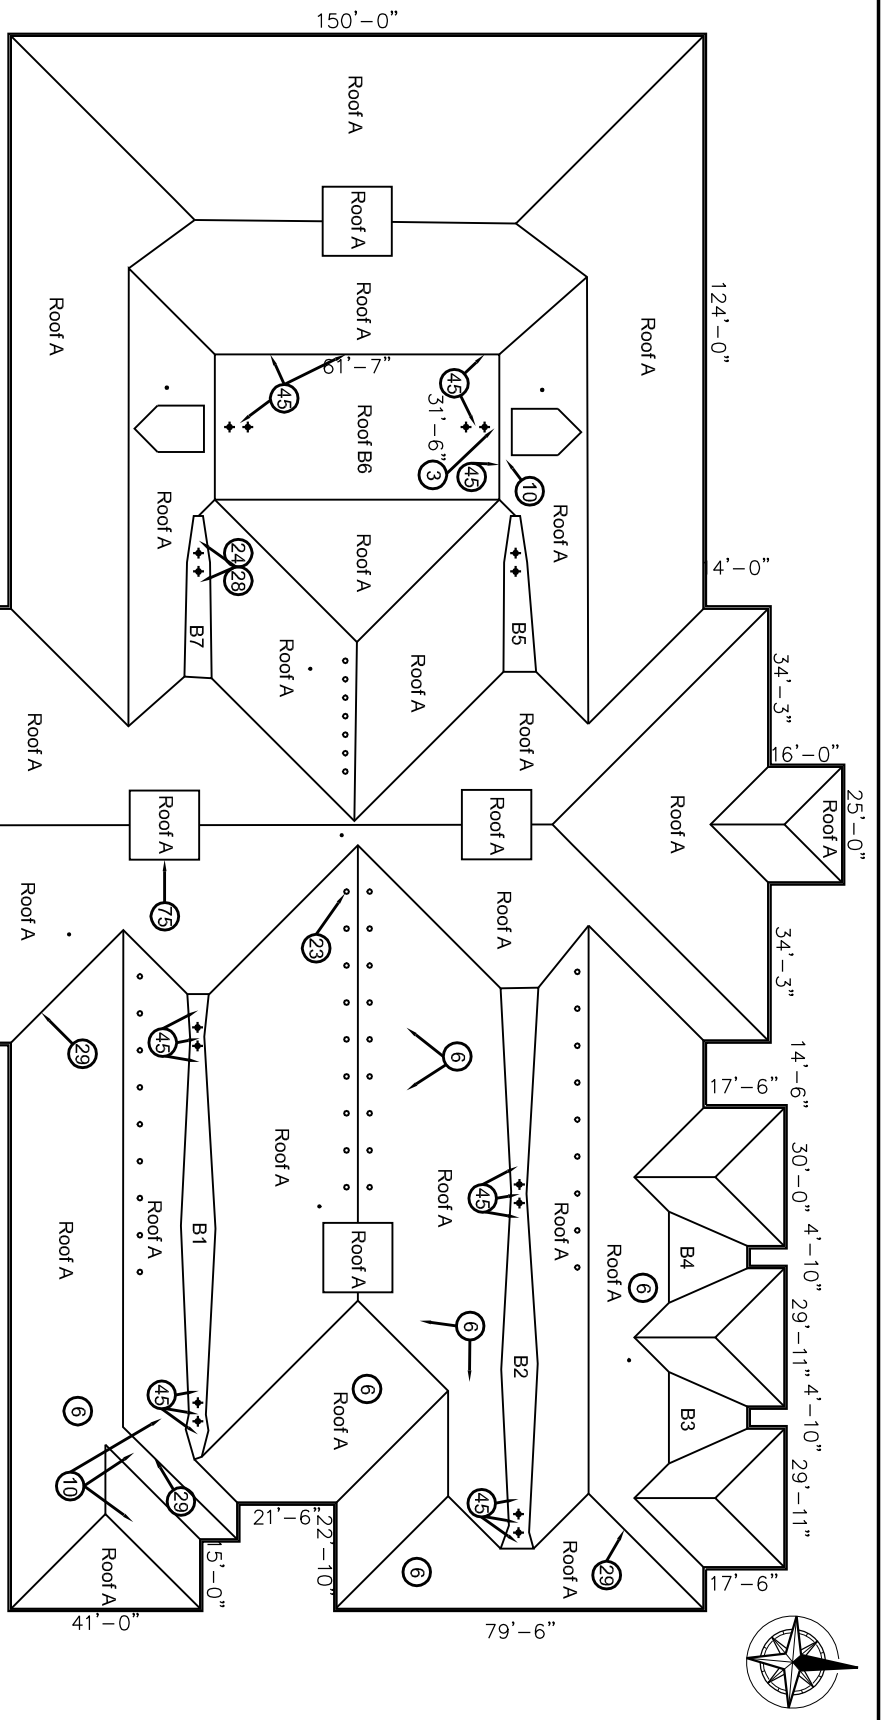
**Sheet Title:**  
**A&B-Roof Plan**

Typical defects on the B roof areas:  
 (7) The drain flashings are wrinkled and buckled.  
 (49) Numerous open laps in the drain flashings.

Typical defects on the A roof area:  
 (6) Random areas with split or damage shingles.  
 (24) Random roof mastic repair attempts made to the shingles.  
 (24) Random repair attempts made to the valley and rake edge flashings.  
 (58) The roof curbs have a narrow metal flange with no additional metal flashing.  
 (59) There are missing starter rows of shingles on the dormer roofs.
