# Roof Inspection Report

Bellevue School Transport  
2824 Arboretum Drive  
Bellevue, NE 68005

Date	Inspection Type	Inspecting Company	Inspector
Apr 05, 2017	Phase 1 Roof Inspection	Roofing Solutions, Inc.	Garry Hendrickson

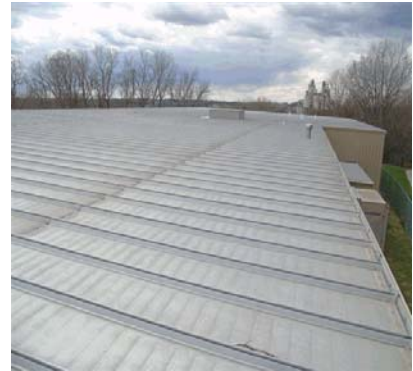
Facility personnel reported past leak issues around the small raised roof area.

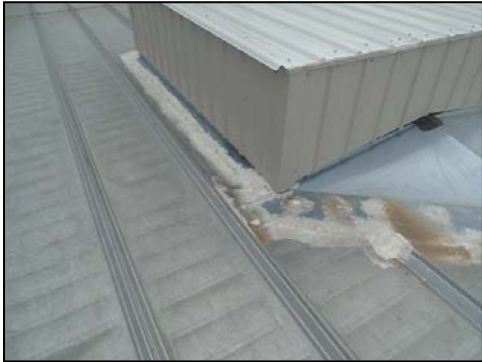
<b>Defect Code:</b>	<b>24</b>	<b>Quantity:</b>	<b>Widespread</b>	<b>Priority:</b>	<b>Monitor</b>
Description: Evidence of past problem and previous repair.					
Repair: Investigate for chronic leak problems and repair any areas that are suspect.

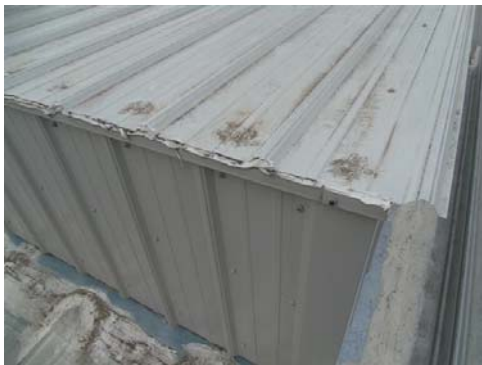
<b>Defect Code:</b>	<b>58</b>	<b>Quantity:</b>	<b>20 LF</b>	<b>Priority:</b>	<b>Monitor</b>
Description: Inadequate, incomplete, nonconforming membrane flashings or flashing details.					
Repair: Complete membrane flashing repairs in accordance with NRCA recommendations and good roofing practices. Follow manufacturer requirements on warranted systems.

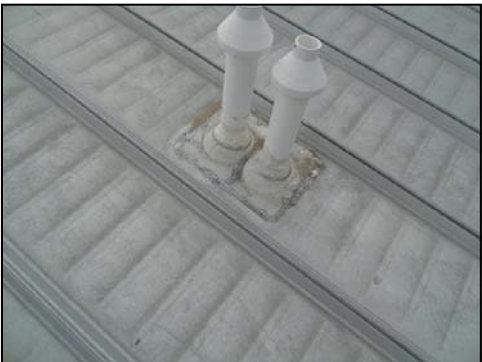
<b>Defect Code:</b>	<b>58</b>	<b>Quantity:</b>	<b>7</b>	<b>Priority:</b>	<b>Monitor</b>
Description: Inadequate, incomplete, nonconforming membrane flashings or flashing details.					
Repair: Complete membrane flashing repairs in accordance with NRCA recommendations and good roofing practices. Follow manufacturer requirements on warranted systems.

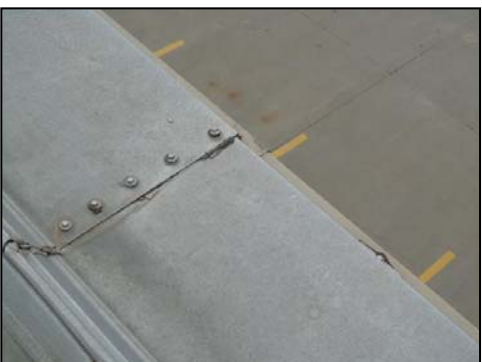
<b>Defect Code:</b>	<b>75</b>	<b>Quantity:</b>	<b>Random</b>	<b>Priority:</b>	<b>First Year</b>
Description: Inadequate attachment of metal flashings.					
Repair: Reattach metal flashings a maximum of two EPDM washered fasteners per side of curb or attach a maximum of 12" O.C for flashings more than 24 " in length.

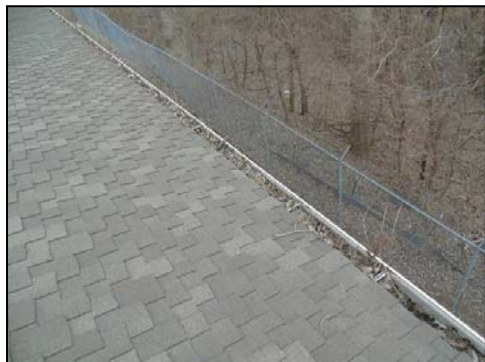
<b>Defect Code:</b>	<b>22</b>	<b>Quantity:</b>	<b>Widespread</b>	<b>Priority:</b>	<b>First Year</b>
Description: Debris, trash, construction materials, HVAC equipment, filters, motors, etc. on roof surface.					
Repair: Remove all trash and debris from roof. Clean and inspect surfaces and repair any damages to the membrane or flashings.

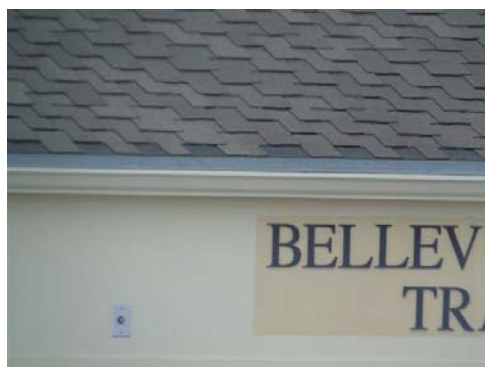
<b>Defect Code:</b>	<b>29</b>	<b>Quantity:</b>	<b>20 LF</b>	<b>Priority:</b>	<b>Monitor</b>
Description: Missing, loose, or broken shingles					
Repair: Remove all damaged shingles and replace all damaged and missing shingles with shingles of like kind and color.

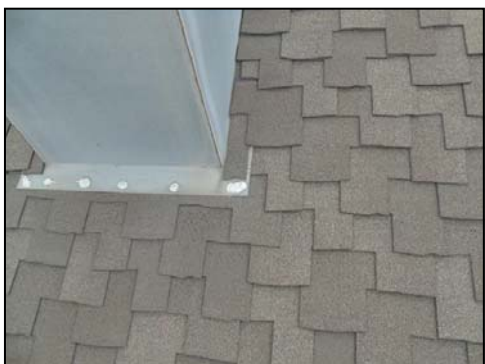
<b>Defect Code:</b>	<b>58</b>	<b>Quantity:</b>	<b>2</b>	<b>Priority:</b>	<b>Monitor</b>
Description: Inadequate, incomplete, nonconforming membrane flashings or flashing details.					
Repair: Complete membrane flashing repairs in accordance with NRCA recommendations and good roofing practices. Follow manufacturer requirements on warranted systems.

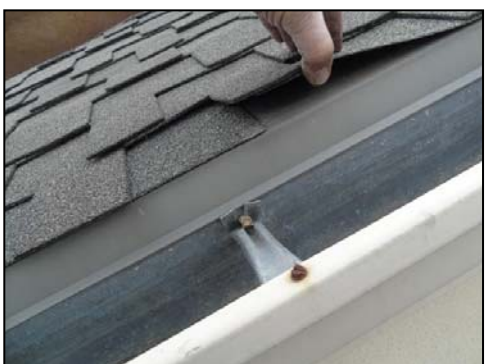
<b>Defect Code:</b>	<b>58</b>	<b>Quantity:</b>	<b>100 LF</b>	<b>Priority:</b>	<b>Monitor</b>
Description: Inadequate, incomplete, nonconforming membrane flashings or flashing details.					
Repair: Complete membrane flashing repairs in accordance with NRCA recommendations and good roofing practices. Follow manufacturer requirements on warranted systems.
