Roof Inspection Report

Bellevue Welcome Center
2600 Arboretum Drive
Bellevue, NE 68005

Date	Inspection Type	Inspecting Company	Inspector
Apr 06, 2017	Phase 1 Roof Inspection	Roofing Solutions, Inc.	Garry Hendrickson

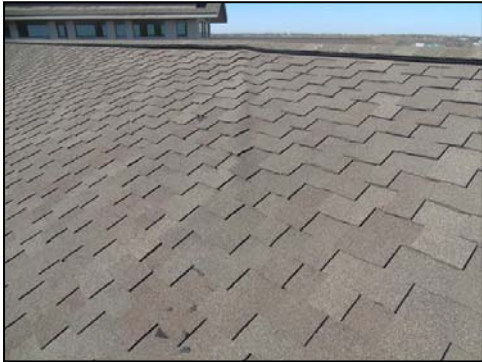
Defect Code:	5	Quantity:	40 LF	Priority:	Monitor
Description: Buckling or ridging of membrane.					
Repair: Cut out deteriorated buckles and ridges and repair membrane with similar membrane material. Extend repair material a minimum of 6" in all directions past repair areas.

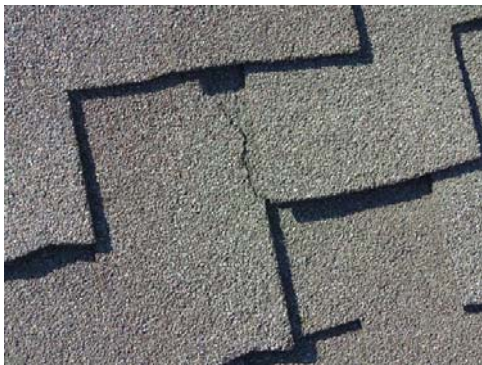
Defect Code:	6	Quantity:	Random	Priority:	Monitor
Description: Split in membrane.					
Repair: Cut out splits and repair membrane with similar membrane material. Extend repair material a minimum of 6" in all directions past repair areas.

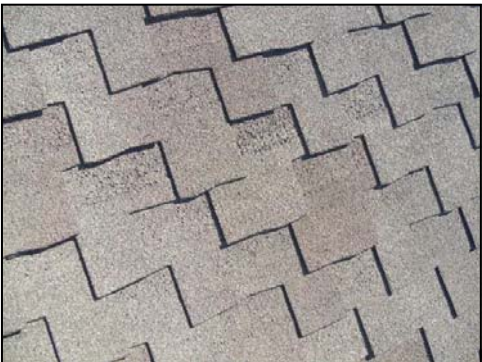
Defect Code:	8	Quantity:	Random	Priority:	Monitor
Description: Surface erosion.					
Repair: Prepare membrane surface by thoroughly cleaning and priming. Apply new surfacing of like materials to eroded areas. On gravel surfaced systems apply gravel in hot asphalt or recommended cold adhesive. Apply granulated fiberglass cap sheet or modified bitumen membrane on like systems. Apply coating system on smooth asphalt surfaces. Transition surfacing to provide for a smooth and neat finished appearance to match the existing surfacing.

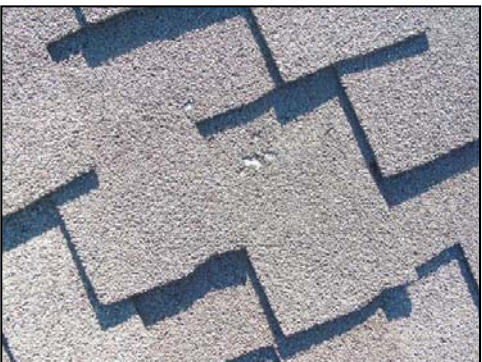
Defect Code:	9	Quantity:	Random	Priority:	Monitor
Description: Membrane deterioration.					
Repair: Replace all deteriorated membrane with new membrane of similar type, gauge, and plies.

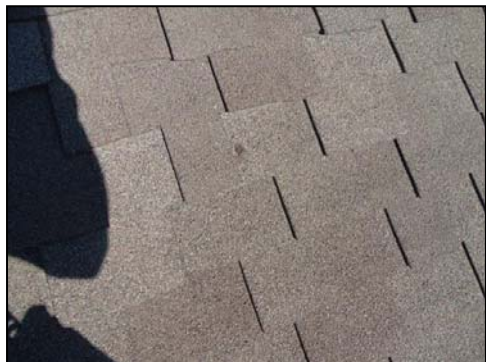
Defect Code:	10	Quantity:	Widespread	Priority:	Monitor
Description: Tented membrane at fastener.					
Repair: Remove fasteners that are loose or not flush with the substrate. Remove underlying substrate materials including insulation and coverboard and replace with matching materials of similar thicknesses to provide for a smooth flush surface.. Install new fasteners and plates per manufacturer's recommendations for system type and apply new membrane repair materials of similar type, gauge, and plies as existing roof system.

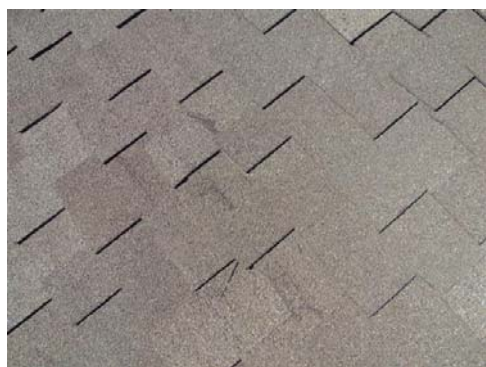
Defect Code:	23	Quantity:	Random	Priority:	Monitor
Description: Physical damage to membrane including cuts, holes, tears, scrapes, scuffs, or abrasions.					
Repair: Apply repair membrane over damaged area, extending repair material a minimum 6" past damage.

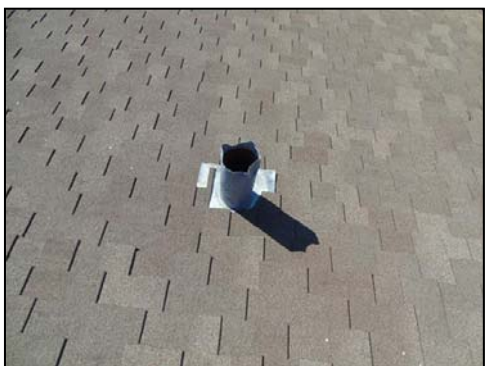
Defect Code:	53	Quantity:	1	Priority:	First Year
Description: Open lead flashing.					
Repair: Provide extension lead and turn into pipe. Counterflash top of short lead with extension a minimum of 3".

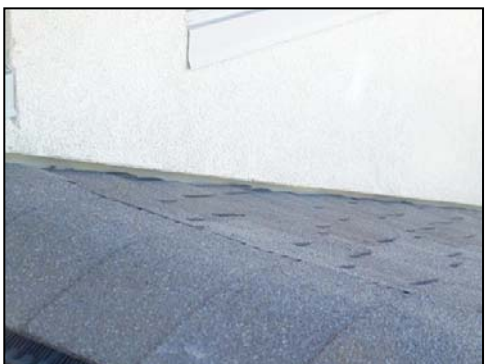
Defect Code:	58	Quantity:	Widespread	Priority:	Monitor
Description: Inadequate, incomplete, nonconforming membrane flashings or flashing details.					
Repair: Complete membrane flashing repairs in accordance with NRCA recommendations and good roofing practices. Follow manufacturer requirements on warranted systems.

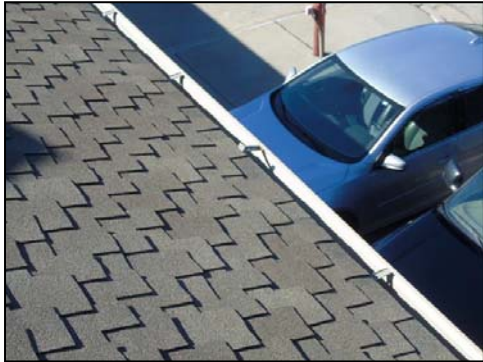
Defect Code:	75	Quantity:	1	Priority:	First Year
Description: Inadequate attachment of metal flashings.					
Repair: Reattach metal flashings a maximum of two EPDM washered fasteners per side of curb or attach a maximum of 12" O.C for flashings more than 24 " in length.

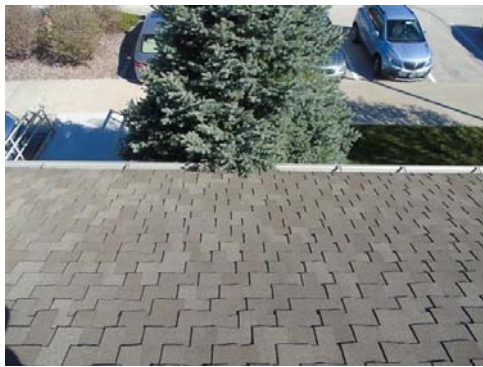
Defect Code:	85	Quantity:	1	Priority:	First Year
Description: Vegetation growth.					
Repair: Remove vegetative growth including all roots and organic matter. Remove all affected roofing and replace with like materials.

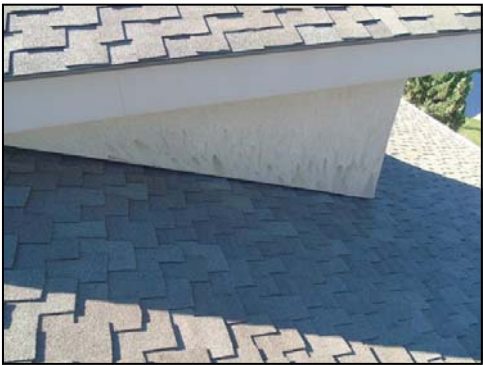
Defect Code:	85	Quantity:	Random	Priority:	Monitor
Description: Vegetation growth.					
Repair: Remove vegetative growth including all roots and organic matter. Remove all affected roofing and replace with like materials.

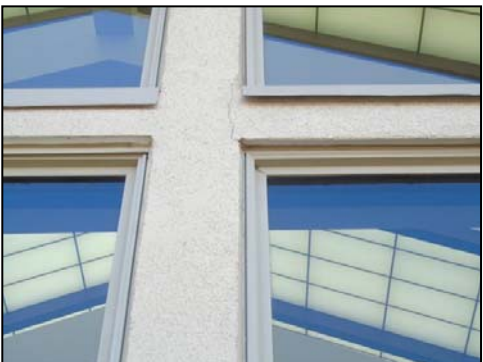
Defect Code:	89	Quantity:	Random	Priority:	First Year
Description: Missing wall covering/cladding.					
Repair: Replace cladding/wall covering with matching materials and methods. Reattach and reseal all joints, seams, laps, etc.
