Roof Inspection Report

Bertha Barber Elementary
1402 S. Main Street
Bellevue, NE 68005

Date	Inspection Type	Inspecting Company	Inspector
Mar 07, 2017	Phase 1 Roof Inspection	Roofing Solutions, Inc.	Garry Hendrickson

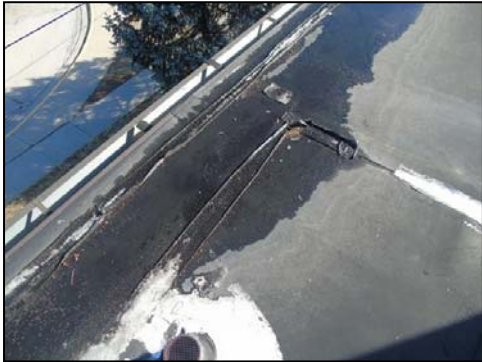
Defect Code:	3	Quantity:	Widespread	Priority:	Monitor
Description: Open lap in field membrane.					
Repair: Clean lap of all dirt and close seam. Overlay edge of affected seam with strip-in of new membrane of like material. Extend a minimum of 4" in all directions past seam edges and repair areas.

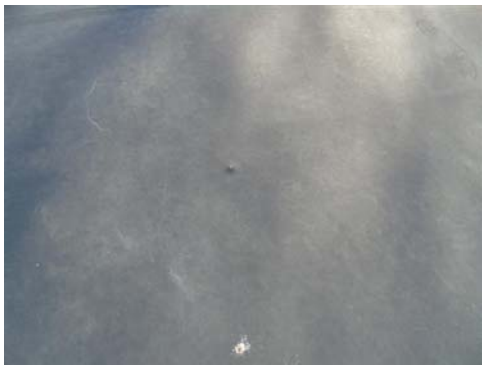
Defect Code:	10	Quantity:	Random	Priority:	Monitor
Description: Tented membrane at fastener.					
Repair: Remove fasteners that are loose or not flush with the substrate. Remove underlying substrate materials including insulation and coverboard and replace with matching materials of similar thicknesses to provide for a smooth flush surface.. Install new fasteners and plates per manufacturer's recommendations for system type and apply new membrane repair materials of similar type, gauge, and plies as existing roof system.

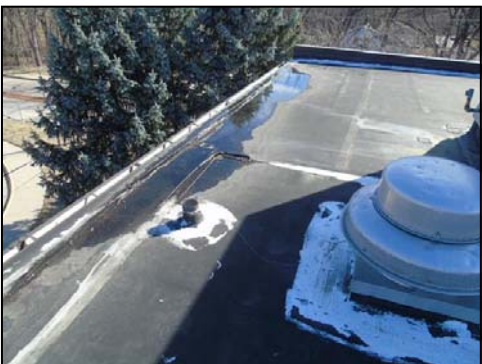
Defect Code:	15	Quantity:	Random	Priority:	Monitor
Description: Ponding of water.					
Repair: Monitor areas for severe or chronic ponding. Provide sacrificial membrane ply in ponded areas where existing membrane is deteriorated. Install additional drain or scupper including collectors and drain piping where ponding conditions are severe and chronic.

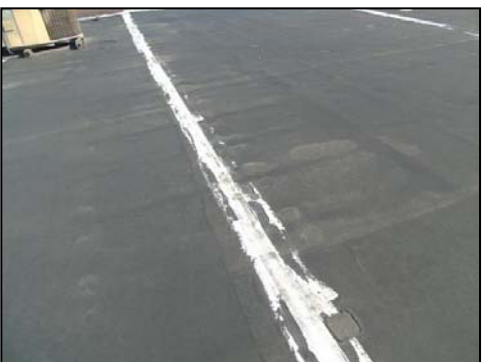
Defect Code:	24	Quantity:	Widespread	Priority:	Monitor
Description: Evidence of past problem and previous repair.					
Repair: Investigate for chronic leak problems and repair any areas that are suspect.

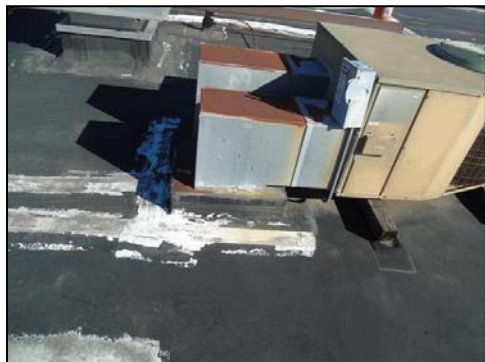
Defect Code:	86	Quantity:	Random	Priority:	Monitor
Description: Corrosion or rust					
Repair: Remove rusted components and replace with similar metal fabricated and installed per SMACNA requirements.

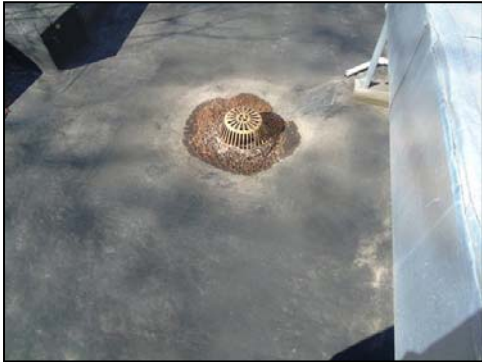
Defect Code:	22	Quantity:	1	Priority:	First Year
Description: Debris, trash, construction materials, HVAC equipment, filters, motors, etc. on roof surface.					
Repair: Remove all trash and debris from roof. Clean and inspect surfaces and repair any damages to the membrane or flashings.

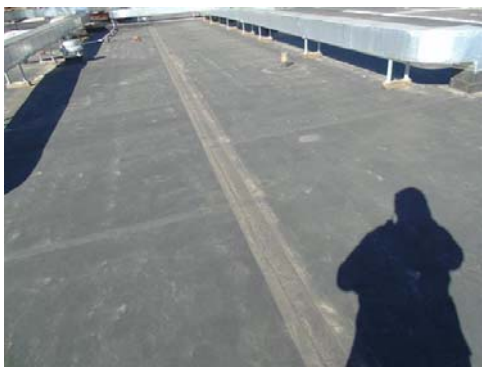
Defect Code:	24	Quantity:	Widespread	Priority:	Monitor
Description: Evidence of past problem and previous repair.					
Repair: Investigate for chronic leak problems and repair any areas that are suspect.

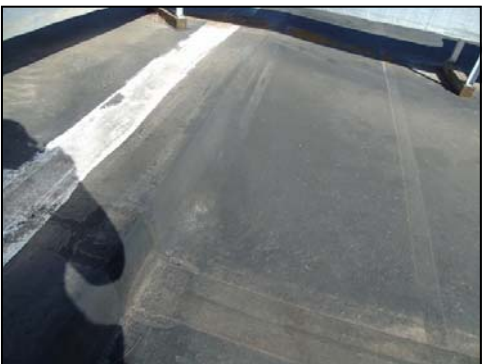
Defect Code:	44	Quantity:	Random	Priority:	Monitor
Description: Bridged flashing					
Cut out all bridged flashings. Clean area thoroughly and apply new flashings. Apply corner flashings and overlay all T-laps, flashings laps, and splice intersections.

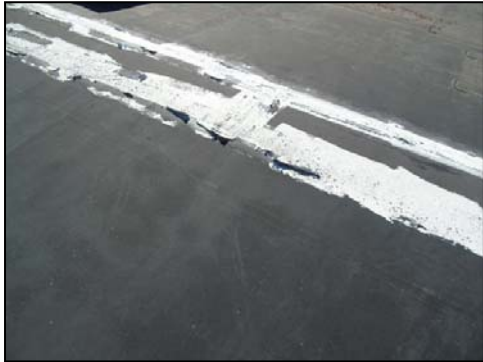
Defect Code:	3	Quantity:	Widespread	Priority:	Monitor
Description: Open lap in field membrane.					
Repair: Clean lap of all dirt and close seam. Overlay edge of affected seam with strip-in of new membrane of like material. Extend a minimum of 4" in all directions past seam edges and repair areas.

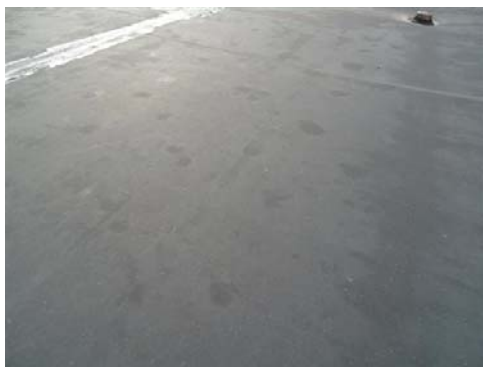
Defect Code:	18	Quantity:	Widespread	Priority:	Monitor
Description: Unadhered membrane or inadequate membrane attachment.					
Repair: At unadhered areas, cut open membrane and readhere to substrate with manufacturer's approved adhesive. At areas with missing securement, provide securement in the form of screws and plates installed a maximum of 12" O.C. Overlay repaired areas with new membrane of similar gauge, type, and plies and extend repairs a minimum of 4" past cut areas or edges of plates.

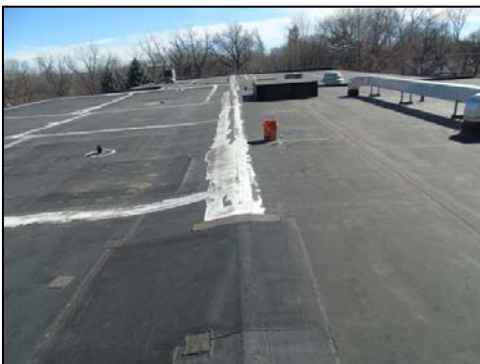
Defect Code:	24	Quantity:	Widespread	Priority:	Monitor
Description: Evidence of past problem and previous repair.					
Repair: Investigate for chronic leak problems and repair any areas that are suspect.

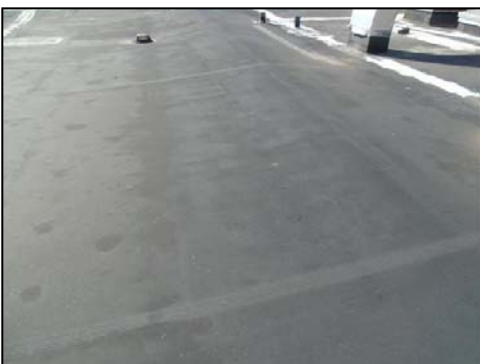
Defect Code:	44	Quantity:	Widespread	Priority:	Monitor
Description: Bridged flashing					
Repair: Cut out all bridged flashings. Clean area thoroughly and apply new flashings. Apply corner flashings and overlay all T-laps, flashings laps, and splice intersections.

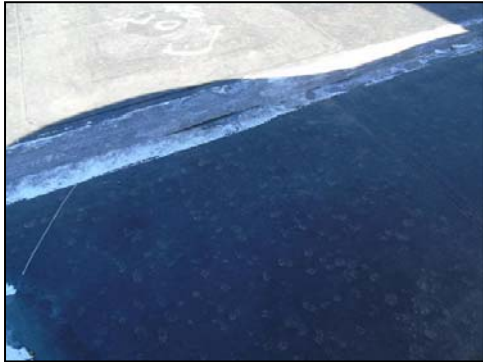
Defect Code:	3	Quantity:	Widespread	Priority:	Monitor
Description: Open lap in field membrane.					
Repair: Clean lap of all dirt and close seam. Overlay edge of affected seam with strip-in of new membrane of like material. Extend a minimum of 4" in all directions past seam edges and repair areas.

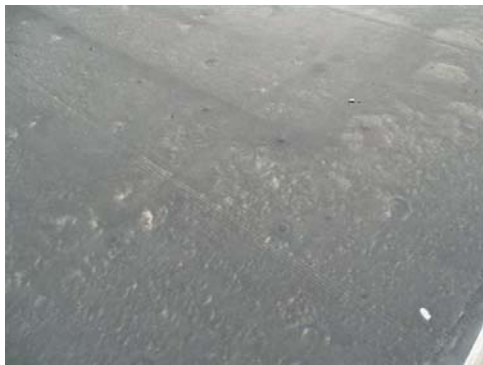
Defect Code:	10	Quantity:	Random	Priority:	Monitor
Description: Tented membrane at fastener.					
Repair: Remove fasteners that are loose or not flush with the substrate. Remove underlying substrate materials including insulation and coverboard and replace with matching materials of similar thicknesses to provide for a smooth flush surface.. Install new fasteners and plates per manufacturer's recommendations for system type and apply new membrane repair materials of similar type, gauge, and plies as existing roof system.

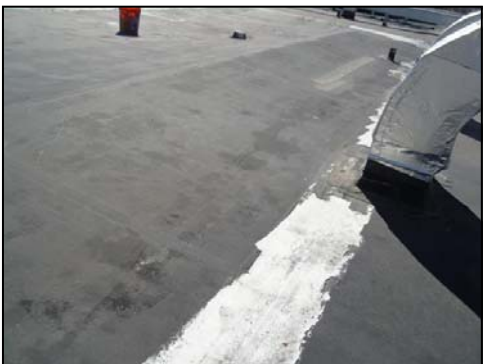
Defect Code:	18	Quantity:	Widespread	Priority:	Monitor
Description: Unadhered membrane or inadequate membrane attachment.					
Repair: At unadhered areas, cut open membrane and readhere to substrate with manufacturer's approved adhesive. At areas with missing securement, provide securement in the form of screws and plates installed a maximum of 12" O.C. Overlay repaired areas with new membrane of similar gauge, type, and plies and extend repairs a minimum of 4" past cut areas or edges of plates.

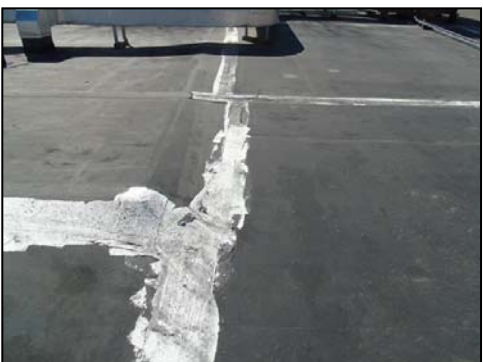
Defect Code:	24	Quantity:	Widespread	Priority:	Monitor
Description: Evidence of past problem and previous repair.					
Repair: Investigate for chronic leak problems and repair any areas that are suspect.

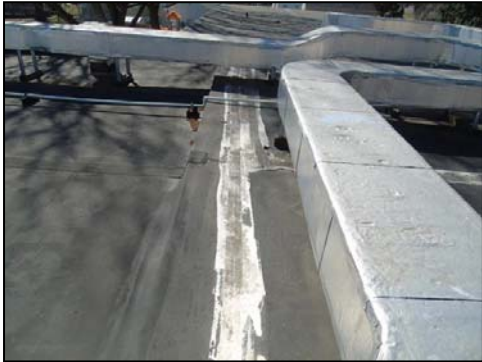
Defect Code:	44	Quantity:	Widespread	Priority:	Monitor
Description: Bridged flashing					
Cut out all bridged flashings. Clean area thoroughly and apply new flashings. Apply corner flashings and overlay all T-laps, flashings laps, and splice intersections.

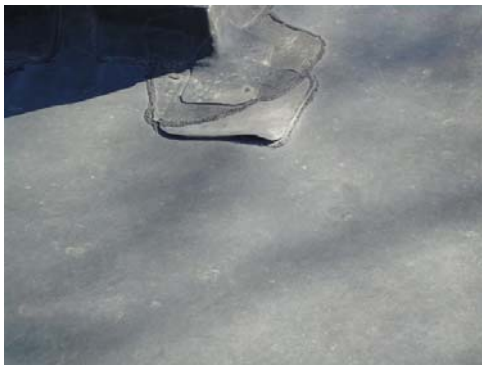
Defect Code:	45	Quantity:	Under 10 LF	Priority:	First Year
Description: Open flashing lap					
Repair: Open loose lap area and clean thoroughly. Prime and reseam or reweld lap per the manufacturer's requirements. Strip-in defective lap with mimum 6" wide membrane on single ply systems or 6" wide fabric and mastic three-course application on asphalt systems. Regranulate or coat flashing repairs.

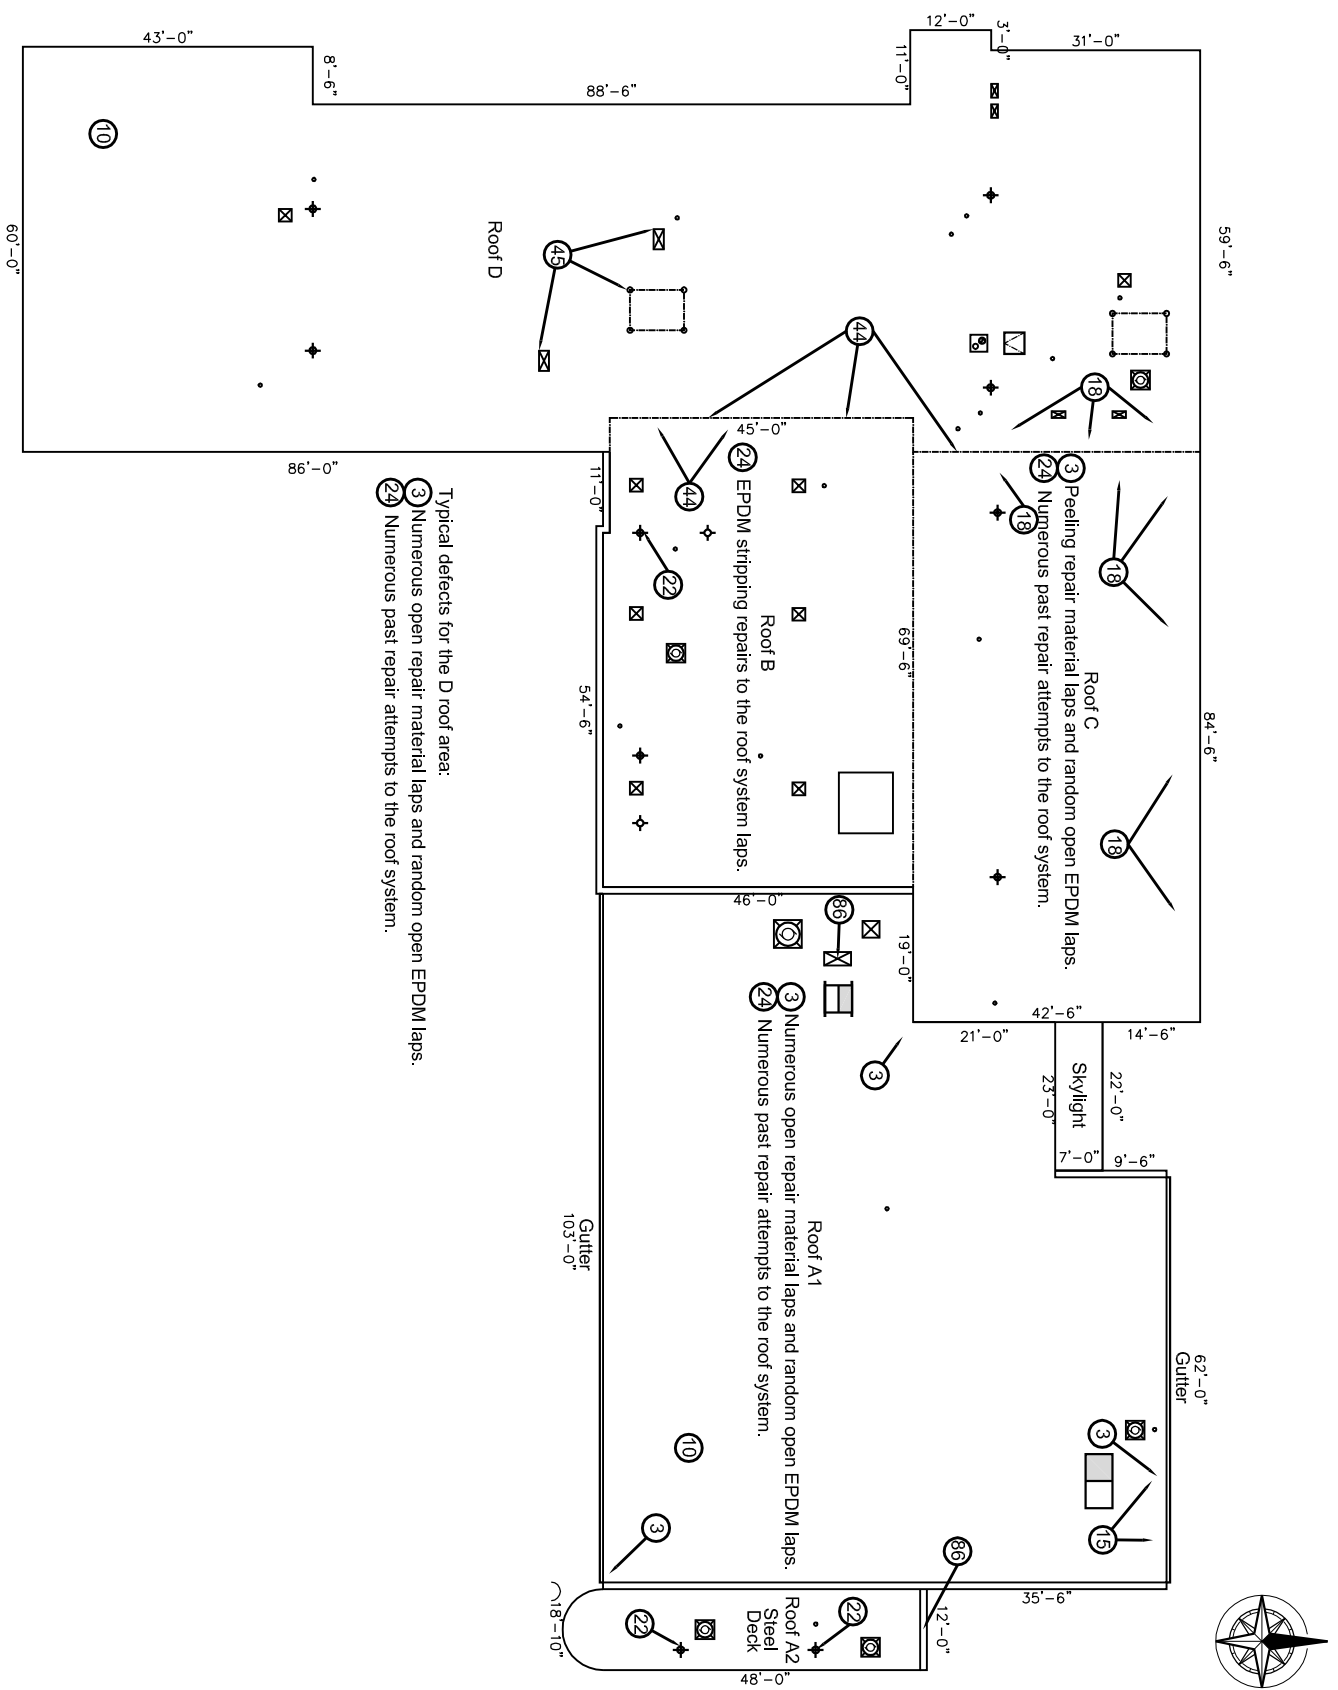
Project Number: 00-000000 **Sheet Title:** A,B,C&D-Roof Plan

Typical defects for the D roof area:
 ③ Numerous open repair material laps and random open EPDM laps.
 ②④ Numerous past repair attempts to the roof system.
