Roof Inspection Report

Fairview Elementary
14110 Tregaron Drive
Bellevue, NE 68123

Fairview Elementary_Bellevue, NE
Ph 1 Inspection Project_Roof A_2017-03-08

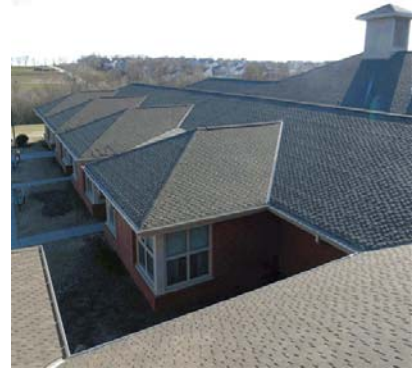
No recent leaks were reported on this roof section at the time of inspection.

Roof Section A refers to the steep sloped, shingle roof system at the Fairview Elementary School. The roof is a seventeen (17) year old laminated shingle. The roof is a hip design with valleys at the offsets in the building. The valleys are flashed with a "W" metal valley flashing. The roof system has eave vents in the soffits with a vented ridge detail and attic vents on the south side of the building. There are also raised roof areas with louvers on the sides of the structures. The rake wall details are flashed with metal shingles. The roof system has metal roof areas between the valleys at the SE corner of the building. There are three (3) metal roof areas totaling approximately 950 square feet of total roof area, which is not included into the estimated square footage of the A roof area. The metal roof system is a prefinished metal roof panel with an interlocking lap. The end laps have a metal cover plate. The dents in the roof panels do not appear to be negatively effecting the performance of the roof system at this time. The roof panels should be replaced in conjunction with the A roof area.

- Random split shingles observed
- There are what appears to be hail dents on the metal roof areas
- Random broken shingles observed
- There is bowed up metal flashings

Overall, the roof system is in fair condition due to its age. With the aforementioned defects addressed, in addition to routine maintenance and regular inspection, the roof system should remain effective for the duration of its assessed service life, approximately three (3) years. There was no warranty information available for this roof section at the time of inspection.

RSI recommends repairs be completed in accordance with the attached deficiency list.

RSI recommends a complete tear-off of existing roof system and the installation of a new twenty (20) year design life roof system. We further recommend the replacement of all perimeter coping cap and projection details per SMACNA Architectural Sheet Metal Manual.

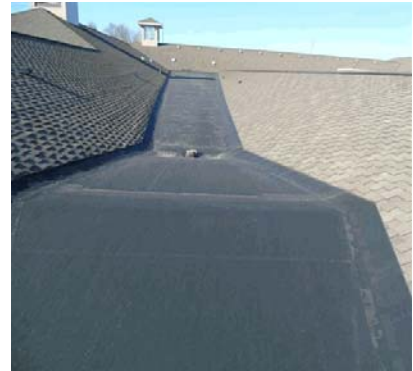
No active leaks were reported on this roof section at the time of inspection.

Date	Inspection Type	Inspecting Company	Inspector
Mar 08, 2017	Phase 1 Roof Inspection	Roofing Solutions, Inc.	Garry Hendrickson
<p>Roof Section B refers to the EPDM valley roofs at the Fairview Elementary School. The roof system is a seventeen (17) year old, fully-adhered EPDM. The roof section includes the B-1 thru B-5 roof areas. The EPDM membrane extends under the shingles on the sides of the areas. The drainage ends of the areas has the EPDM membrane adhered to the valley metal on the shingle roof areas.</p> <p>Defects and conditions found during the inspection include the following:</p> <ul style="list-style-type: none"> - Loose EPDM lap edges observed - High anchors under the EPDM flashing on the B-1 roof area - Previous repair attempts observed on the B-4 roof area <p>Overall, the roof system is in fair condition due to its age. With the aforementioned defects addressed, in addition to routine maintenance and regular inspection, the roof system should remain effective for the duration of its assessed service life, approximately three (3) years. There was no warranty information available for this roof section at the time of inspection.</p>

Budget Year	Activity Type	Action Item ?	Allocation	Urgency	Quotation \$
2017	Repair	Yes	Expense	High	\$3,500
RSI recommends repairs be completed in accordance with the attached deficiency list.					
2020	Partial Tear-Off	Yes	Capital	Moderate	\$42,150
RSI recommends a partial tear-off of the existing roof system, leaving the existing insulation in place, and installation of a new twenty (20) year design life roof system. We further recommend installation of new perimeter metal and projection details per SMACNA Architectural Sheet Metal Manual.					
					\$45,650
