# Roof Inspection Report

LeMay Elementary  
2726 Kennedy Blvd.  
Bellevue, NE 68123

Date	Inspection Type	Inspecting Company	Inspector
Mar 20, 2017	Phase 1 Roof Inspection	Roofing Solutions, Inc.	Garry Hendrickson

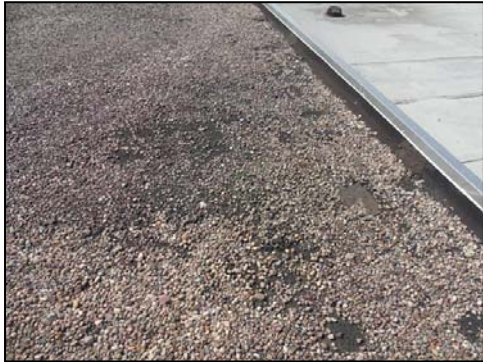
Defect Code:	8	Quantity:	Random	Priority:	Monitor
Description: Surface erosion.					
Repair: Prepare membrane surface by thoroughly cleaning and priming. Apply new surfacing of like materials to eroded areas. On gravel surfaced systems apply gravel in hot asphalt or recommended cold adhesive. Apply granulated fiberglass cap sheet or modified bitumen membrane on like systems. Apply coating system on smooth asphalt surfaces. Transition surfacing to provide for a smooth and neat finished appearance to match the existing surfacing.

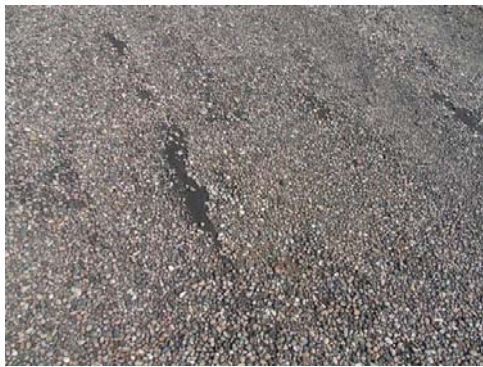
Defect Code:	11	Quantity:	Random	Priority:	Monitor
Description: Blister in field membrane or flashing.					
Repair: Monitor blisters that are not broken. Repair any broken blisters or blisters in traffic areas or those applying stress to seams or flashings. Cut out blistered membrane and remove wet materials. Apply new membrane and extend a minimum of 6" on

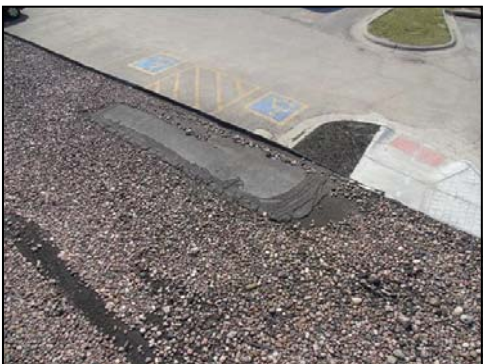
Defect Code:	24	Quantity:	Random	Priority:	Monitor
Description: Evidence of past problem and previous repair.					
Repair: Investigate for chronic leak problems and repair any areas that are suspect.

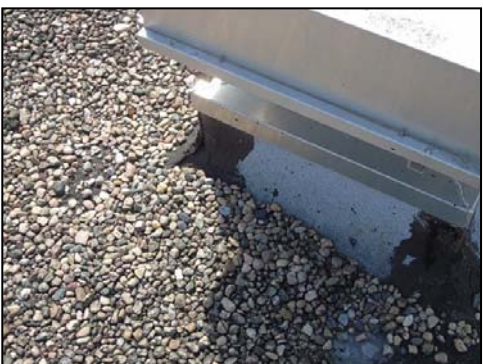
Defect Code:	45	Quantity:	Under 10 LF	Priority:	First Year
Description: Open flashing lap					
Repair: Open loose lap area and clean thoroughly. Prime and reseam or reweld lap per the manufacturer's requirements. Strip-in defective lap with mimum 6" wide membrane on single ply systems or 6" wide fabric and mastic three-course application on asphalt systems. Regranulate or coat flashing repairs.

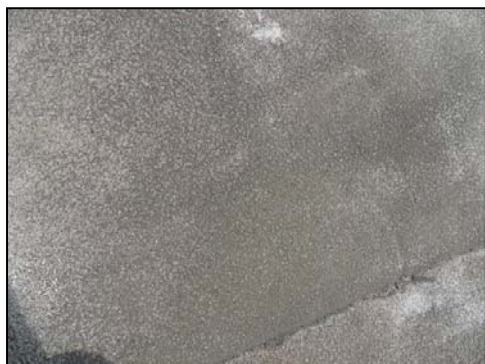
<b>Defect Code:</b>	<b>12</b>	<b>Quantity:</b>	<b>Random</b>	<b>Priority:</b>	<b>Monitor</b>
Description: Alligatoring of asphalt surfacing.					
Repair: Monitor areas and apply new membrane over severely alligatored surfaces. Extend repairs a minimum of 6" past all alligatored areas and three course edges of repairs.

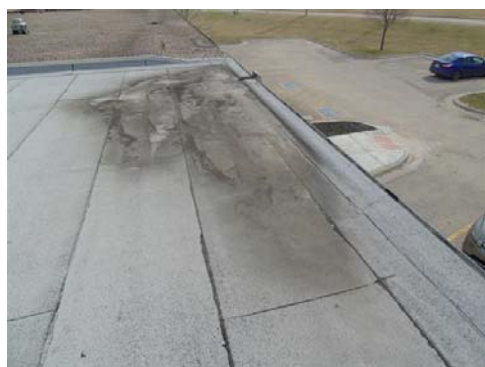
<b>Defect Code:</b>	<b>15</b>	<b>Quantity:</b>	<b>Widespread</b>	<b>Priority:</b>	<b>Monitor</b>
Description: Ponding of water.					
Repair: Monitor areas for severe or chronic ponding. Provide sacrificial membrane ply in ponded areas where existing membrane is deteriorated. Install additional drain or scupper including collectors and drain piping where ponding conditions are severe and chronic.

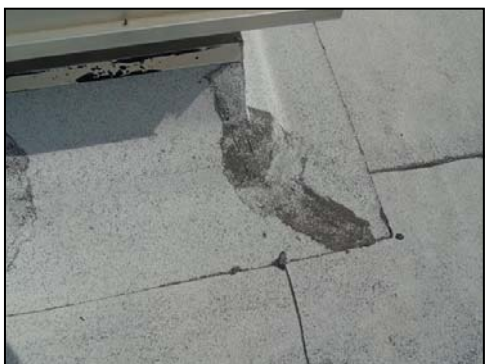
<b>Defect Code:</b>	<b>45</b>	<b>Quantity:</b>	<b>Under 10 LF</b>	<b>Priority:</b>	<b>First Year</b>
Description: Open flashing lap					
Repair: Open loose lap area and clean thoroughly. Prime and reseam or reweld lap per the manufacturer's requirements. Strip-in defective lap with mimum 6" wide membrane on single ply systems or 6" wide fabric and mastic three-course application on asphalt systems. Regranulate or coat flashing repairs.

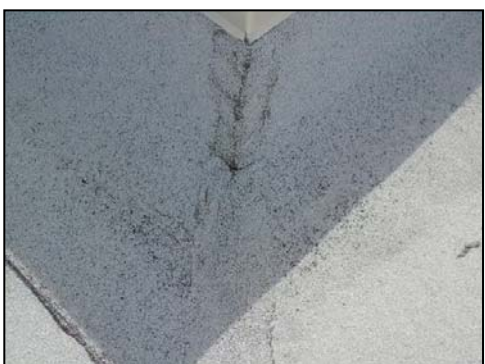
<b>Defect Code:</b>	<b>46</b>	<b>Quantity:</b>	<b>Under 10 LF</b>	<b>Priority:</b>	<b>First Year</b>
Description: Split in flashing					
Repair: Cut away loose flashing and clean and prime repair area. Apply strip in of like material centered over split extending a minimum of 4" in all directions past prepared area.

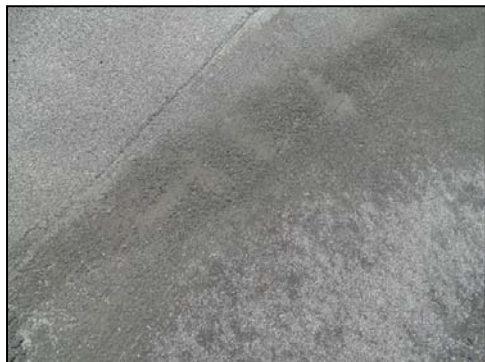
Defect Code:	12	Quantity:	Random	Priority:	Monitor
Description: Alligating of asphalt surfacing.					
Repair: Monitor areas and apply new membrane over severely alligatored surfaces. Extend repairs a minimum of 6" past all alligatored areas and three course edges of repairs.

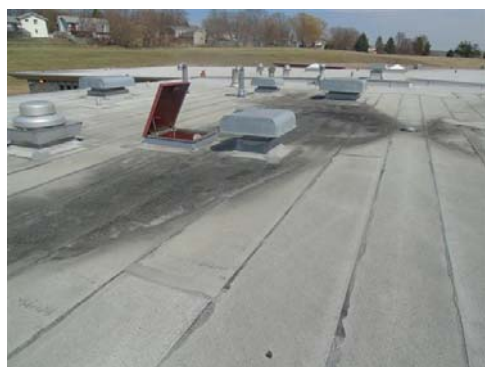
Defect Code:	15	Quantity:	Widespread	Priority:	Monitor
Description: Ponding of water.					
Repair: Monitor areas for severe or chronic ponding. Provide sacrificial membrane ply in ponded areas where existing membrane is deteriorated. Install additional drain or scupper including collectors and drain piping where ponding conditions are severe and chronic.

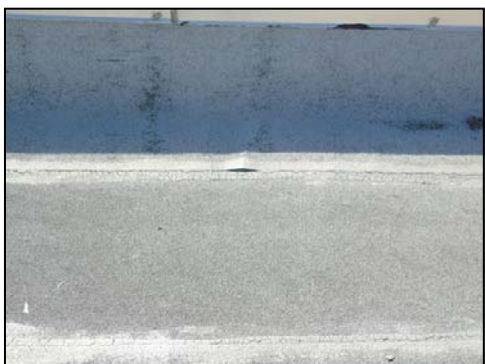
Defect Code:	45	Quantity:	Under 10 LF	Priority:	First Year
Description: Open flashing lap					
Repair: Open loose lap area and clean thoroughly. Prime and reseat or reweld lap per the manufacturer's requirements. Strip-in defective lap with mimum 6" wide membrane on single ply systems or 6" wide fabric and mastic three-course application on asphalt systems. Regranulate or coat flashing repairs.

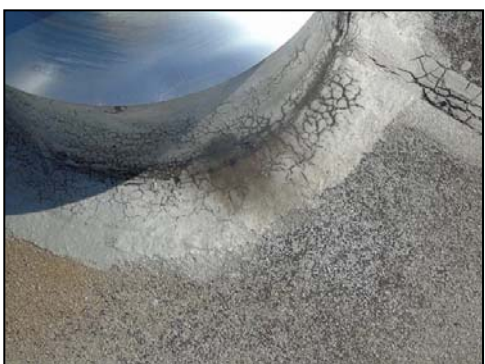
Defect Code:	46	Quantity:	10 LF	Priority:	First Year
Description: Split in flashing					
Repair: Cut away loose flashing and clean and prime repair area. Apply strip in of like material centered over split extending a minimum of 4" in all directions past prepared area.

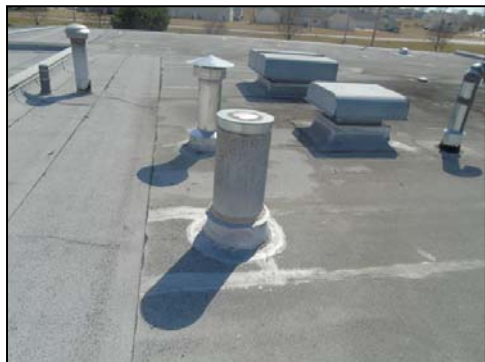
Defect Code:	56	Quantity:	2	Priority:	Monitor
Description: Abandoned and obsolete equipment.					
Repair: Monitor for leaks. Check systems are abandoned and disconnected and will not be used in the future. Remove abandoned equipment and repair deck at scheduled roof replacement.

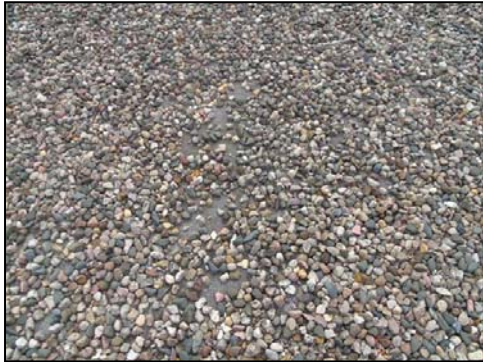
<b>Defect Code:</b>	<b>8</b>	<b>Quantity:</b>	<b>Widespread</b>	<b>Priority:</b>	<b>Monitor</b>
Description: Surface erosion.					
Repair: Prepare membrane surface by thoroughly cleaning and priming. Apply new surfacing of like materials to eroded areas. On gravel surfaced systems apply gravel in hot asphalt or recommended cold adhesive. Apply granulated fiberglass cap sheet or modified bitumen membrane on like systems. Apply coating system on smooth asphalt surfaces. Transition surfacing to provide for a smooth and neat finished appearance to match the existing surfacing.

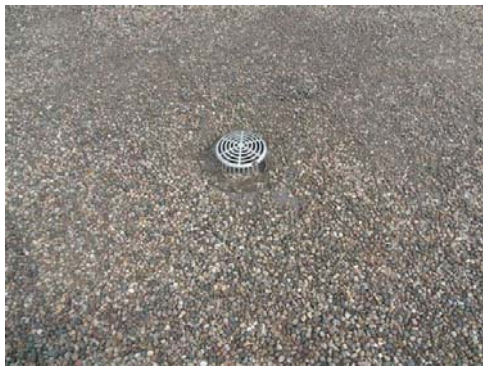
<b>Defect Code:</b>	<b>22</b>	<b>Quantity:</b>	<b>2</b>	<b>Priority:</b>	<b>First Year</b>
Description: Debris, trash, construction materials, HVAC equipment, filters, motors, etc. on roof surface.					
Repair: Remove all trash and debris from roof. Clean and inspect surfaces and repair any damages to the membrane or flashings.

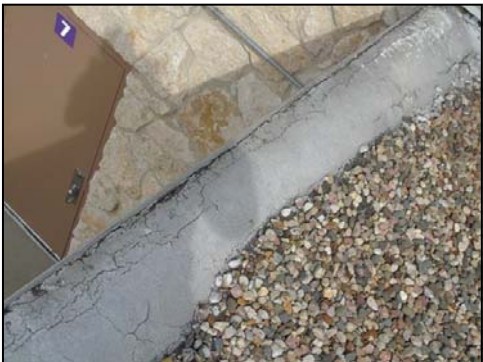
<b>Defect Code:</b>	<b>46</b>	<b>Quantity:</b>	<b>10 LF</b>	<b>Priority:</b>	<b>First Year</b>
Description: Split in flashing					
Repair: Cut away loose flashing and clean and prime repair area. Apply strip in of like material centered over split extending a minimum of 4" in all directions past prepared area.

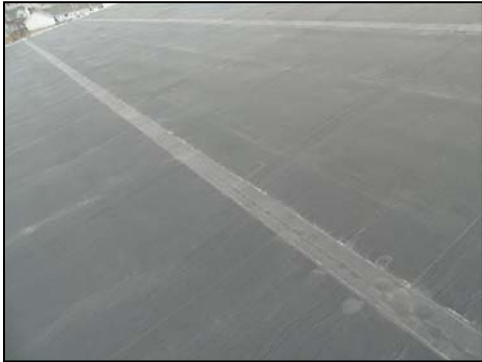
Defect Code:	24	Quantity:	Numerous	Priority:	Monitor
Description: Evidence of past problem and previous repair.					
Repair: Investigate for chronic leak problems and repair any areas that are suspect.

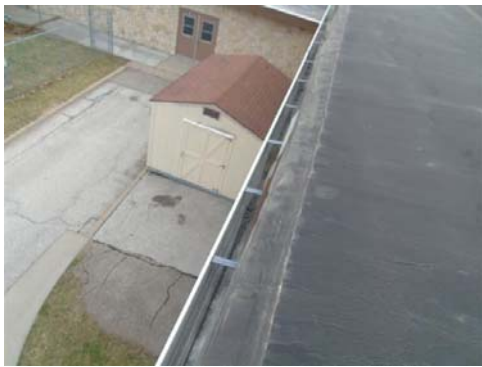
Defect Code:	86	Quantity:	Random	Priority:	Monitor
Description: Corrosion or rust					
Repair: Remove rusted components and replace with similar metal fabricated and installed per SMACNA requirements.

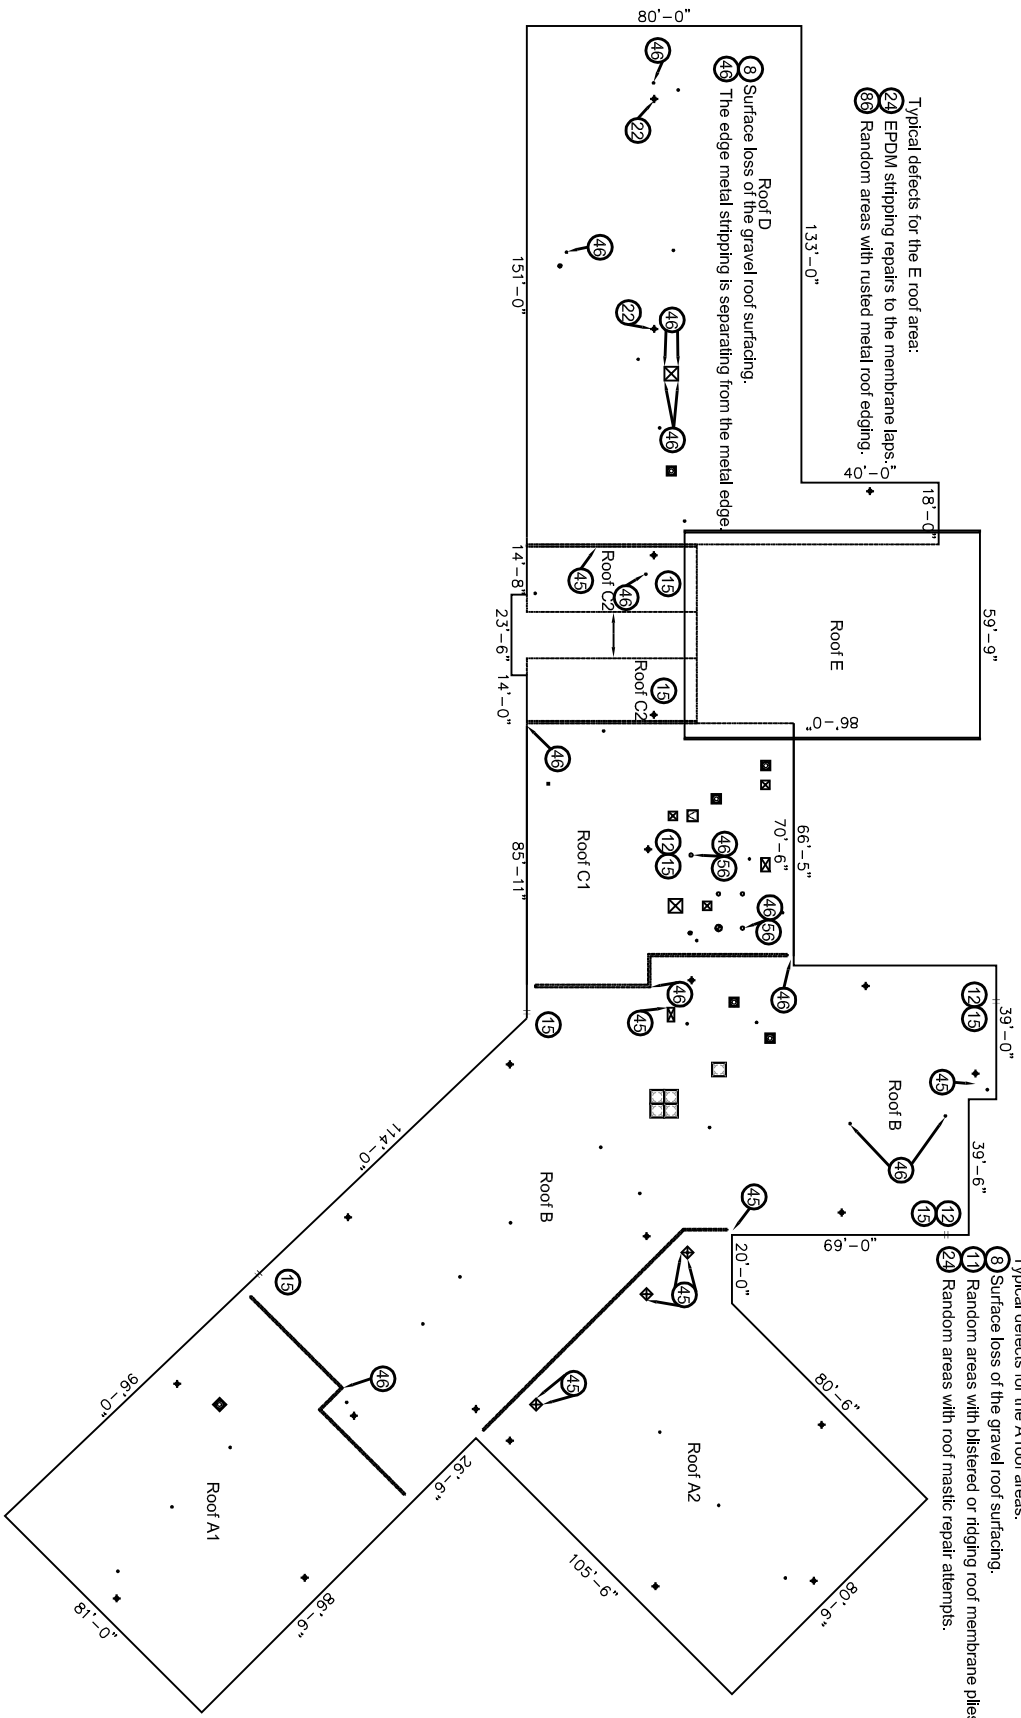
Typical defects for the E roof area:  
 24 EPDM stripping repairs to the membrane laps.  
 29 Random areas with rusted metal roofing.

Typical defects for the A roof areas:  
 8 Surface loss of the gravel roof surfacing.  
 17 Random areas with blistered or ridging roof membrane plies.  
 22 Random areas with roof mastic repair attempts.
