Roof Inspection Report

Leonard Lawrence Elementary
13204 S. 29th Street
Bellevue, NE 68123

Leonard Lawrence Elementary_Bellevue, NE
Ph 1 Roof Inspection_Roof A_2017-02-28

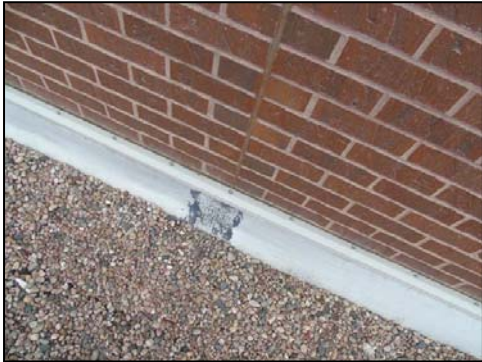
Defect Code:	1	Quantity:	Widespread	Priority:	Monitor
Description: Deteriorated or missing sealant at counterflashing, termination bar, sealant lip, metal flashing, expansion joint, etc.					
Repair: Clean loose sealant and dirt from all surfaces. Apply new polyurethane sealant and tool to shed water.

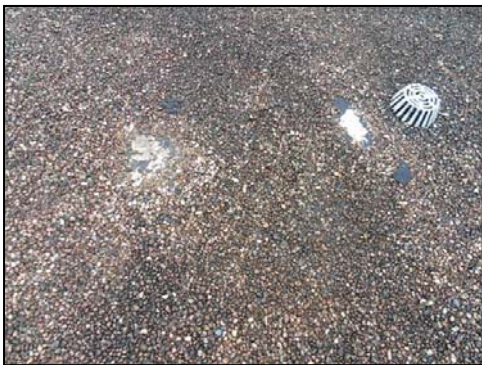
Defect Code:	8	Quantity:	Random	Priority:	Monitor
Description: Surface erosion.					
Repair: Prepare membrane surface by thoroughly cleaning and priming. Apply new surfacing of like materials to eroded areas. On gravel surfaced systems apply gravel in hot asphalt or recommended cold adhesive. Apply granulated fiberglass cap sheet or modified bitumen membrane on like systems. Apply coating system on smooth asphalt surfaces. Transition surfacing to provide for a smooth and neat finished appearance to match the existing surfacing.

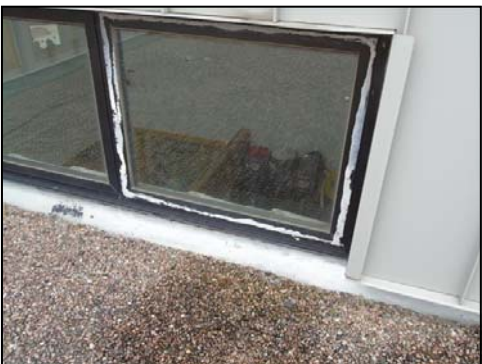
Defect Code:	24	Quantity:	Random	Priority:	Monitor
Description: Evidence of past problem and previous repair.					
Repair: Investigate for chronic leak problems and repair any areas that are suspect.

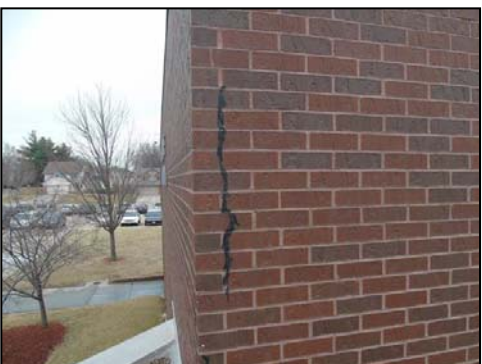
Defect Code:	24	Quantity:	Under 10 LF	Priority:	Monitor
Description: Evidence of past problem and previous repair.					
Repair: Investigate for chronic leak problems and repair any areas that are suspect.

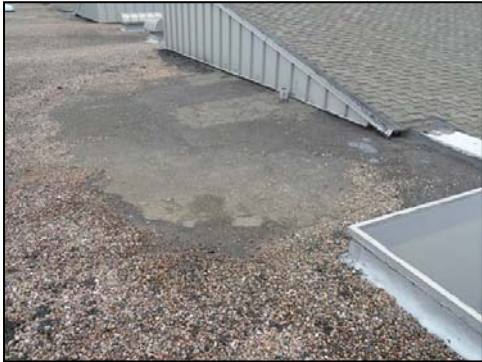
Defect Code:	24	Quantity:	Widespread	Priority:	Monitor
Description: Evidence of past problem and previous repair.					
Repair: Investigate for chronic leak problems and repair any areas that are suspect.

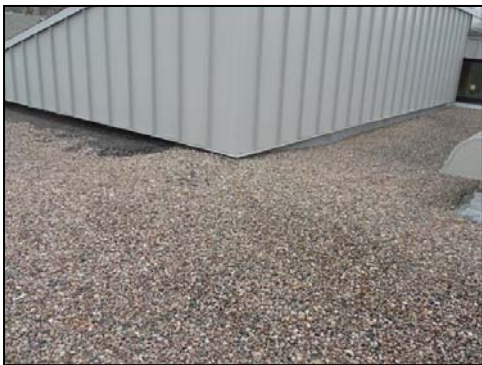
Defect Code:	40	Quantity:	Random	Priority:	Monitor
Description: Low flashing height.					
Repair: Raise flashing height to a minimum of 8" above finished roof surface. Provide appropriate termination of flashings with metal copings or counterflashings. Provide a compression bar termination of flashings to concrete or block surface if flashings cannot be maintained at 8" minimum height.

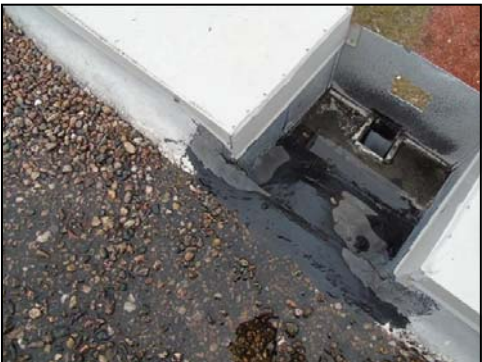
Defect Code:	46	Quantity:	Random	Priority:	First Year
Description: Split in flashing					
Repair: Cut away loose flashing and clean and prime repair area. Apply strip in of like material centered over split extending a minimum of 4" in all directions past prepared area.

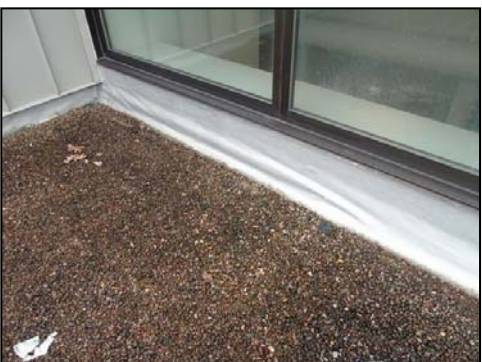
Defect Code:	47	Quantity:	Random	Priority:	Monitor
Description: Racked flashings					
Repair: Monitor flashings and repair when identified as deteriorated.

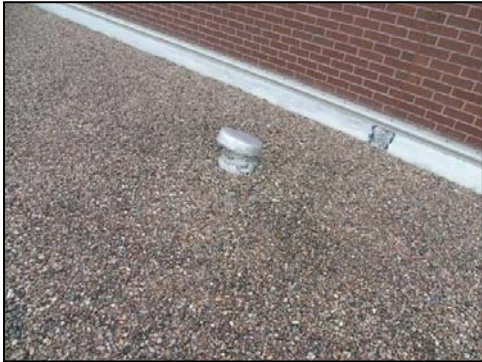
Defect Code:	52	Quantity:	1	Priority:	Monitor
Description: Missing rain cap, rain collar, or hood.					
Repair: Install rain cap, hood, or collar and secure and seal to pipe.

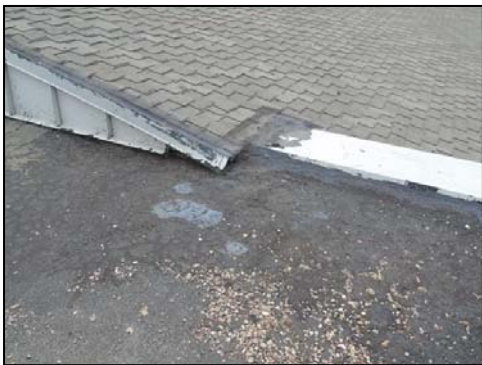
Defect Code:	76	Quantity:	Random	Priority:	Monitor
Description: Inadequate transition flashings.					
Repair: Provide custom fabricated high grade flashing materials to seal transitions between elevations and substrates.

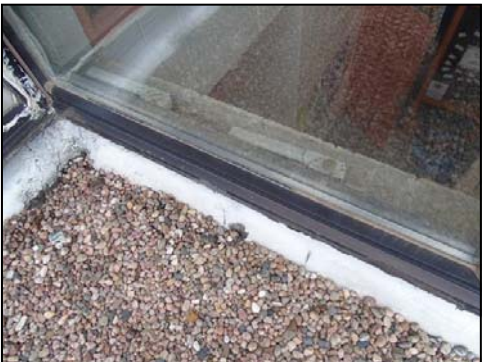
Defect Code:	89	Quantity:	Widespread	Priority:	Monitor
Description: Missing wall covering/cladding.					
Repair: Replace cladding/wall covering with matching materials and methods. Reattach and reseal all joints, seams, laps, etc.

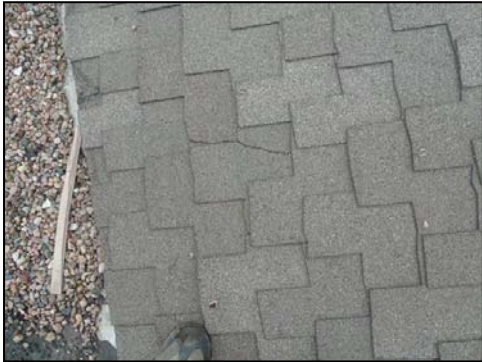
Defect Code:	6	Quantity:	Widespread	Priority:	Monitor
Description: Split in membrane.					
Repair: Cut out splits and repair membrane with similar membrane material. Extend repair material a minimum of 6" in all directions past repair areas.

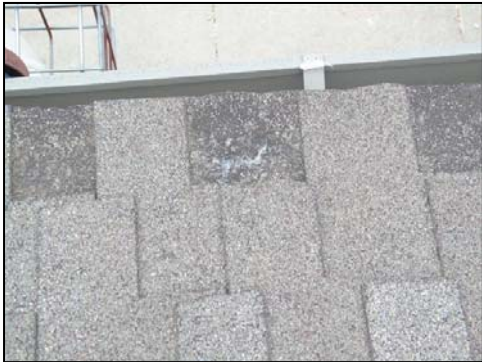
Defect Code:	9	Quantity:	Random	Priority:	Monitor
Description: Membrane deterioration.					
Repair: Replace all deteriorated membrane with new membrane of similar type, gauge, and plies.

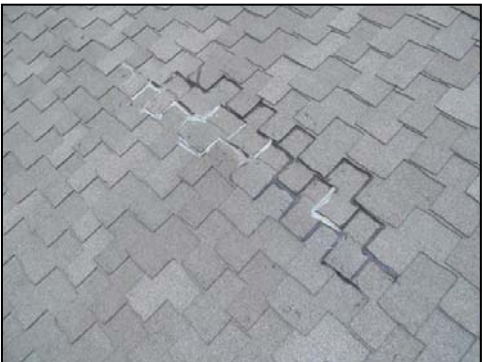
Defect Code:	24	Quantity:	Widespread	Priority:	Monitor
Description: Evidence of past problem and previous repair.					
Repair: Investigate for chronic leak problems and repair any areas that are suspect.

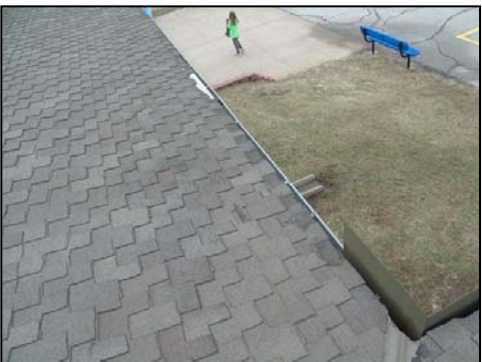
Defect Code:	29	Quantity:	Random	Priority:	Monitor
Description: Missing, loose, or broken shingles					
Repair: Remove all damaged shingles and replace all damaged and missing shingles with shingles of like kind and color.

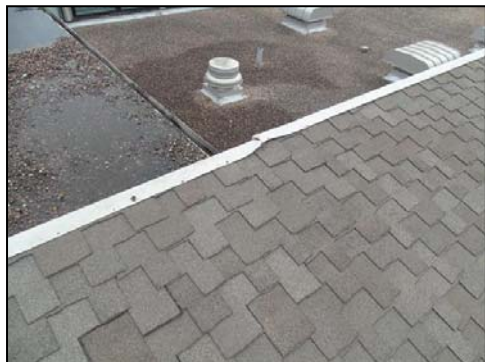
Defect Code:	75	Quantity:	Random	Priority:	Monitor
Description: Inadequate attachment of metal flashings.					
Repair: Reattach metal flashings a maximum of two EPDM washered fasteners per side of curb or attach a maximum of 12" O.C for flashings more than 24 " in length.

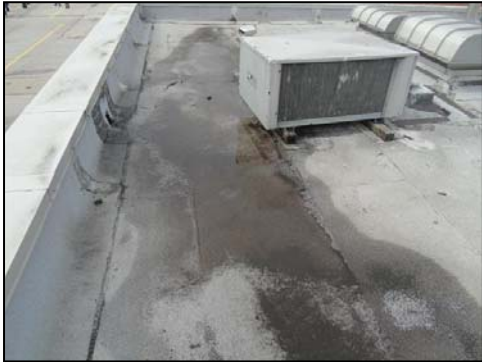
Defect Code:	15	Quantity:	2	Priority:	Monitor
Description: Ponding of water.					
Repair: Monitor areas for severe or chronic ponding. Provide sacrificial membrane ply in ponded areas where existing membrane is deteriorated. Install additional drain or scupper including collectors and drain piping where ponding conditions are severe and chronic.

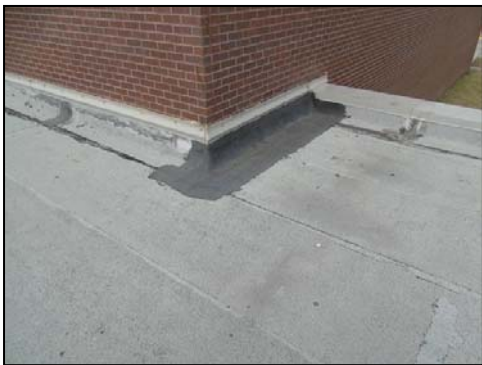
Defect Code:	24	Quantity:	Random	Priority:	Monitor
Description: Evidence of past problem and previous repair.					
Repair: Investigate for chronic leak problems and repair any areas that are suspect.

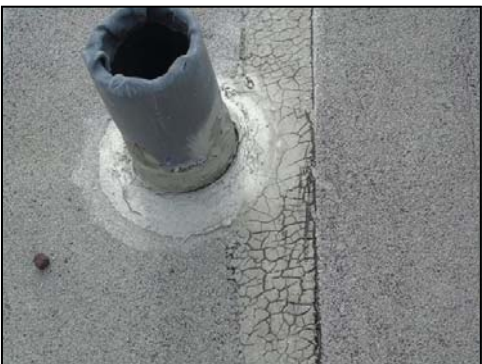
Defect Code:	46	Quantity:	10 LF	Priority:	First Year
Description: Split in flashing					
Repair: Cut away loose flashing and clean and prime repair area. Apply strip in of like material centered over split extending a minimum of 4" in all directions past prepared area.

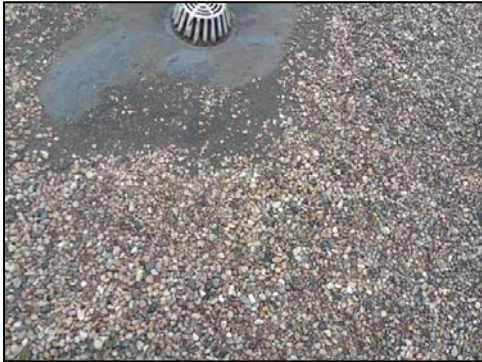
Defect Code:	8	Quantity:	Random	Priority:	Monitor
Description: Surface erosion.					
Repair: Prepare membrane surface by thoroughly cleaning and priming. Apply new surfacing of like materials to eroded areas. On gravel surfaced systems apply gravel in hot asphalt or recommended cold adhesive. Apply granulated fiberglass cap sheet or modified bitumen membrane on like systems. Apply coating system on smooth asphalt surfaces. Transition surfacing to provide for a smooth and neat finished appearance to match the existing surfacing.

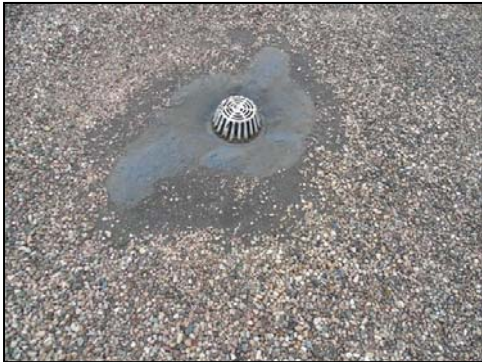
Defect Code:	24	Quantity:	1	Priority:	Monitor
Description: Evidence of past problem and previous repair.					
Repair: Investigate for chronic leak problems and repair any areas that are suspect.

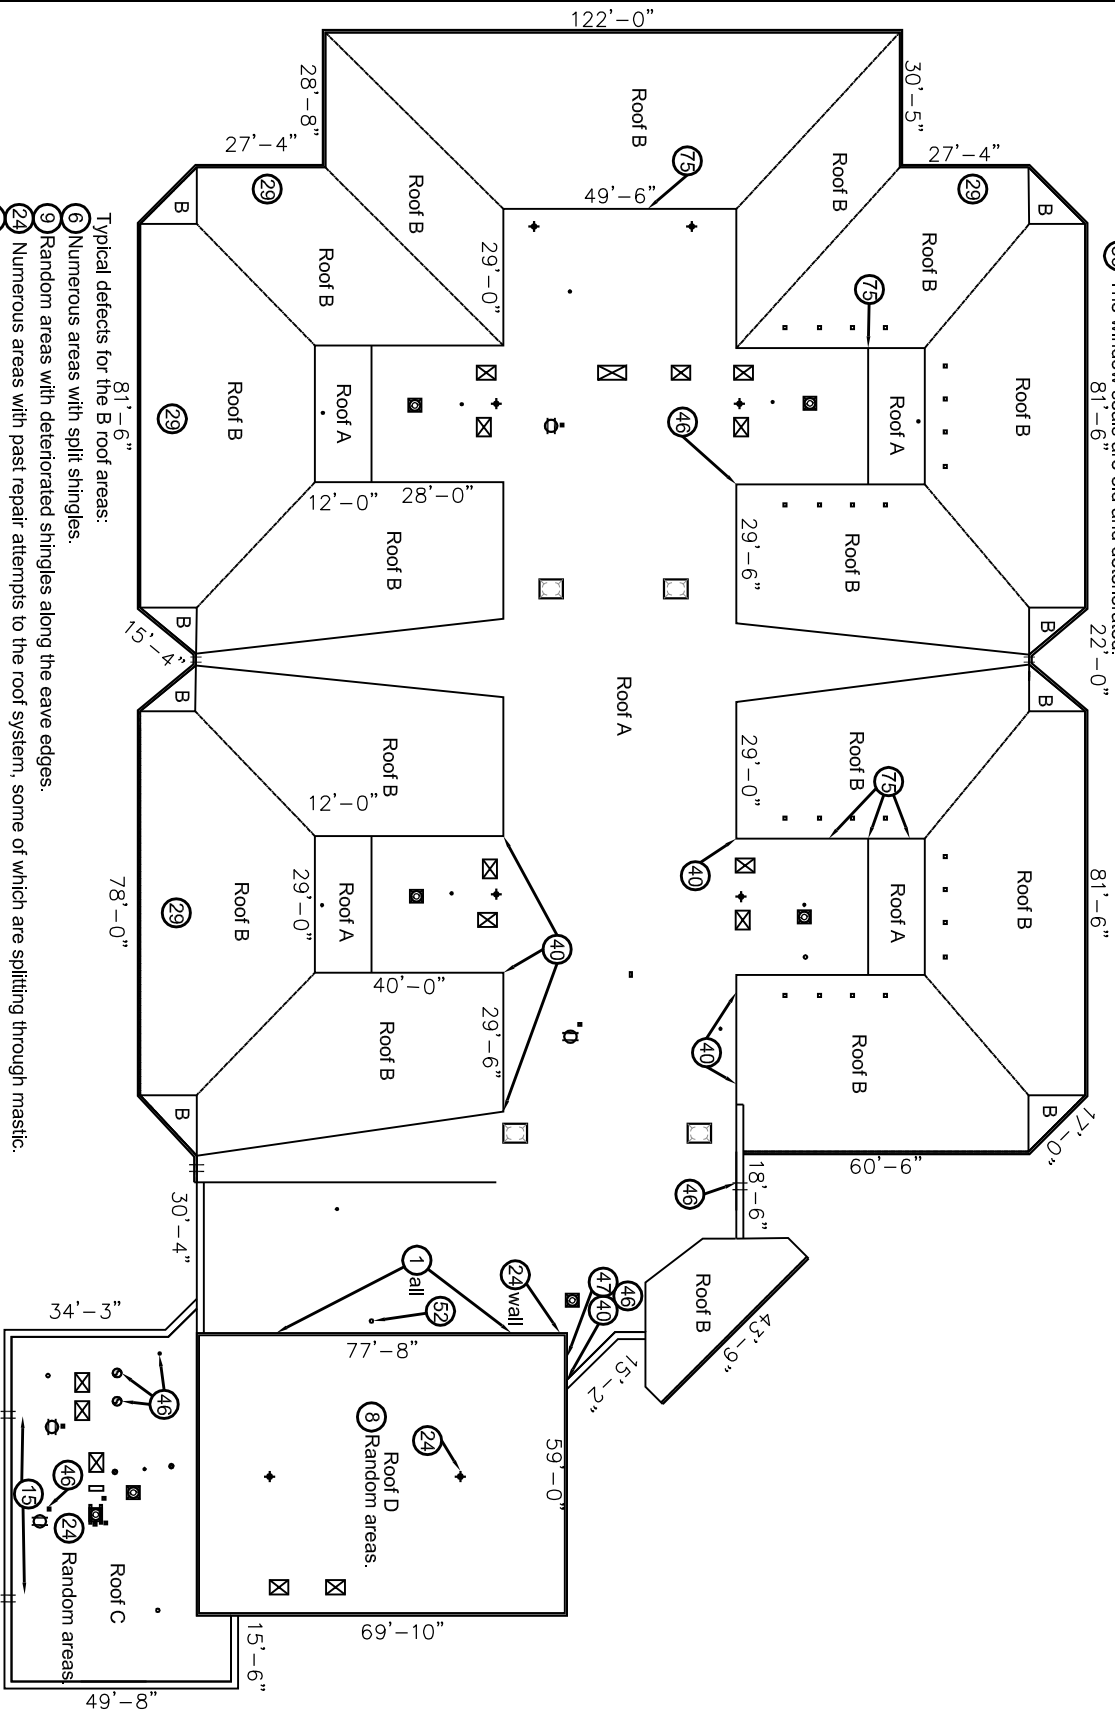
Sheet Title:
 A,B,C&D-Roof Plan

- Typical defects for the A roof area:**
- 8 Random areas with surface loss of the gravel roof surfacing.
 - 24 Numerous areas with past repair attempts to the roof system.
 - 29 Caulking repairs to the window seals.
 - 47 The BUR flashings are wrinkled or racked at the corners.
 - 76 There are poor transition flashings at the bottom ends of the shingle roof areas.
 - 89 The window seals are old and deteriorated.

- Typical defects for the B roof areas:**
- 6 Numerous areas with split shingles.
 - 9 Random areas with deteriorated shingles along the eave edges.
 - 24 Numerous areas with past repair attempts to the roof system, some of which are splitting through mastic.
 - 29 Random areas with broken and missing shingles near the eave edges.
 - 75 Random areas with loose anchors and bowed metal flashings along the top edge flashing.
