Roof Inspection Report

Lewis & Clark Middle School
13502 S. 38th Street
Bellevue, NE 68123

Lewis & Clark Middle School_Bellevue, NE
Ph 1 Roof Inspection_Roof A-1_2017-03-28

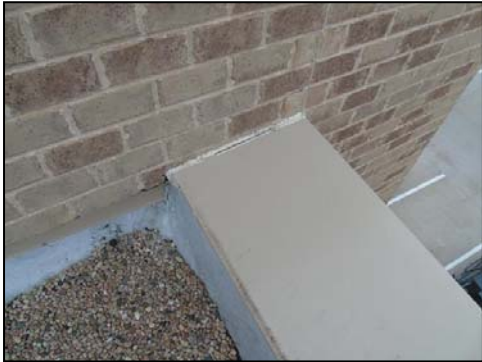
Defect Code:	1	Quantity:	Under 10 LF	Priority:	First Year
Description: Deteriorated or missing sealant at counterflashing, termination bar, sealant lip, metal flashing, expansion joint, etc.					
Repair: Clean loose sealant and dirt from all surfaces. Apply new polyurethane sealant and tool to shed water.

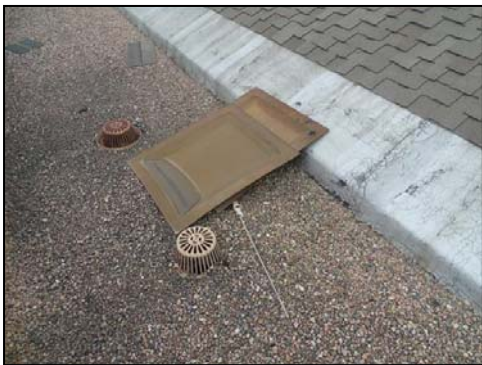
Defect Code:	22	Quantity:	Random	Priority:	First Year
Description: Debris, trash, construction materials, HVAC equipment, filters, motors, etc. on roof surface.					
Repair: Remove all trash and debris from roof. Clean and inspect surfaces and repair any damages to the membrane or flashings.

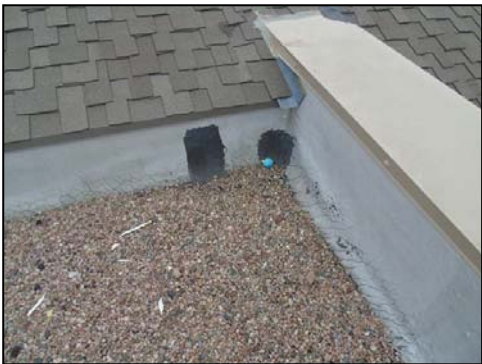
Defect Code:	24	Quantity:	Random	Priority:	Monitor
Description: Evidence of past problem and previous repair.					
Repair: Investigate for chronic leak problems and repair any areas that are suspect.

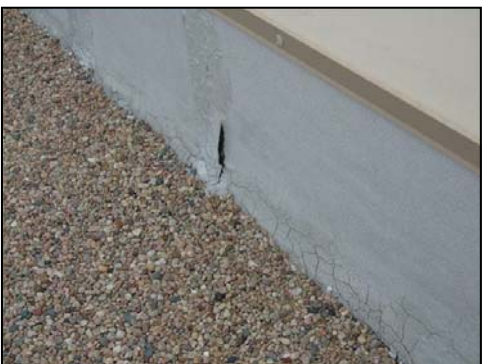
Defect Code:	45	Quantity:	Under 10 LF	Priority:	First Year
Description: Open flashing lap					
Repair: Open loose lap area and clean thoroughly. Prime and reseam or reweld lap per the manufacturer's requirements. Strip-in defective lap with minimum 6" wide membrane on single ply systems or 6" wide fabric and mastic three-course application on asphalt systems. Regranulate or coat flashing repairs.

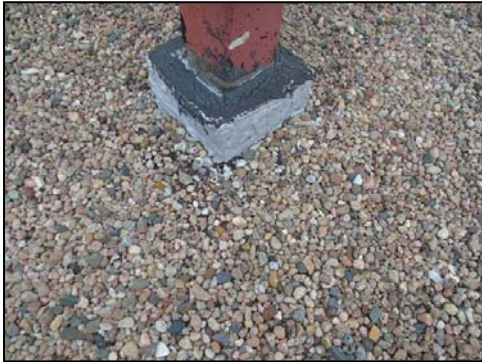
Defect Code:	46	Quantity:	Under 10 LF	Priority:	First Year
Description: Split in flashing					
Repair: Cut away loose flashing and clean and prime repair area. Apply strip in of like material centered over split extending a minimum of 4" in all directions past prepared area.

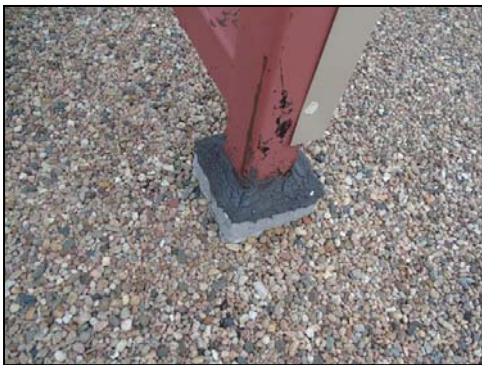
Defect Code:	55	Quantity:	2	Priority:	First Year
Description: Deteriorated or shrunken pitch pan filler.					
Repair: Clean pocket and penetrations of all dirt, insulation, and other materials and debris. Install manufacturer's recommended sealant in prepared pitch pan.

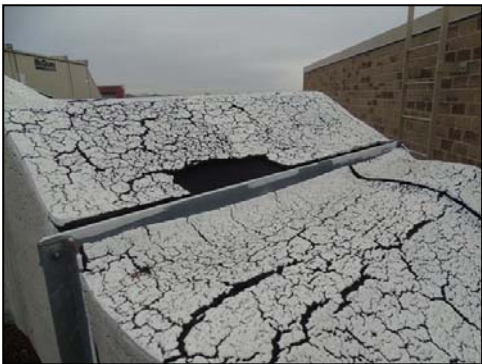
Defect Code:	87	Quantity:	Widespread	Priority:	Monitor
Description: Mechanical defect					
Repair: Repair mechanical defect. Replace or reinstall missing access doors and panels. Reseal rooftop unit, pans, ducts, curbs, etc.

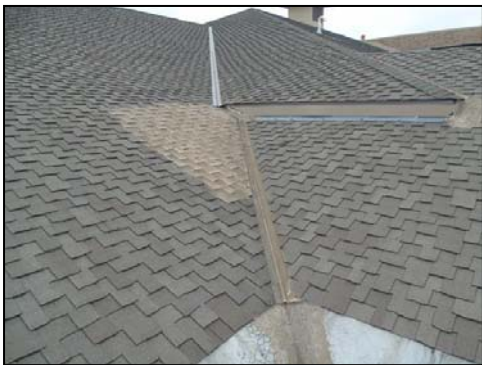
Defect Code:	24	Quantity:	Random	Priority:	Monitor
Description: Evidence of past problem and previous repair.					
Repair: Investigate for chronic leak problems and repair any areas that are suspect.

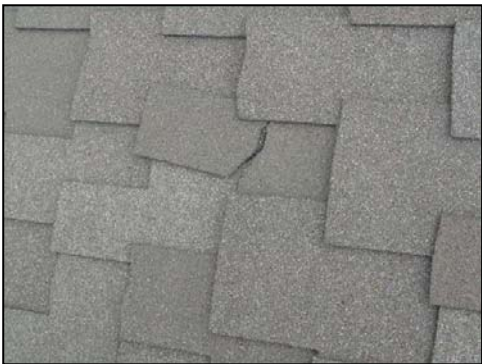
Defect Code:	29	Quantity:	Random	Priority:	Monitor
Description: Missing, loose, or broken shingles					
Repair: Remove all damaged shingles and replace all damaged and missing shingles with shingles of like kind and color.

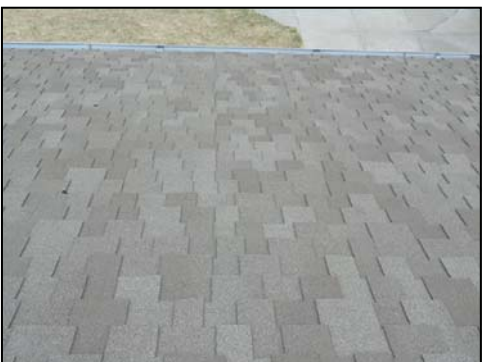
Defect Code:	58	Quantity:	Random	Priority:	Monitor
Description: Inadequate, incomplete, nonconforming membrane flashings or flashing details.					
Repair: Complete membrane flashing repairs in accordance with NRCA recommendations and good roofing practices. Follow manufacturer requirements on warranted systems.

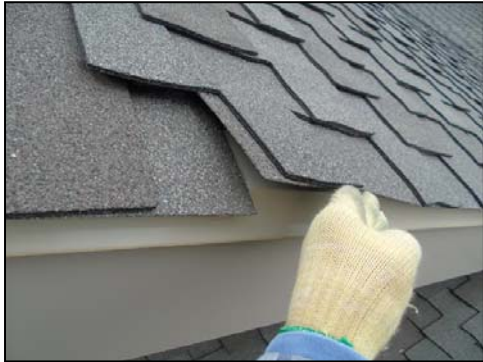
Defect Code:	58	Quantity:	Widespread	Priority:	Monitor
Description: Inadequate, incomplete, nonconforming membrane flashings or flashing details.					
Repair: Complete membrane flashing repairs in accordance with NRCA recommendations and good roofing practices. Follow manufacturer requirements on warranted systems.

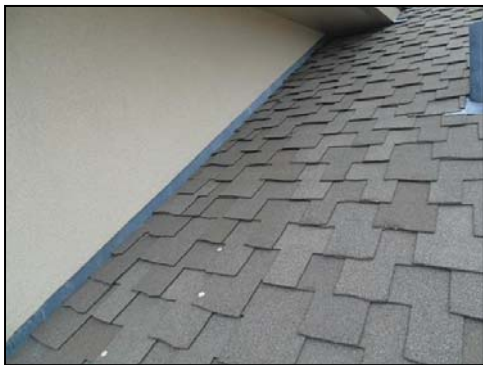
Defect Code:	58	Quantity:	Widespread	Priority:	Monitor
Description: Inadequate, incomplete, nonconforming membrane flashings or flashing details.					
Repair: Complete membrane flashing repairs in accordance with NRCA recommendations and good roofing practices. Follow manufacturer requirements on warranted systems.

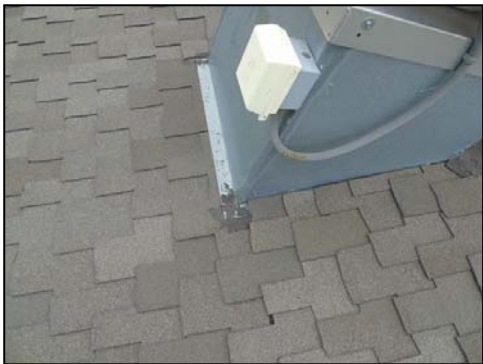
Defect Code:	58	Quantity:	7	Priority:	Monitor
Description: Inadequate, incomplete, nonconforming membrane flashings or flashing details.					
Repair: Complete membrane flashing repairs in accordance with NRCA recommendations and good roofing practices. Follow manufacturer requirements on warranted systems.

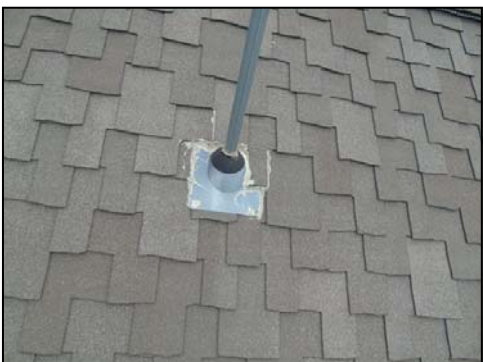
Defect Code:	58	Quantity:	2	Priority:	Monitor
Description: Inadequate, incomplete, nonconforming membrane flashings or flashing details.					
Repair: Complete membrane flashing repairs in accordance with NRCA recommendations and good roofing practices. Follow manufacturer requirements on warranted systems.

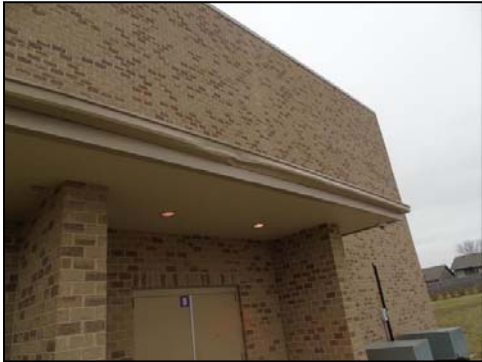
Defect Code:	78	Quantity:	Random	Priority:	Monitor
Description: Leaking or damaged gutters/downspouts.					
Repair: Replace damaged gutter and downspout sections with same gauge and style to match existing. Repair minor leaks with solder or high grade sealant.

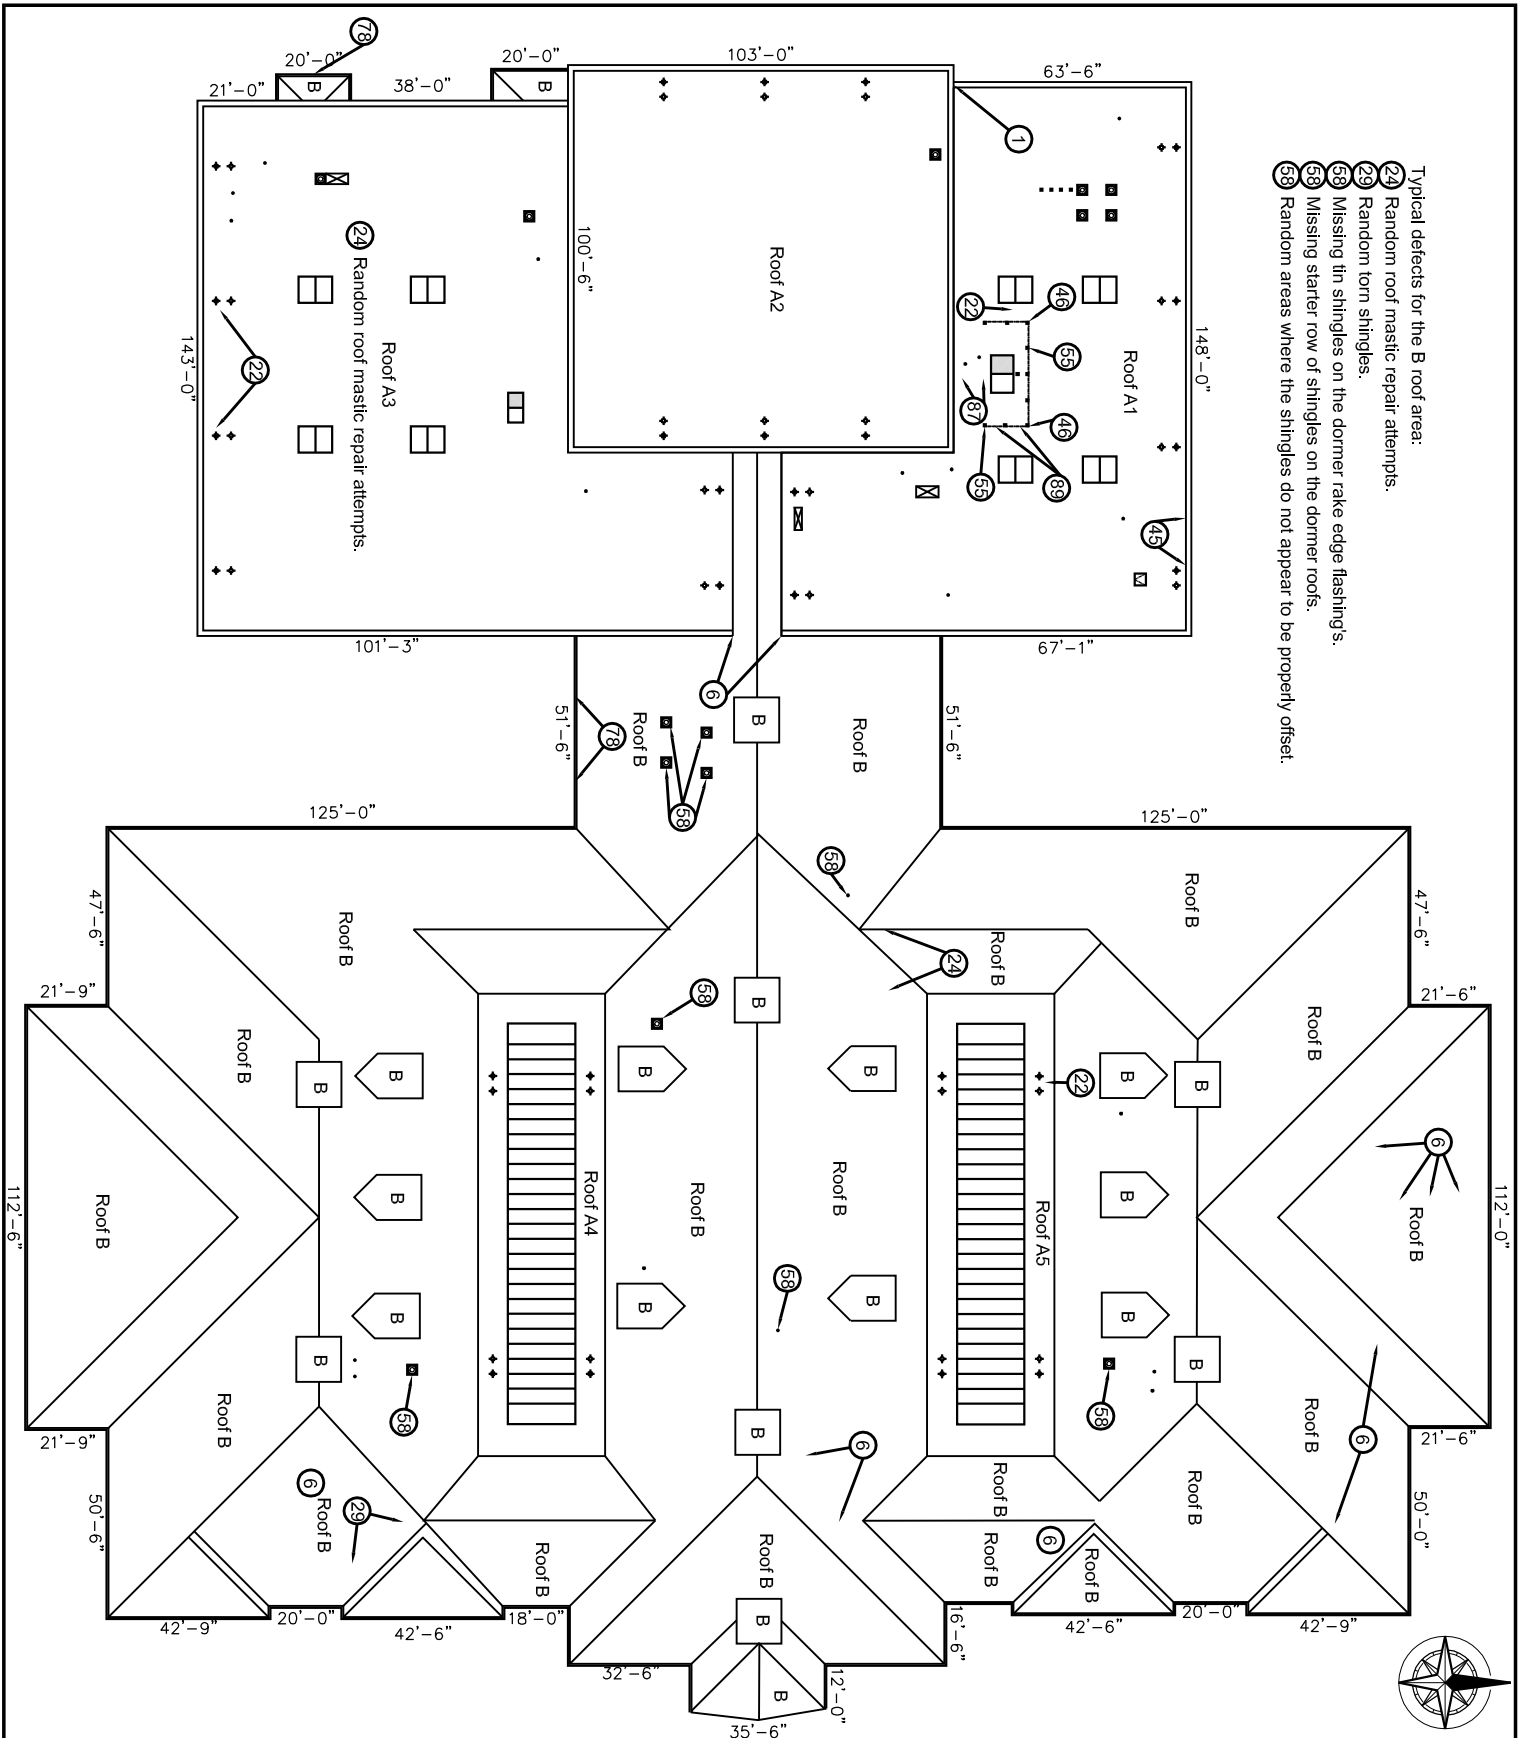
Project Number: 17-7642
Sheet Title: A&B-Roof Plan

- Typical defects for the B roof area:
- 24 Random roof mastic repair attempts.
 - 29 Random torn shingles.
 - 58 Missing tin shingles on the dormer rake edge flashings.
 - 59 Missing starter row of shingles on the dormer roofs.
 - 59 Random areas where the shingles do not appear to be properly offset.
