Roof Inspection Report

Lied Activity Center
2700 Arboretum Drive
Bellevue, NE 68005

Lied Activity Center_Bellevue, NE
Ph 1 Roof Inspection_Roof A_2017-02-28

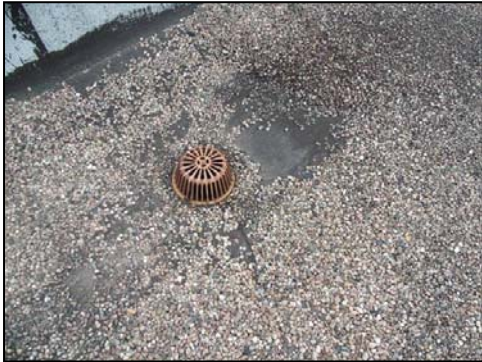
Defect Code:	8	Quantity:	Random	Priority:	Monitor
Description: Surface erosion.					
Repair: Prepare membrane surface by thoroughly cleaning and priming. Apply new surfacing of like materials to eroded areas. On gravel surfaced systems apply gravel in hot asphalt or recommended cold adhesive. Apply granulated fiberglass cap sheet or modified bitumen membrane on like systems. Apply coating system on smooth asphalt surfaces. Transition surfacing to provide for a smooth and neat finished appearance to match the existing surfacing.

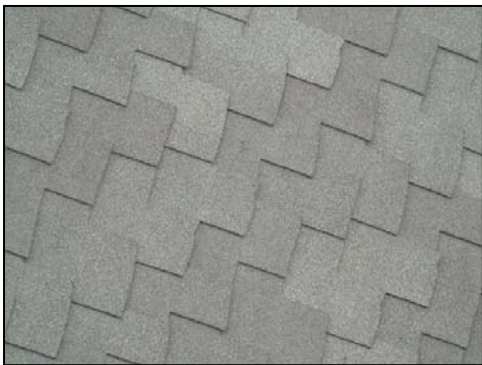
Defect Code:	23	Quantity:	Random	Priority:	Monitor
Description: Physical damage to membrane including cuts, holes, tears, scrapes, scuffs, or abrasions.					
Repair: Apply repair membrane over damaged area, extending repair material a minimum 6" past damage.

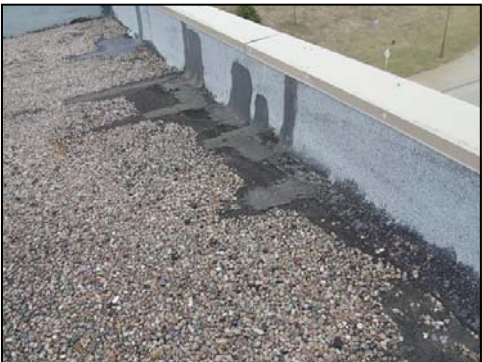
Defect Code:	24	Quantity:	Random	Priority:	Monitor
Description: Evidence of past problem and previous repair.					
Repair: Investigate for chronic leak problems and repair any areas that are suspect.

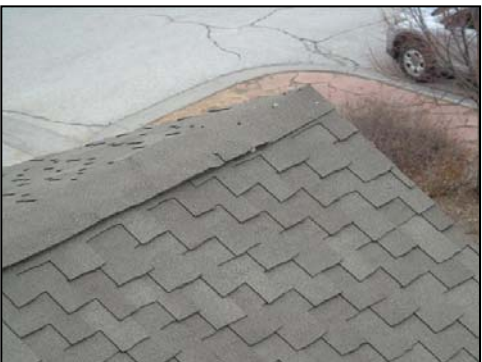
Defect Code:	29	Quantity:	1	Priority:	Monitor
Description: Missing, loose, or broken shingles					
Repair: Remove all damaged shingles and replace all damaged and missing shingles with shingles of like kind and color.

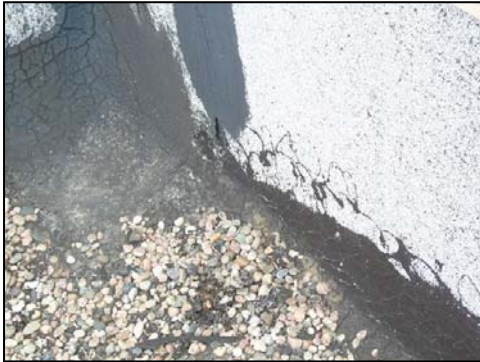
Defect Code:	45	Quantity:	Under 10 LF	Priority:	First Year
Description: Open flashing lap					
Repair: Open loose lap area and clean thoroughly. Prime and reseam or reweld lap per the manufacturer's requirements. Strip-in defective lap with minimum 6" wide membrane on single ply systems or 6" wide fabric and mastic three-course application on asphalt systems. Regranulate or coat flashing repairs.

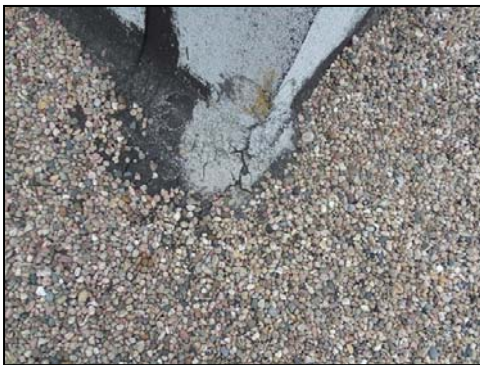
Defect Code:	46	Quantity:	10 LF	Priority:	First Year
Description: Split in flashing					
Repair: Cut away loose flashing and clean and prime repair area. Apply strip in of like material centered over split extending a minimum of 4" in all directions past prepared area.

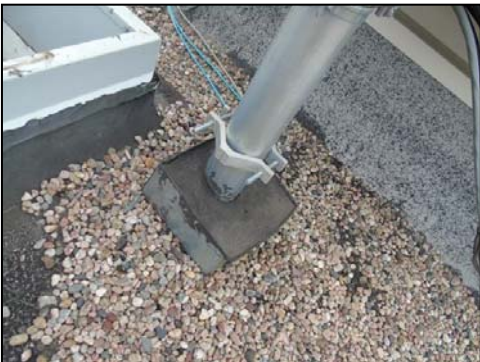
Defect Code:	55	Quantity:	1	Priority:	First Year
Description: Deteriorated or shrunken pitch pan filler.					
Repair: Clean pocket and penetrations of all dirt, insulation, and other materials and debris. Install manufacturer's recommended sealant in prepared pitch pan.

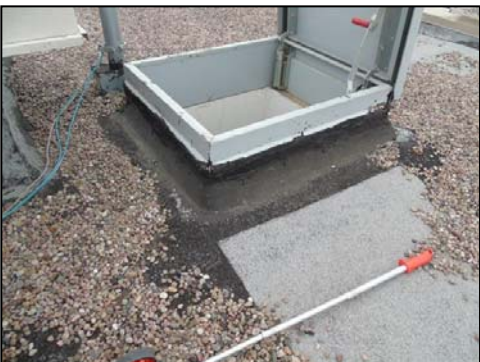
Defect Code:	58	Quantity:	20 LF	Priority:	Monitor
Description: Inadequate, incomplete, nonconforming membrane flashings or flashing details.					
Repair: Complete membrane flashing repairs in accordance with NRCA recommendations and good roofing practices. Follow manufacturer requirements on warranted systems.

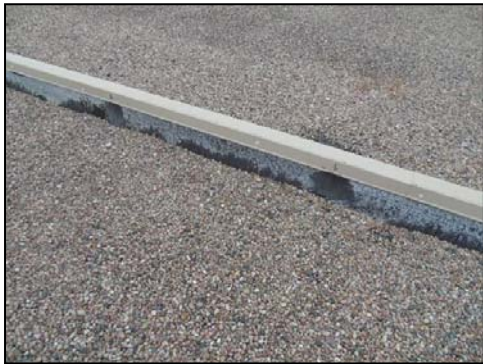
Defect Code:	24	Quantity:	Random	Priority:	Monitor
Description: Evidence of past problem and previous repair.					
Repair: Investigate for chronic leak problems and repair any areas that are suspect.

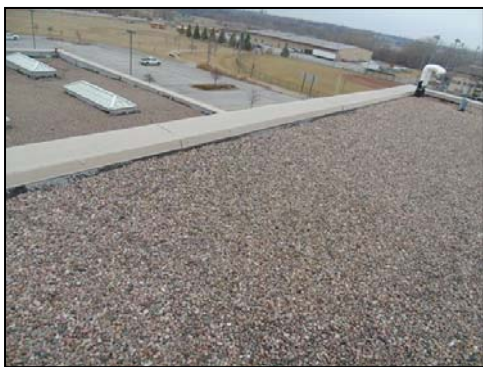
Defect Code:	40	Quantity:	35 LF	Priority:	Monitor
Description: Low flashing height.					
Repair: Raise flashing height to a minimum of 8" above finished roof surface. Provide appropriate termination of flashings with metal copings or counterflashings. Provide a compression bar termination of flashings to concrete or block surface if flashings cannot be maintained at 8" minimum height.

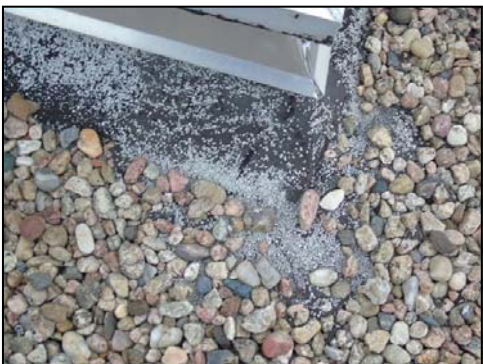
Defect Code:	46	Quantity:	10 LF	Priority:	First Year
Description: Split in flashing					
Repair: Cut away loose flashing and clean and prime repair area. Apply strip in of like material centered over split extending a minimum of 4" in all directions past prepared area.

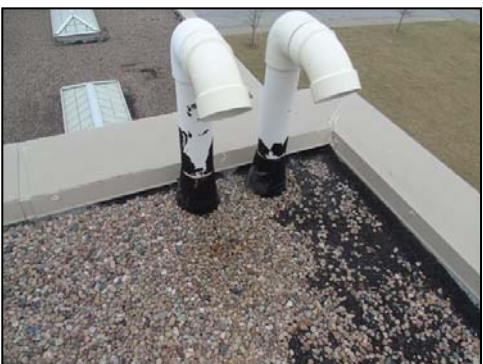
Defect Code:	52	Quantity:	2	Priority:	First Year
Description: Missing rain cap, rain collar, or hood.					
Repair: Install rain cap, hood, or collar and secure and seal to pipe.

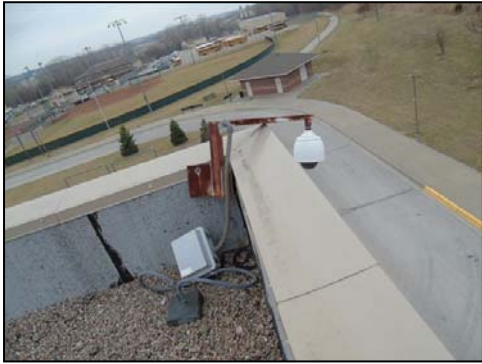
Defect Code:	81	Quantity:	1	Priority:	First Year
Description: Displaced antenna, sign, bracing, support, strap, etc.					
Repair: Reattach equipment and repair damages to membrane and flashings.

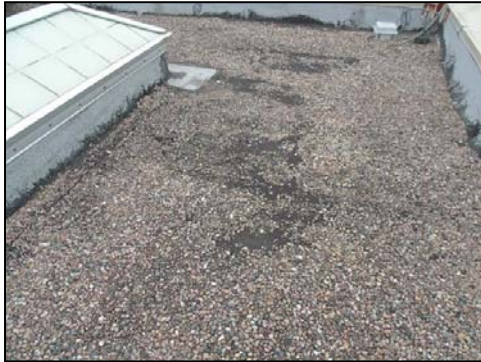
Defect Code:	8	Quantity:	Random	Priority:	Monitor
Description: Surface erosion.					
Repair: Prepare membrane surface by thoroughly cleaning and priming. Apply new surfacing of like materials to eroded areas. On gravel surfaced systems apply gravel in hot asphalt or recommended cold adhesive. Apply granulated fiberglass cap sheet or modified bitumen membrane on like systems. Apply coating system on smooth asphalt surfaces. Transition surfacing to provide for a smooth and neat finished appearance to match the existing surfacing.

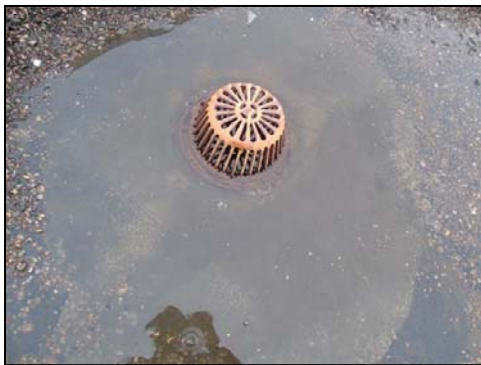
Defect Code:	16	Quantity:	1	Priority:	First Year
Description: Blocked drain, scupper, or downspout.					
Repair: Remove all debris from drainage system and ensure drain or scupper is free flowing without restrictions at strainer or piping.

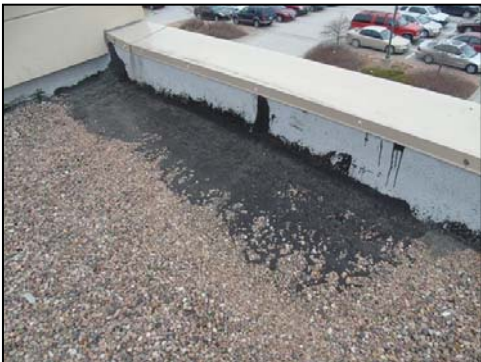
Defect Code:	24	Quantity:	Random	Priority:	Monitor
Description: Evidence of past problem and previous repair.					
Repair: Investigate for chronic leak problems and repair any areas that are suspect.

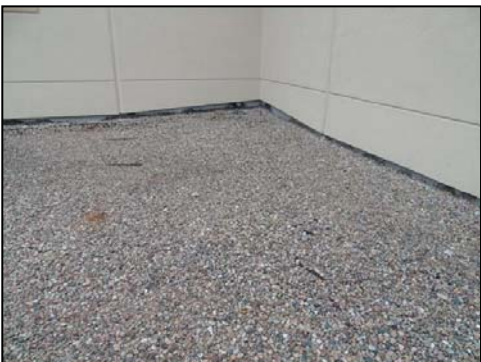
Defect Code:	40	Quantity:	Random	Priority:	Monitor
Description: Low flashing height.					
Repair: Raise flashing height to a minimum of 8" above finished roof surface. Provide appropriate termination of flashings with metal copings or counterflashings. Provide a compression bar termination of flashings to concrete or block surface if flashings cannot be maintained at 8" minimum height.

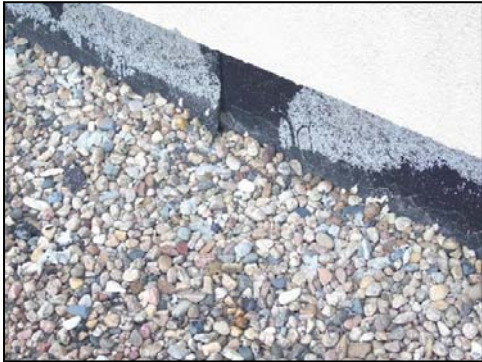
Defect Code:	45	Quantity:	Under 10 LF	Priority:	First Year
Description: Open flashing lap					
Repair: Open loose lap area and clean thoroughly. Prime and reseal or reweld lap per the manufacturer's requirements. Strip-in defective lap with mimum 6" wide membrane on single ply systems or 6" wide fabric and mastic three-course application on asphalt systems. Regranulate or coat flashing repairs.

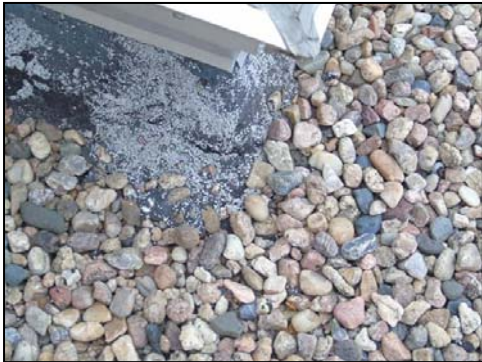
Defect Code:	46	Quantity:	10 LF	Priority:	First Year
Description: Split in flashing					
Repair: Cut away loose flashing and clean and prime repair area. Apply strip in of like material centered over split extending a minimum of 4" in all directions past prepared area.

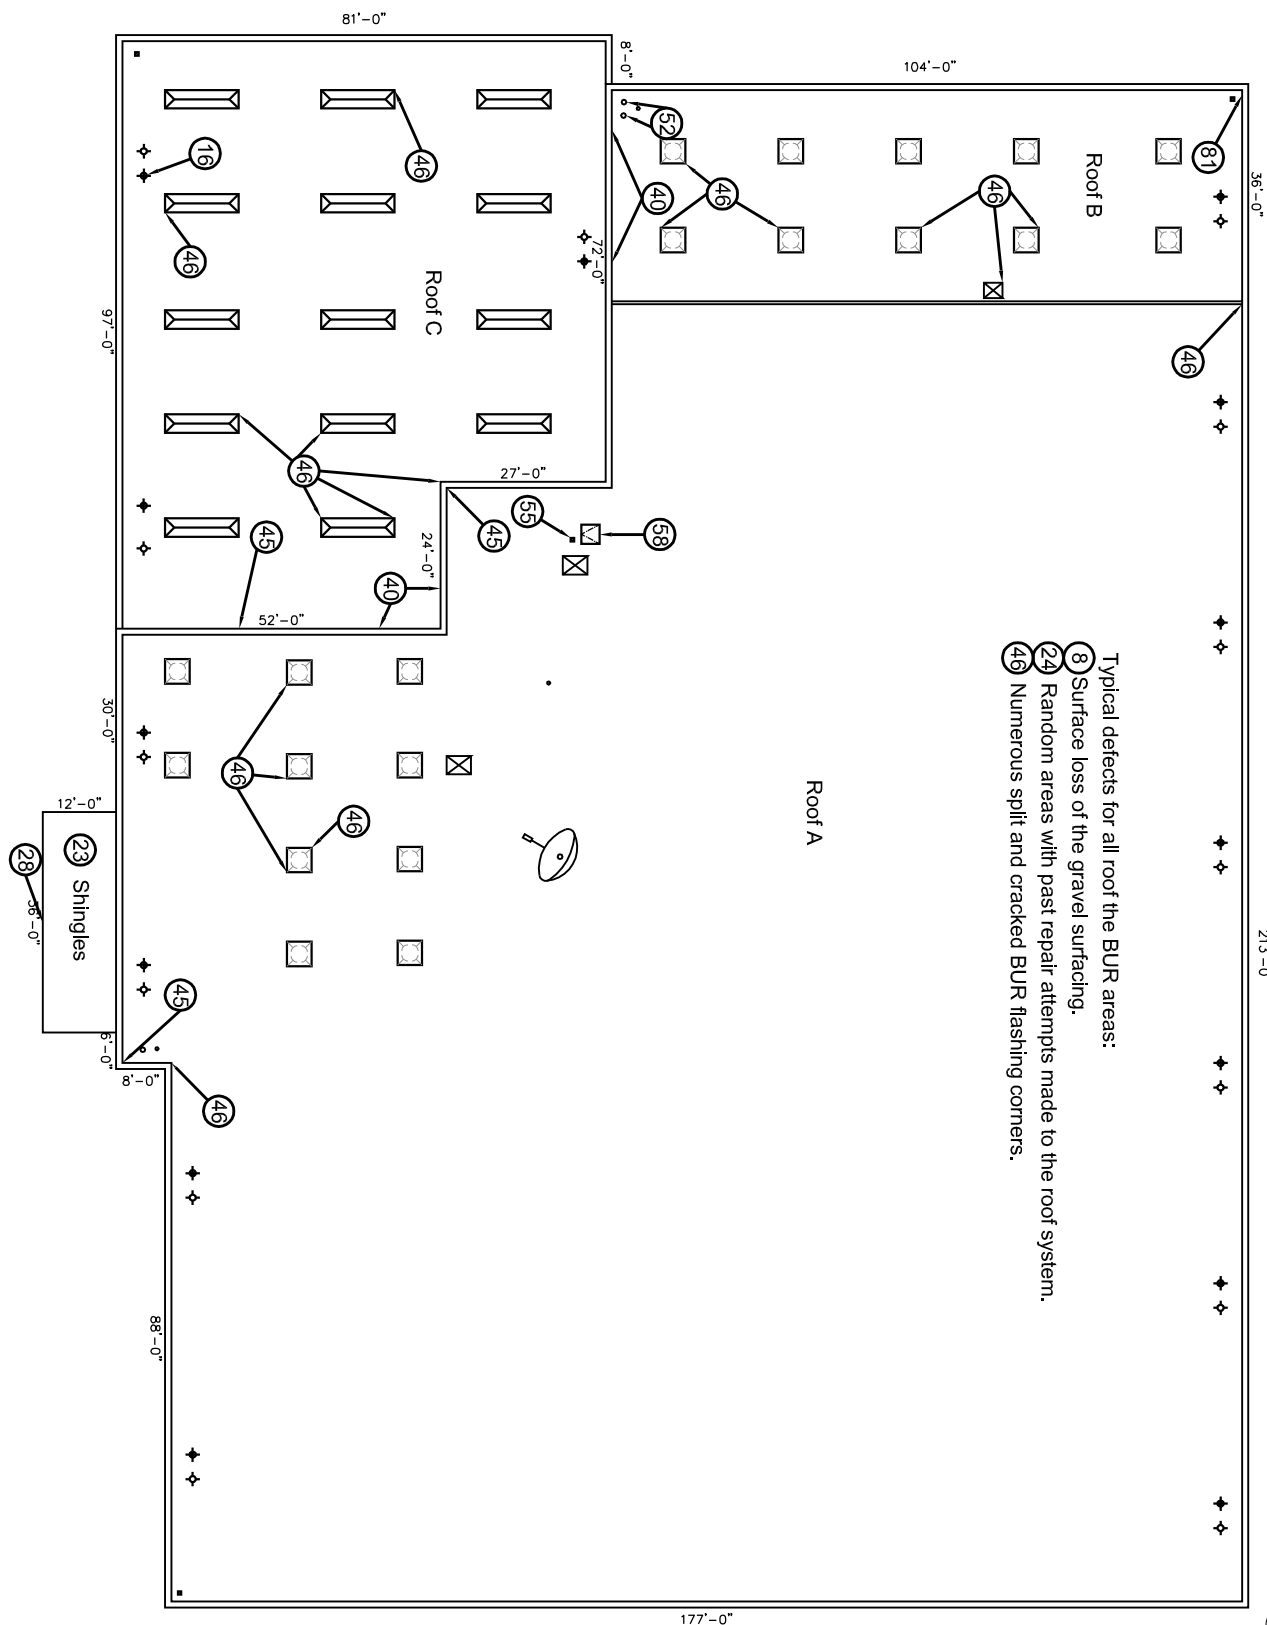
Project Number: 00-000000 **Sheet Title:** A,B&C-Roof Plan

Typical defects for all roof the BUR areas:
 8 Surface loss of the gravel surfacing.
 24 Random areas with past repair attempts made to the roof system.
 46 Numerous split and cracked BUR flashing corners.
