Roof Inspection Report

Mr. Greg Boettger
Bellevue Schools
&
Mr. Ralph Gladbach
GP Architecture, LLC.

Roofing Solutions, Inc.
6728 W. 153rd Street
Overland Park, KS 66223

Mission Middle School
2202 S. Washington Street
Bellevue, NE 68005

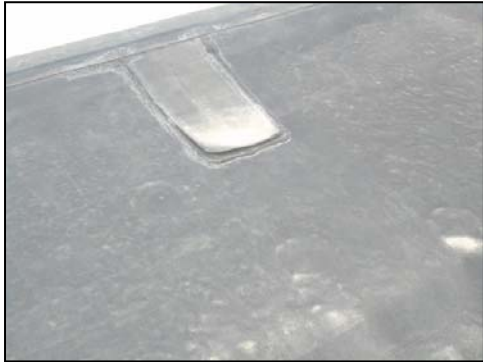
Defect Code:	3	Quantity:	Widespread	Priority:	Monitor
Description: Open lap in field membrane.					
Repair: Clean lap of all dirt and close seam. Overlay edge of affected seam with strip-in of new membrane of like material. Extend a minimum of 4" in all directions past seam edges and repair areas.

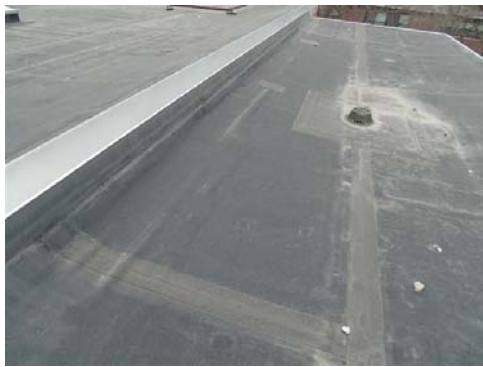
Defect Code:	18	Quantity:	Random	Priority:	Monitor
Description: Unadhered membrane or inadequate membrane attachment.					
Repair: At unadhered areas, cut open membrane and readhere to substrate with manufacturer's approved adhesive. At areas with missing securement, provide securement in the form of screws and plates installed a maximum of 12" O.C. Overlay repaired areas with new membrane of similar gauge, type, and plies and extend repairs a minimum of 4" past cut areas or edges of plates.

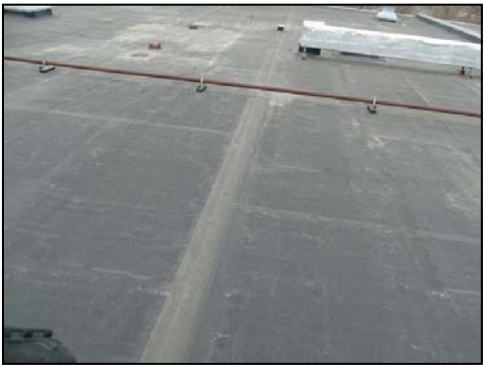
Defect Code:	24	Quantity:	Widespread	Priority:	Monitor
Description: Evidence of past problem and previous repair.					
Repair: Investigate for chronic leak problems and repair any areas that are suspect.

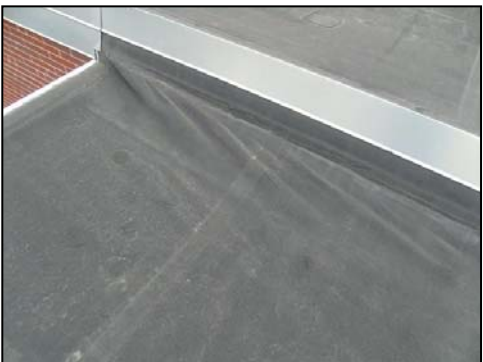
Defect Code:	26	Quantity:	Random	Priority:	Monitor
Description: Membrane shrinkage					
Repair: Investigate and repair cause of shrinkage. Cut away affected areas and prepare to receive new membrane. Install new membrane and secure at base flashings. Adhere to walls and substrates and reinstall metal copings, counterflashings, and termination bars to complete the repair. On ballasted systems redistribute ballast evenly.

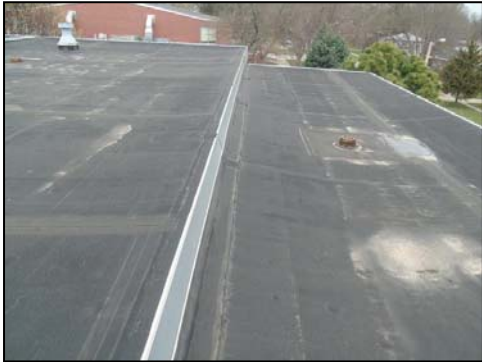
Defect Code:	44	Quantity:	Random	Priority:	Monitor
Description: Bridged flashing					
Cut out all bridged flashings. Clean area thoroughly and apply new flashings. Apply corner flashings and overlay all T-laps, flashings laps, and splice intersections.

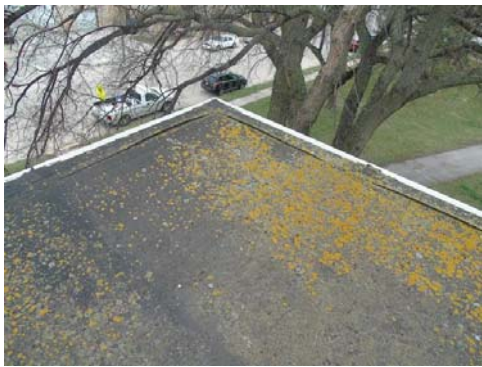
Defect Code:	45	Quantity:	Widespread	Priority:	Monitor
Description: Open flashing lap					
Repair: Open loose lap area and clean thoroughly. Prime and reseam or reweld lap per the manufacturer's requirements. Strip-in defective lap with mimum 6" wide membrane on single ply systems or 6" wide fabric and mastic three-course application on asphalt systems. Regranulate or coat flashing repairs.

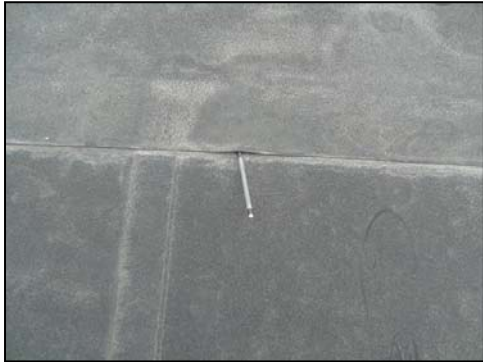
Defect Code:	3	Quantity:	Widespread	Priority:	Monitor
Description: Open lap in field membrane.					
Repair: Clean lap of all dirt and close seam. Overlay edge of affected seam with strip-in of new membrane of like material. Extend a minimum of 4" in all directions past seam edges and repair areas.

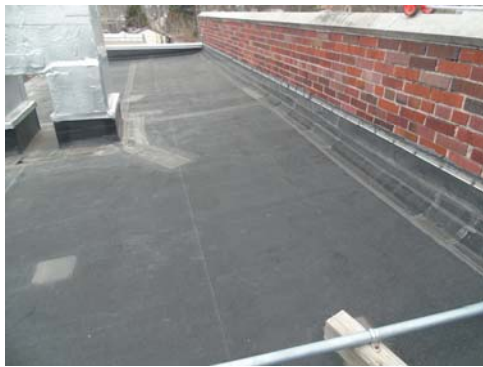
Defect Code:	18	Quantity:	500 SF	Priority:	Monitor
Description: Unadhered membrane or inadequate membrane attachment.					
Repair: At unadhered areas, cut open membrane and readhere to substrate with manufacturer's approved adhesive. At areas with missing securement, provide securement in the form of screws and plates installed a maximum of 12" O.C. Overlay repaired areas with new membrane of similar gauge, type, and plies and extend repairs a minimum of 4" past cut areas or edges of plates.

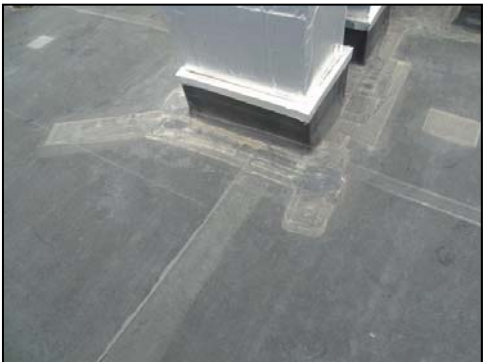
Defect Code:	24	Quantity:	Random	Priority:	Monitor
Description: Evidence of past problem and previous repair.					
Repair: Investigate for chronic leak problems and repair any areas that are suspect.

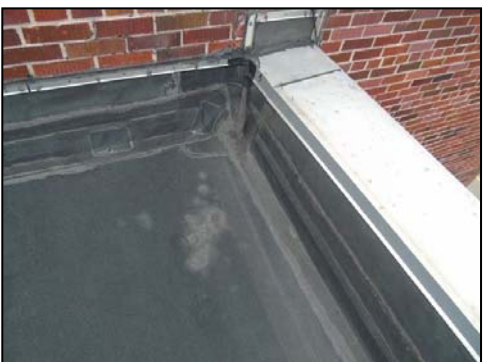
Defect Code:	26	Quantity:	Random	Priority:	Monitor
Description: Membrane shrinkage					
Repair: Investigate and repair cause of shrinkage. Cut away affected areas and prepare to receive new membrane. Install new membrane and secure at base flashings. Adhere to walls and substrates and reinstall metal copings, counterflashings, and termination bars to complete the repair. On ballasted systems redistribute ballast evenly.

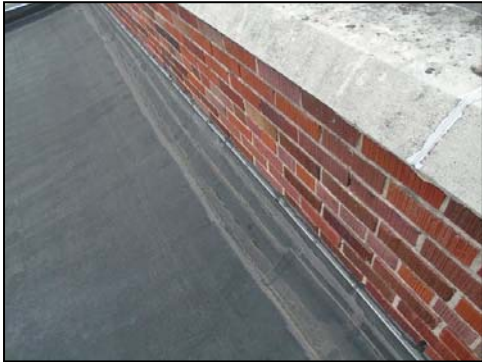
Defect Code:	44	Quantity:	Widespread	Priority:	Monitor
Description: Bridged flashing					
Cut out all bridged flashings. Clean area thoroughly and apply new flashings. Apply corner flashings and overlay all T-laps, flashings laps, and splice intersections.

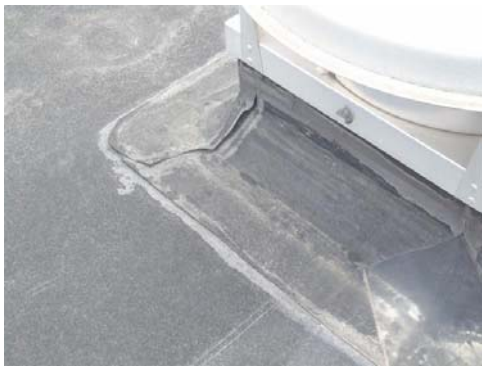
Defect Code:	45	Quantity:	Widespread	Priority:	Monitor
Description: Open flashing lap					
Repair: Open loose lap area and clean thoroughly. Prime and reseam or reweld lap per the manufacturer's requirements. Strip-in defective lap with mimum 6" wide membrane on single ply systems or 6" wide fabric and mastic three-course application on asphalt systems. Regranulate or coat flashing repairs.

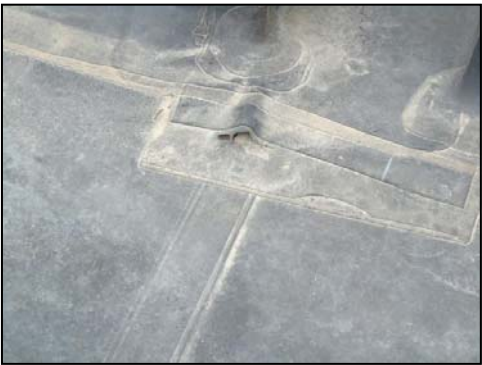
Defect Code:	46	Quantity:	Under 10 LF	Priority:	First Year
Description: Split in flashing					
Repair: Cut away loose flashing and clean and prime repair area. Apply strip in of like material centered over split extending a minimum of 4" in all directions past prepared area.

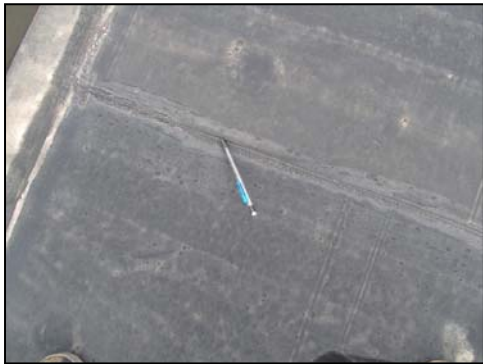
Defect Code:	3	Quantity:	Widespread	Priority:	Monitor
Description: Open lap in field membrane.					
Repair: Clean lap of all dirt and close seam. Overlay edge of affected seam with strip-in of new membrane of like material. Extend a minimum of 4" in all directions past seam edges and repair areas.

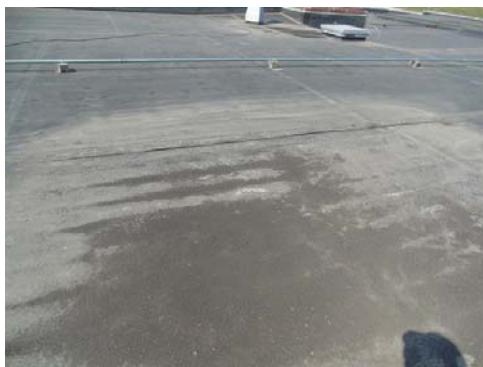
Defect Code:	15	Quantity:	Random	Priority:	Monitor
Description: Ponding of water.					
Repair: Monitor areas for severe or chronic ponding. Provide sacrificial membrane ply in ponded areas where existing membrane is deteriorated. Install additional drain or scupper including collectors and drain piping where ponding conditions are severe and chronic.

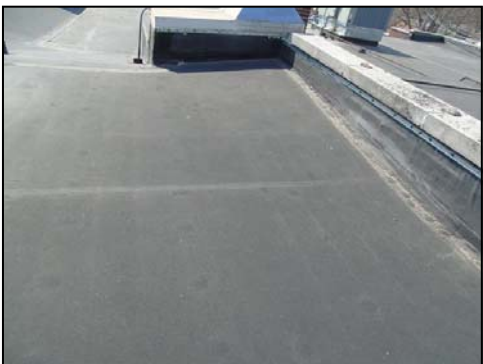
Defect Code:	18	Quantity:	Random	Priority:	Monitor
Description: Unadhered membrane or inadequate membrane attachment.					
Repair: At unadhered areas, cut open membrane and readhere to substrate with manufacturer's approved adhesive. At areas with missing securement, provide securement in the form of screws and plates installed a maximum of 12" O.C. Overlay repaired areas with new membrane of similar gauge, type, and plies and extend repairs a minimum of 4" past cut areas or edges of plates.

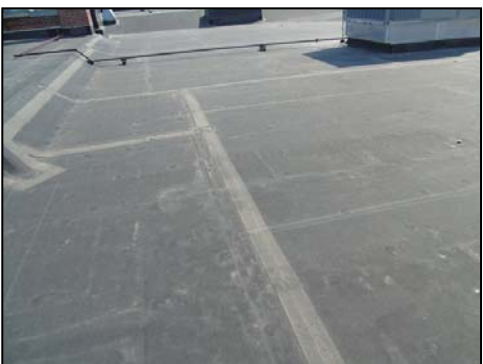
Defect Code:	24	Quantity:	Widespread	Priority:	Monitor
Description: Evidence of past problem and previous repair.					
Repair: Investigate for chronic leak problems and repair any areas that are suspect.

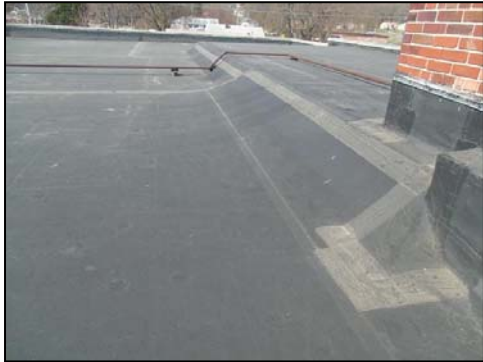
Defect Code:	44	Quantity:	Widespread	Priority:	Monitor
Description: Bridged flashing					
Cut out all bridged flashings. Clean area thoroughly and apply new flashings. Apply corner flashings and overlay all T-laps, flashings laps, and splice intersections.

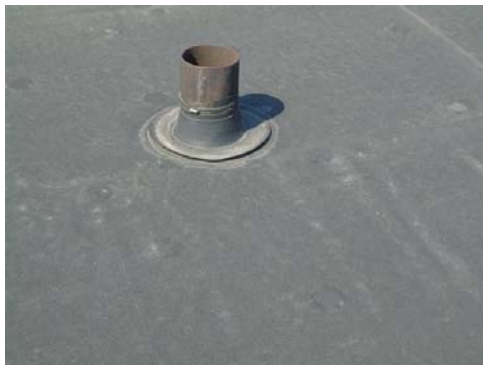
Defect Code:	45	Quantity:	Widespread	Priority:	Monitor
Description: Open flashing lap					
Repair: Open loose lap area and clean thoroughly. Prime and reseam or reweld lap per the manufacturer's requirements. Strip-in defective lap with mimum 6" wide membrane on single ply systems or 6" wide fabric and mastic three-course application on asphalt systems. Regranulate or coat flashing repairs.

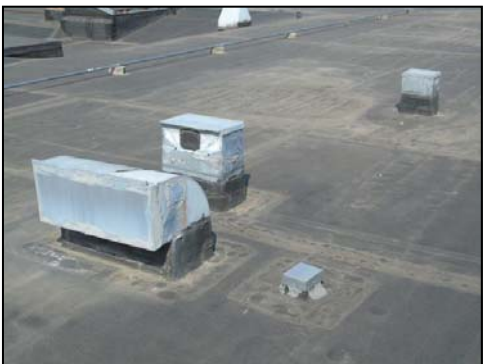
Defect Code:	56	Quantity:	7	Priority:	Monitor
Description: Abandoned and obsolete equipment.					
Repair: Monitor for leaks. Check systems are abandoned and disconnected and will not be used in the future. Remove abandoned equipment and repair deck at scheduled roof replacement.

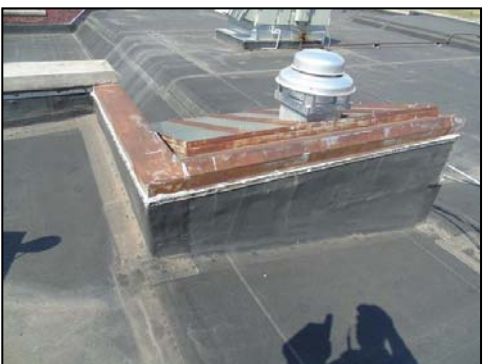
Defect Code:	86	Quantity:	Widespread	Priority:	Monitor
Description: Corrosion or rust					
Repair: Remove rusted components and replace with similar metal fabricated and installed per SMACNA requirements.

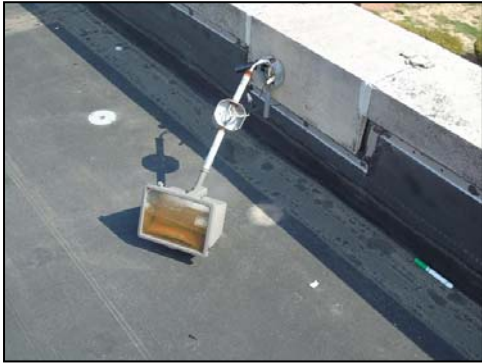
Defect Code:	87	Quantity:	1	Priority:	First Year
Description: Mechanical defect					
Repair: Repair mechanical defect. Replace or reinstall missing access doors and panels. Reseal rooftop unit, pans, ducts, curbs, etc.

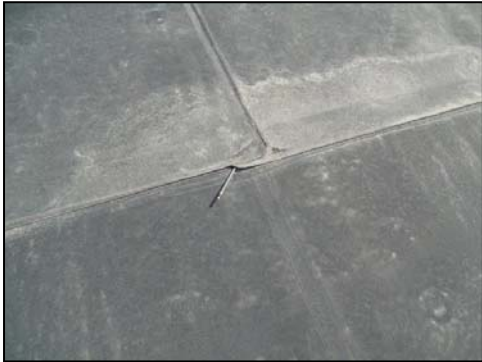
Defect Code:	3	Quantity:	Random	Priority:	Monitor
Description: Open lap in field membrane.					
Repair: Clean lap of all dirt and close seam. Overlay edge of affected seam with strip-in of new membrane of like material. Extend a minimum of 4" in all directions past seam edges and repair areas.

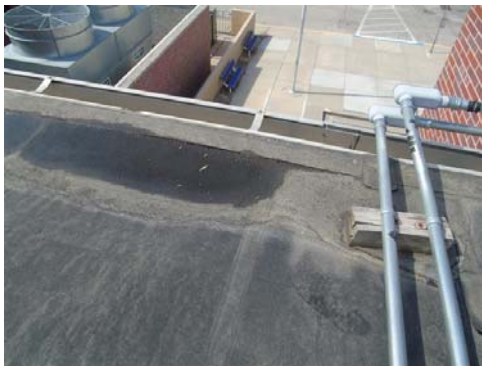
Defect Code:	45	Quantity:	Random	Priority:	Monitor
Description: Open flashing lap					
Repair: Open loose lap area and clean thoroughly. Prime and reseam or reweld lap per the manufacturer's requirements. Strip-in defective lap with mimum 6" wide membrane on single ply systems or 6" wide fabric and mastic three-course application on asphalt systems. Regranulate or coat flashing repairs.

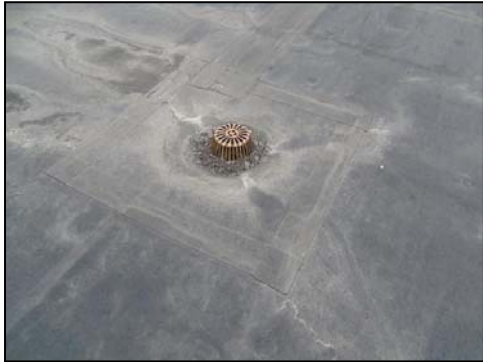
Defect Code:	22	Quantity:	1	Priority:	Monitor
Description: Debris, trash, construction materials, HVAC equipment, filters, motors, etc. on roof surface.					
Repair: Remove all trash and debris from roof. Clean and inspect surfaces and repair any damages to the membrane or flashings.

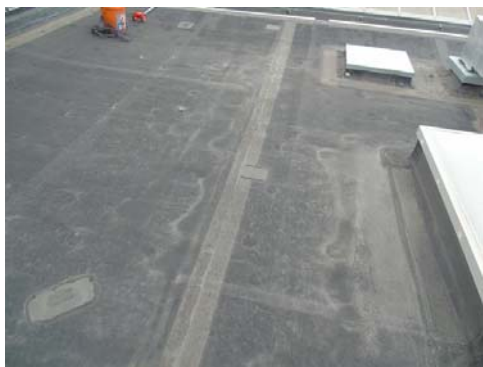
Defect Code:	24	Quantity:	Widespread	Priority:	Monitor
Description: Evidence of past problem and previous repair.					
Repair: Investigate for chronic leak problems and repair any areas that are suspect.

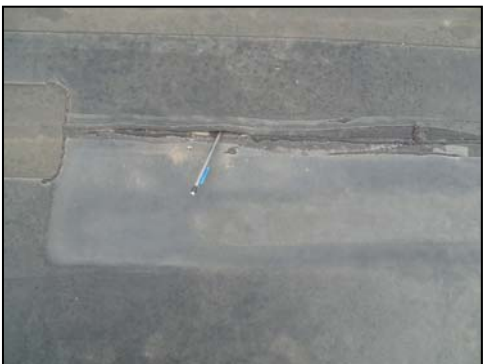
Defect Code:	45	Quantity:	Random	Priority:	Monitor
Description: Open flashing lap					
Repair: Open loose lap area and clean thoroughly. Prime and reseam or reweld lap per the manufacturer's requirements. Strip-in defective lap with minimum 6" wide membrane on single ply systems or 6" wide fabric and mastic three-course application on asphalt systems. Regranulate or coat flashing repairs.

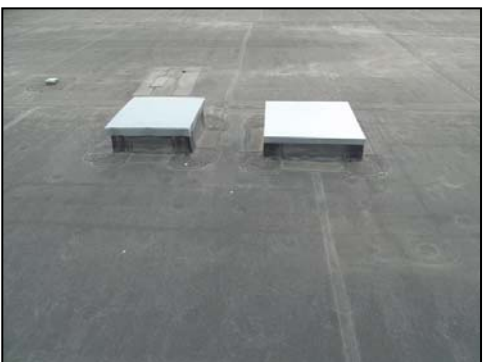
Defect Code:	56	Quantity:	5	Priority:	Monitor
Description: Abandoned and obsolete equipment.					
Repair: Monitor for leaks. Check systems are abandoned and disconnected and will not be used in the future. Remove abandoned equipment and repair deck at scheduled roof replacement.

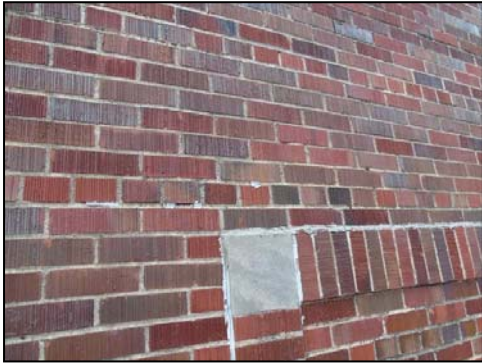
Defect Code:	82	Quantity:	Random	Priority:	Monitor
Description: Open or deteriorated wall joint.					
Repair: Clean out joints of old sealants and mortar, and repoint to match existing joint type and reseal. On joints between panels, clean out old sealants and backer rod and install new backer rod and high grade sealant for horizontal and vertical applications as noted.

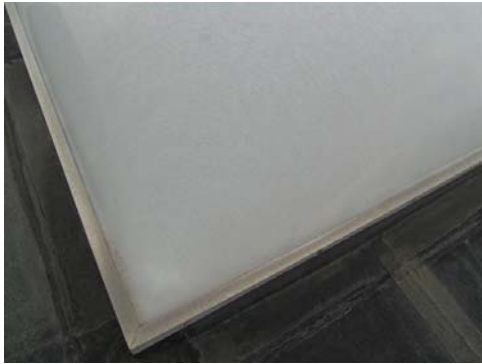
Defect Code:	88	Quantity:	1	Priority:	Monitor
Description: Skylight defect/cracked/deteriorated					
Repair: Remove and replace affected components.

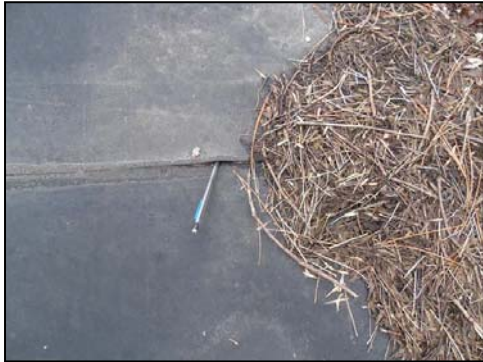
Defect Code:	3	Quantity:	Widespread	Priority:	Monitor
Description: Open lap in field membrane.					
Repair: Clean lap of all dirt and close seam. Overlay edge of affected seam with strip-in of new membrane of like material. Extend a minimum of 4" in all directions past seam edges and repair areas.

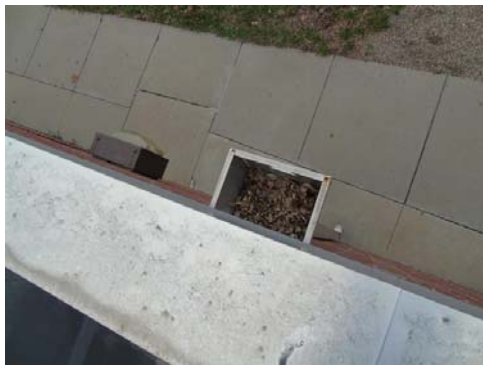
Defect Code:	16	Quantity:	3	Priority:	First Year
Description: Blocked drain, scupper, or downspout.					
Repair: Remove all debris from drainage system and ensure drain or scupper is free flowing without restrictions at strainer or piping.

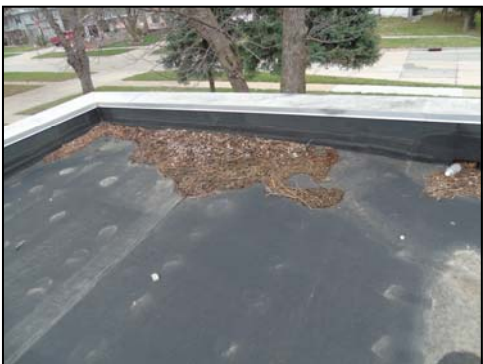
Defect Code:	22	Quantity:	Widespread	Priority:	First Year
Description: Debris, trash, construction materials, HVAC equipment, filters, motors, etc. on roof surface.					
Repair: Remove all trash and debris from roof. Clean and inspect surfaces and repair any damages to the membrane or flashings.

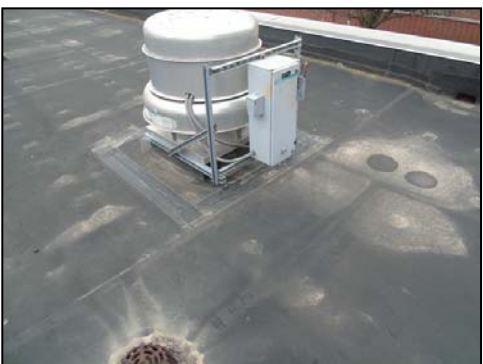
Defect Code:	24	Quantity:	Random	Priority:	Monitor
Description: Evidence of past problem and previous repair.					
Repair: Investigate for chronic leak problems and repair any areas that are suspect.

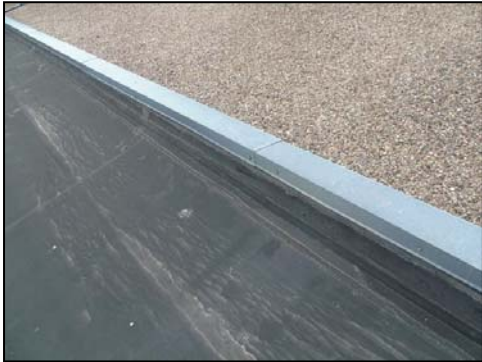
Defect Code:	44	Quantity:	Widespread	Priority:	Monitor
Description: Bridged flashing					
Cut out all bridged flashings. Clean area thoroughly and apply new flashings. Apply corner flashings and overlay all T-laps, flashings laps, and splice intersections.

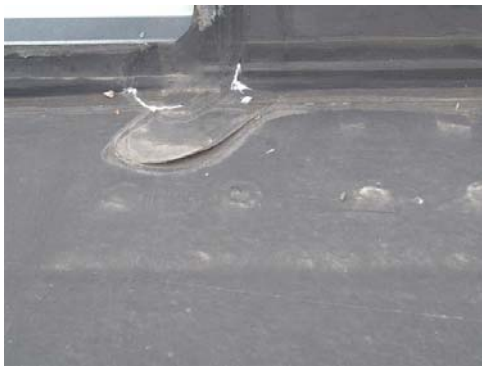
Defect Code:	45	Quantity:	Widespread	Priority:	Monitor
Description: Open flashing lap					
Repair: Open loose lap area and clean thoroughly. Prime and reseam or reweld lap per the manufacturer's requirements. Strip-in defective lap with mimum 6" wide membrane on single ply systems or 6" wide fabric and mastic three-course application on asphalt systems. Regranulate or coat flashing repairs.

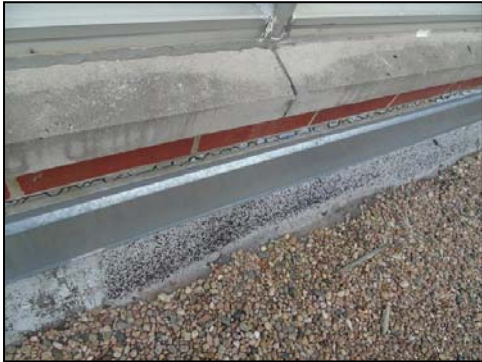
Defect Code:	1	Quantity:	Random	Priority:	Monitor
Description: Deteriorated or missing sealant at counterflashing, termination bar, sealant lip, metal flashing, expansion joint, etc.					
Repair: Clean loose sealant and dirt from all surfaces. Apply new polyurethane sealant and tool to shed water.

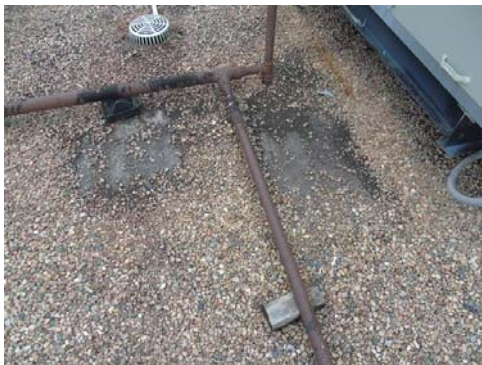
Defect Code:	8	Quantity:	Random	Priority:	Monitor
Description: Surface erosion.					
Repair: Prepare membrane surface by thoroughly cleaning and priming. Apply new surfacing of like materials to eroded areas. On gravel surfaced systems apply gravel in hot asphalt or recommended cold adhesive. Apply granulated fiberglass cap sheet or modified bitumen membrane on like systems. Apply coating system on smooth asphalt surfaces. Transition surfacing to provide for a smooth and neat finished appearance to match the existing surfacing.

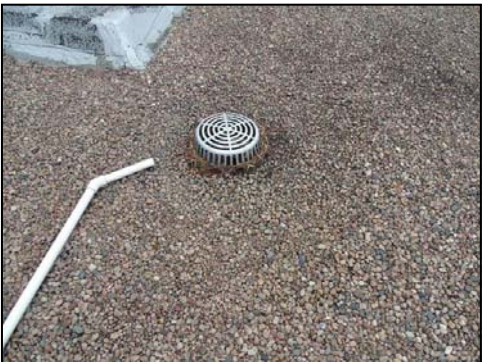
Defect Code:	22	Quantity:	2	Priority:	First Year
Description: Debris, trash, construction materials, HVAC equipment, filters, motors, etc. on roof surface.					
Repair: Remove all trash and debris from roof. Clean and inspect surfaces and repair any damages to the membrane or flashings.

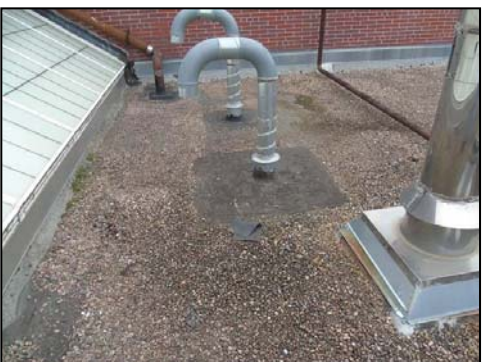
Defect Code:	24	Quantity:	Random	Priority:	Monitor
Description: Evidence of past problem and previous repair.					
Repair: Investigate for chronic leak problems and repair any areas that are suspect.

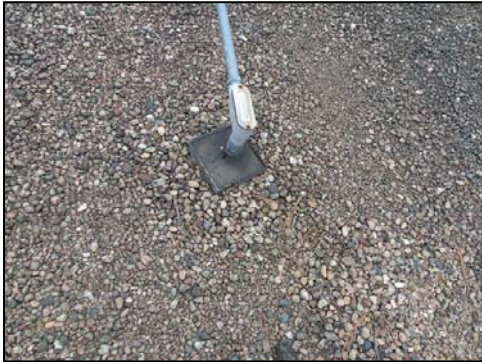
Defect Code:	55	Quantity:	1	Priority:	First Year
Description: Deteriorated or shrunken pitch pan filler.					
Repair: Clean pocket and penetrations of all dirt, insulation, and other materials and debris. Install manufacturer's recommended sealant in prepared pitch pan.

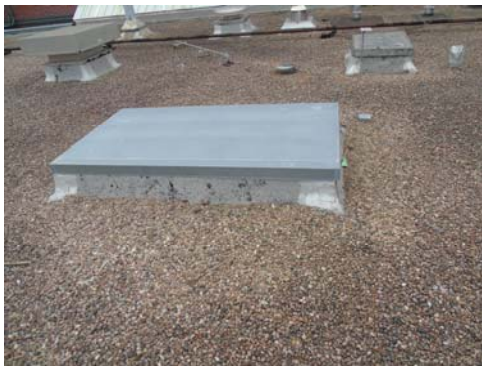
Defect Code:	56	Quantity:	4	Priority:	Monitor
Description: Abandoned and obsolete equipment.					
Repair: Monitor for leaks. Check systems are abandoned and disconnected and will not be used in the future. Remove abandoned equipment and repair deck at scheduled roof replacement.

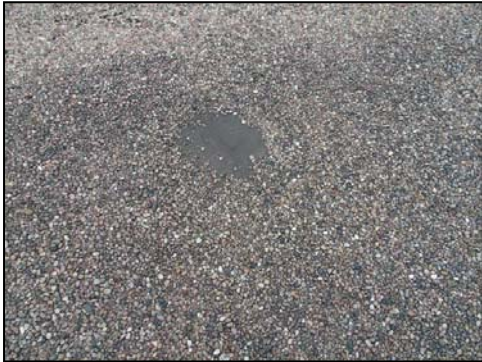
Defect Code:	8	Quantity:	Random	Priority:	Monitor
Description: Surface erosion.					
Repair: Prepare membrane surface by thoroughly cleaning and priming. Apply new surfacing of like materials to eroded areas. On gravel surfaced systems apply gravel in hot asphalt or recommended cold adhesive. Apply granulated fiberglass cap sheet or modified bitumen membrane on like systems. Apply coating system on smooth asphalt surfaces. Transition surfacing to provide for a smooth and neat finished appearance to match the existing surfacing.

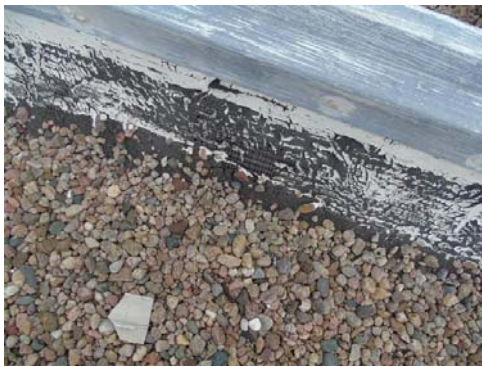
Defect Code:	9	Quantity:	Under 10 SF	Priority:	First Year
Description: Membrane deterioration.					
Repair: Replace all deteriorated membrane with new membrane of similar type, gauge, and plies.

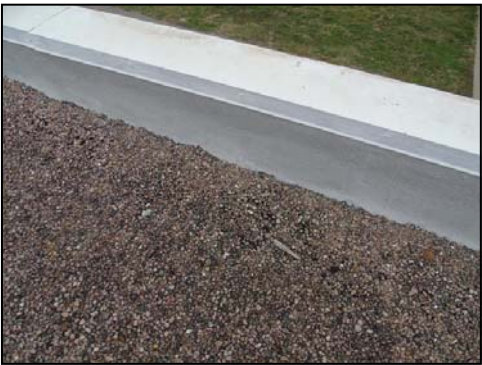
Defect Code:	24	Quantity:	Widespread	Priority:	Monitor
Description: Evidence of past problem and previous repair.					
Repair: Investigate for chronic leak problems and repair any areas that are suspect.

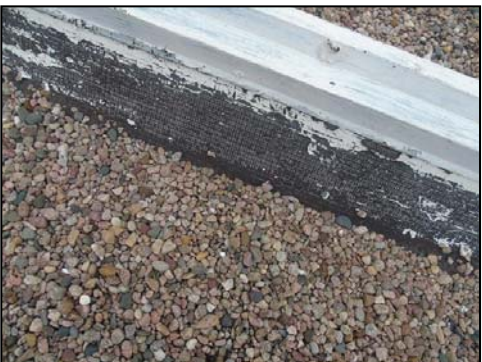
Defect Code:	43	Quantity:	Widespread	Priority:	Monitor
Description: Weathered and deteriorated flashing					
Repair: Clean and prepare surfaces by removing loose granules, dirt, and other debris. Apply two coats of elastomeric coating compatible with the flashing materials.

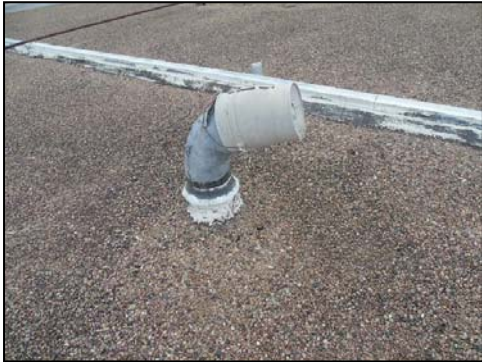
Defect Code:	52	Quantity:	2	Priority:	Monitor
Description: Missing rain cap, rain collar, or hood.					
Repair: Install rain cap, hood, or collar and secure and seal to pipe.

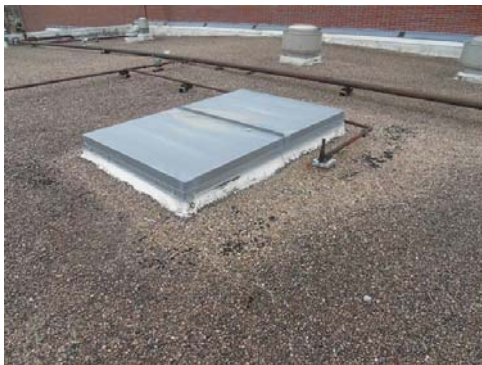
Defect Code:	56	Quantity:	Numerous	Priority:	Monitor
Description: Abandoned and obsolete equipment.					
Repair: Monitor for leaks. Check systems are abandoned and disconnected and will not be used in the future. Remove abandoned equipment and repair deck at scheduled roof replacement.

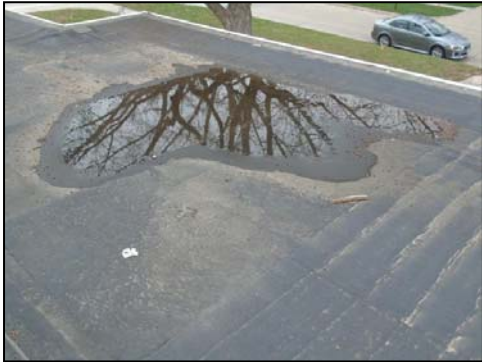
Defect Code:	15	Quantity:	Random	Priority:	Monitor
Description: Ponding of water.					
Repair: Monitor areas for severe or chronic ponding. Provide sacrificial membrane ply in ponded areas where existing membrane is deteriorated. Install additional drain or scupper including collectors and drain piping where ponding conditions are severe and chronic.

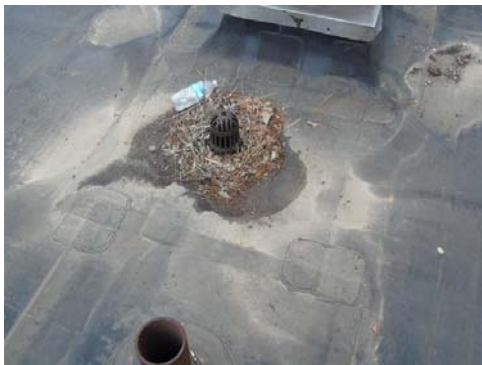
Defect Code:	22	Quantity:	Random	Priority:	First Year
Description: Debris, trash, construction materials, HVAC equipment, filters, motors, etc. on roof surface.					
Repair: Remove all trash and debris from roof. Clean and inspect surfaces and repair any damages to the membrane or flashings.

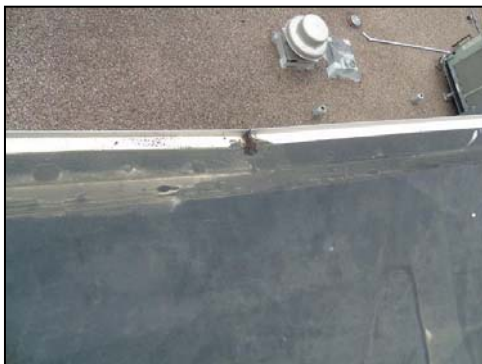
Defect Code:	70	Quantity:	Widespread	Priority:	First Year
Description: Open joint in metal flashing.					
Repair: Remove metal and old sealants from joint. Reinstall metal with new polyurethane sealants at joints per SMACNA requirements.

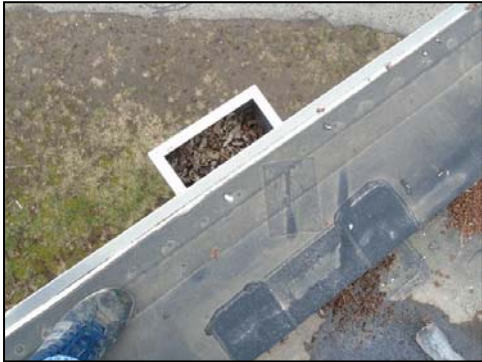
Defect Code:	16	Quantity:	1	Priority:	First Year
Description: Blocked drain, scupper, or downspout.					
Repair: Remove all debris from drainage system and ensure drain or scupper is free flowing without restrictions at strainer or piping.
