## Roof Inspection Report

Peter Sarpy Elementary  
2908 Vandenberg Avenue  
Bellevue, NE 68123

Date	Inspection Type	Inspecting Company	Inspector
Mar 16, 2017	Phase 1 Roof Inspection	Roofing Solutions, Inc.	Garry Hendrickson

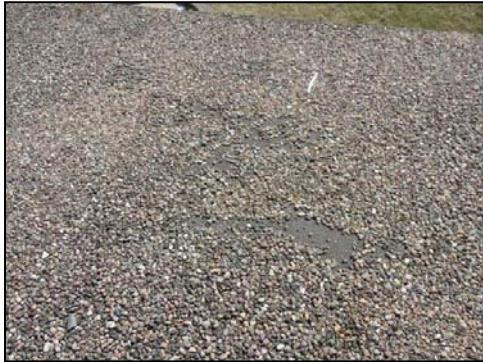
<b>Defect Code:</b>	<b>8</b>	<b>Quantity:</b>	<b>Widespread</b>	<b>Priority:</b>	<b>Monitor</b>
Description: Surface erosion.					
Repair: Prepare membrane surface by thoroughly cleaning and priming. Apply new surfacing of like materials to eroded areas. On gravel surfaced systems apply gravel in hot asphalt or recommended cold adhesive. Apply granulated fiberglass cap sheet or modified bitumen membrane on like systems. Apply coating system on smooth asphalt surfaces. Transition surfacing to provide for a smooth and neat finished appearance to match the existing surfacing.

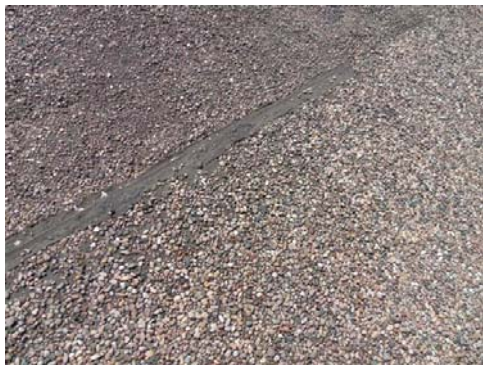
<b>Defect Code:</b>	<b>24</b>	<b>Quantity:</b>	<b>Random</b>	<b>Priority:</b>	<b>Monitor</b>
Description: Evidence of past problem and previous repair.					
Repair: Investigate for chronic leak problems and repair any areas that are suspect.

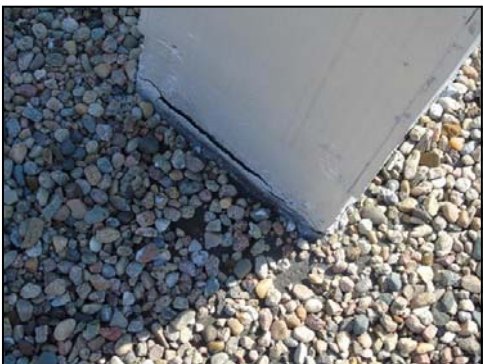
<b>Defect Code:</b>	<b>46</b>	<b>Quantity:</b>	<b>25 LF</b>	<b>Priority:</b>	<b>First Year</b>
Description: Split in flashing					
Repair: Cut away loose flashing and clean and prime repair area. Apply strip in of like material centered over split extending a minimum of 4" in all directions past prepared area.

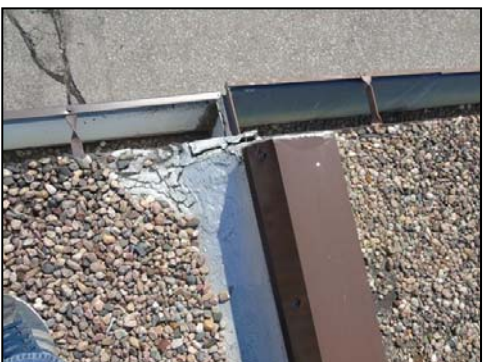
<b>Defect Code:</b>	<b>57</b>	<b>Quantity:</b>	<b>Under 10 LF</b>	<b>Priority:</b>	<b>First Year</b>
Description: Expansion joint deficiencies.					
Repair: Repair defects in rubber expansion joint or joint covers with two layers of flashing with the second layer being 3" larger in all directions than the first. Install flashing with manufacturer's recommended cleaners and primers.

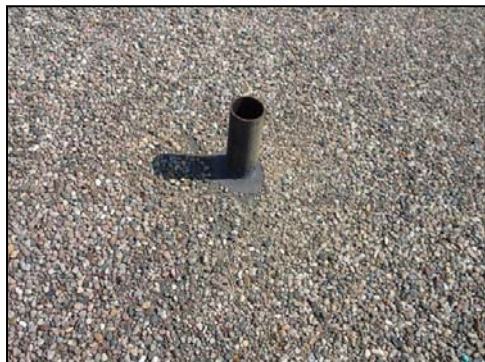
<b>Defect Code:</b>	<b>58</b>	<b>Quantity:</b>	<b>1</b>	<b>Priority:</b>	<b>First Year</b>
Description: Inadequate, incomplete, nonconforming membrane flashings or flashing details.					
Repair: Complete membrane flashing repairs in accordance with NRCA recommendations and good roofing practices. Follow manufacturer requirements on warranted systems.

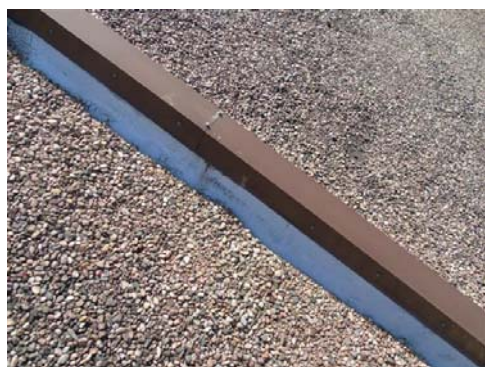
<b>Defect Code:</b>	<b>75</b>	<b>Quantity:</b>	<b>Random</b>	<b>Priority:</b>	<b>First Year</b>
Description: Inadequate attachment of metal flashings.					
Repair: Reattach metal flashings a maximum of two EPDM washered fasteners per side of curb or attach a maximum of 12" O.C for flashings more than 24 " in length.

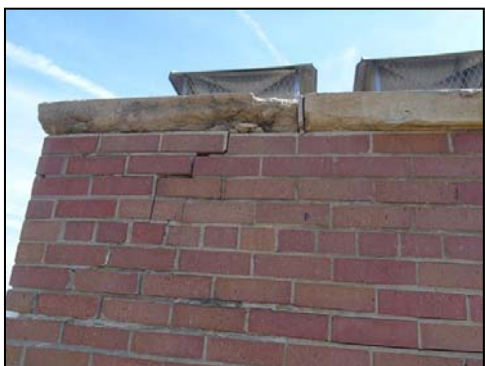
<b>Defect Code:</b>	<b>79</b>	<b>Quantity:</b>	<b>Widespread</b>	<b>Priority:</b>	<b>First Year</b>
Description: Cracks in walls.					
Repair: Investigate and repair cracks in walls. Apply elastomeric coating or membrane waterproofing to seal wall surface.

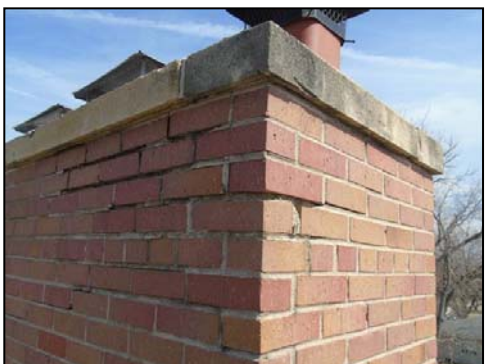
<b>Defect Code:</b>	<b>82</b>	<b>Quantity:</b>	<b>Widespread</b>	<b>Priority:</b>	<b>First Year</b>
Description: Open or deteriorated wall joint.					
Repair: Clean out joints of old sealants and mortar, and repoint to match existing joint type and reseal. On joints between panels, clean out old sealants and backer rod and install new backer rod and high grade sealant for horizontal and vertical applications as noted.

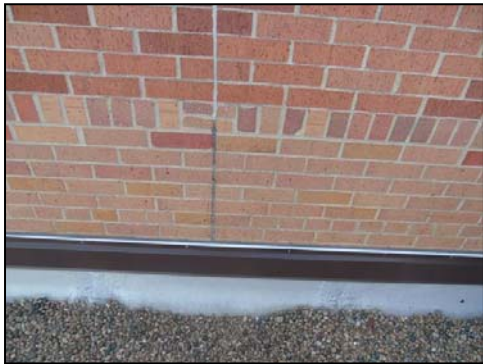
<b>Defect Code:</b>	<b>1</b>	<b>Quantity:</b>	<b>Under 10 LF</b>	<b>Priority:</b>	<b>First Year</b>
Description: Deteriorated or missing sealant at counterflashing, termination bar, sealant lip, metal flashing, expansion joint, etc.					
Repair: Clean loose sealant and dirt from all surfaces. Apply new polyurethane sealant and tool to shed water.

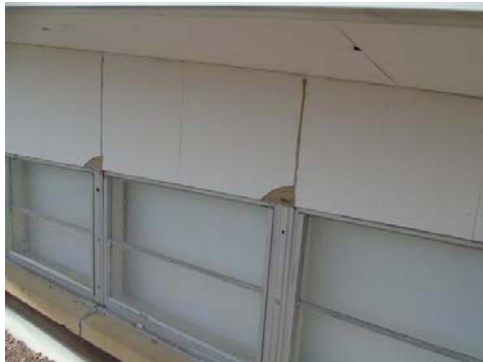
<b>Defect Code:</b>	<b>24</b>	<b>Quantity:</b>	<b>Widespread</b>	<b>Priority:</b>	<b>Monitor</b>
Description: Evidence of past problem and previous repair.					
Repair: Investigate for chronic leak problems and repair any areas that are suspect.

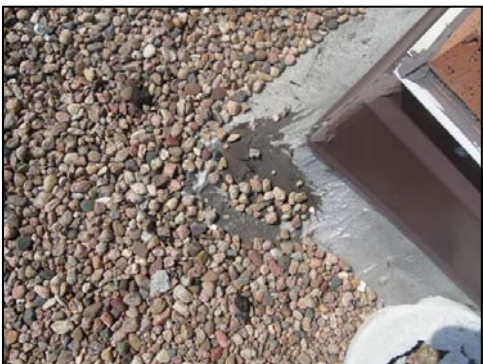
<b>Defect Code:</b>	<b>46</b>	<b>Quantity:</b>	<b>Under 10 LF</b>	<b>Priority:</b>	<b>First Year</b>
Description: Split in flashing					
Repair: Cut away loose flashing and clean and prime repair area. Apply strip in of like material centered over split extending a minimum of 4" in all directions past prepared area.

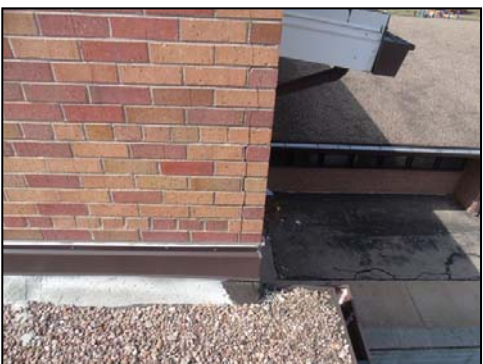
<b>Defect Code:</b>	<b>79</b>	<b>Quantity:</b>	<b>Random</b>	<b>Priority:</b>	<b>First Year</b>
Description: Cracks in walls.					
Repair: Investigate and repair cracks in walls. Apply elastomeric coating or membrane waterproofing to seal wall surface.

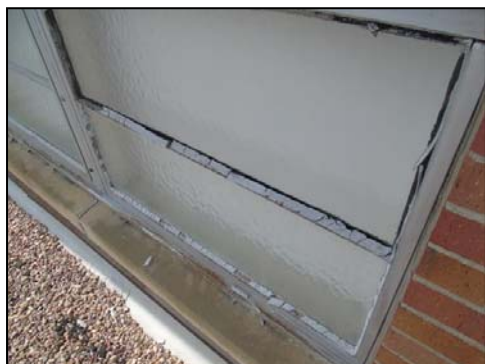
Defect Code:	89	Quantity:	Widespread	Priority:	Monitor
Description: Missing wall covering/cladding.					
Repair: Replace cladding/wall covering with matching materials and methods. Reattach and reseal all joints, seams, laps, etc.

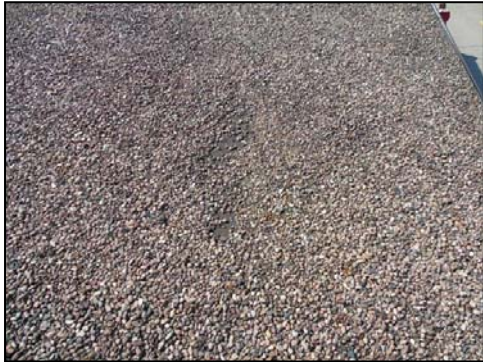
<b>Defect Code:</b>	<b>8</b>	<b>Quantity:</b>	<b>Random</b>	<b>Priority:</b>	<b>Monitor</b>
Description: Surface erosion.					
Repair: Prepare membrane surface by thoroughly cleaning and priming. Apply new surfacing of like materials to eroded areas. On gravel surfaced systems apply gravel in hot asphalt or recommended cold adhesive. Apply granulated fiberglass cap sheet or modified bitumen membrane on like systems. Apply coating system on smooth asphalt surfaces. Transition surfacing to provide for a smooth and neat finished appearance to match the existing surfacing.

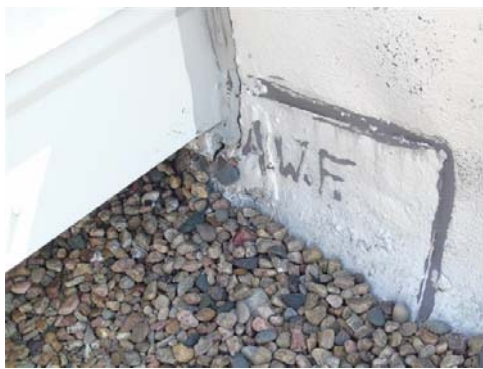
<b>Defect Code:</b>	<b>46</b>	<b>Quantity:</b>	<b>Under 10 LF</b>	<b>Priority:</b>	<b>First Year</b>
Description: Split in flashing					
Repair: Cut away loose flashing and clean and prime repair area. Apply strip in of like material centered over split extending a minimum of 4" in all directions past prepared area.

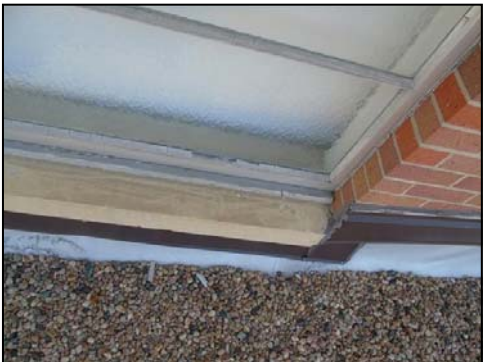
<b>Defect Code:</b>	<b>89</b>	<b>Quantity:</b>	<b>Widespread</b>	<b>Priority:</b>	<b>Monitor</b>
Description: Missing wall covering/cladding.					
Repair: Replace cladding/wall covering with matching materials and methods. Reattach and reseal all joints, seams, laps, etc.

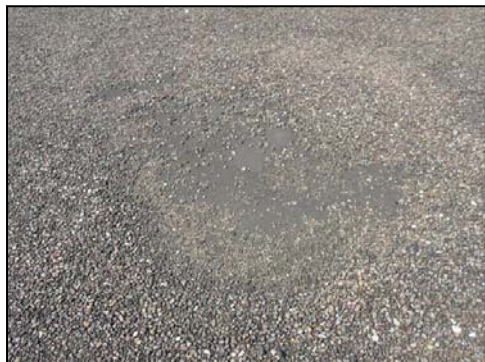
<b>Defect Code:</b>	<b>8</b>	<b>Quantity:</b>	<b>Random</b>	<b>Priority:</b>	<b>Monitor</b>
Description: Surface erosion.					
Repair: Prepare membrane surface by thoroughly cleaning and priming. Apply new surfacing of like materials to eroded areas. On gravel surfaced systems apply gravel in hot asphalt or recommended cold adhesive. Apply granulated fiberglass cap sheet or modified bitumen membrane on like systems. Apply coating system on smooth asphalt surfaces. Transition surfacing to provide for a smooth and neat finished appearance to match the existing surfacing.

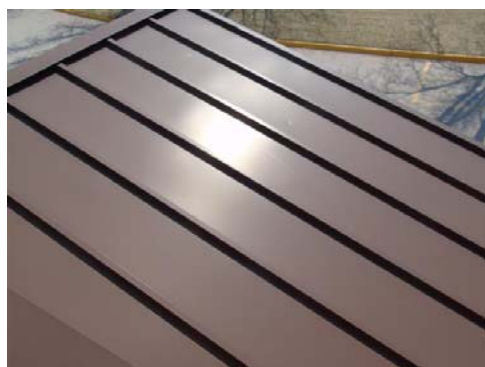
<b>Defect Code:</b>	<b>23</b>	<b>Quantity:</b>	<b>Random</b>	<b>Priority:</b>	<b>Monitor</b>
Description: Physical damage to membrane including cuts, holes, tears, scrapes, scuffs, or abrasions.					
Repair: Apply repair membrane over damaged area, extending repair material a minimum 6" past damage.

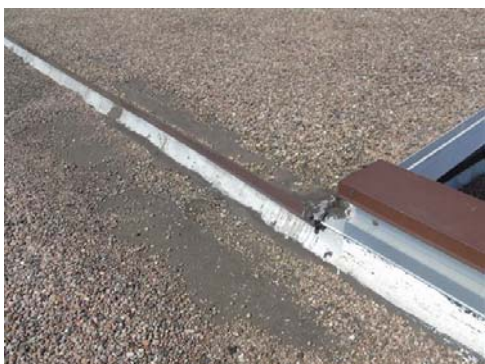
<b>Defect Code:</b>	<b>24</b>	<b>Quantity:</b>	<b>Random</b>	<b>Priority:</b>	<b>Monitor</b>
Description: Evidence of past problem and previous repair.					
Repair: Investigate for chronic leak problems and repair any areas that are suspect.

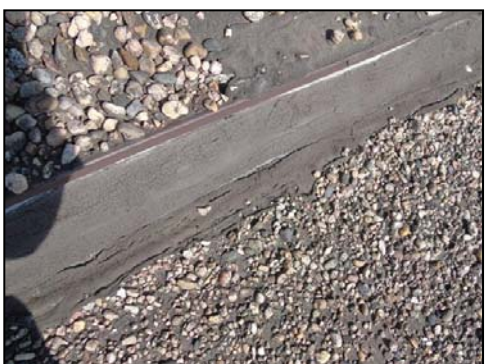
<b>Defect Code:</b>	<b>46</b>	<b>Quantity:</b>	<b>Random</b>	<b>Priority:</b>	<b>First Year</b>
Description: Split in flashing					
Repair: Cut away loose flashing and clean and prime repair area. Apply strip in of like material centered over split extending a minimum of 4" in all directions past prepared area.

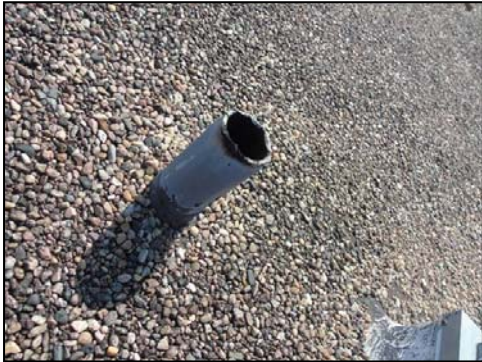
<b>Defect Code:</b>	<b>53</b>	<b>Quantity:</b>	<b>1</b>	<b>Priority:</b>	<b>First Year</b>
Description: Open lead flashing.					
Repair: Provide extension lead and turn into pipe. Counterflash top of short lead with extension a minimum of 3".

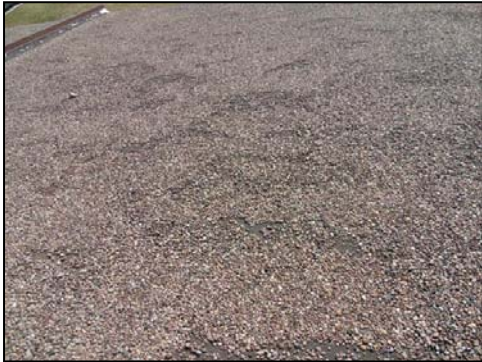
Defect Code:	8	Quantity:	Widespread	Priority:	Monitor
Description: Surface erosion.					
Repair: Prepare membrane surface by thoroughly cleaning and priming. Apply new surfacing of like materials to eroded areas. On gravel surfaced systems apply gravel in hot asphalt or recommended cold adhesive. Apply granulated fiberglass cap sheet or modified bitumen membrane on like systems. Apply coating system on smooth asphalt surfaces. Transition surfacing to provide for a smooth and neat finished

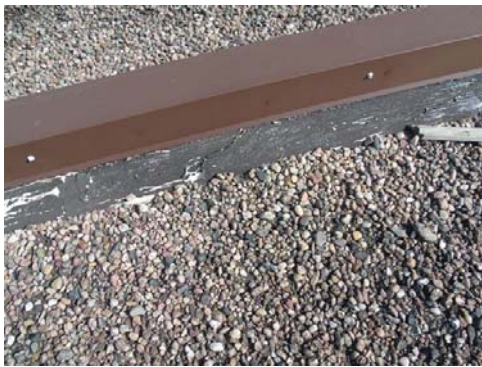
Defect Code:	43	Quantity:	100SF	Priority:	Monitor
Description: Weathered and deteriorated flashing					
Repair: Clean and prepare surfaces by removing loose granules, dirt, and other debris. Apply two coats of elastomeric coating compatible with the flashing materials.
