# Roof Inspection Report

Bellevue Public Schools Support Center  
2820 Arboretum Drive  
Bellevue, NE 68005

Bellevue Public Schools Support Center\_Bellevue, NE  
Ph 1 Roof Inspection\_Roof A\_2017-03-21

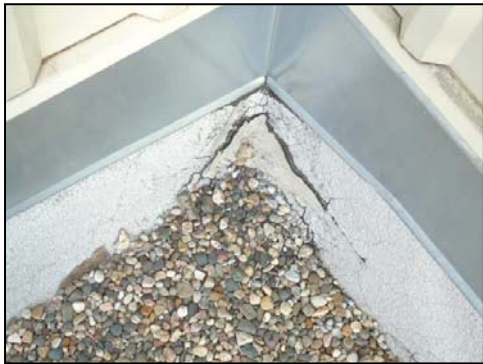
Photos and Deficiencies

- One (1) split corner observed on a wall flashing
- One (1) split flashing seal observed around a pitch pocket detail

<b>Defect Code:</b>	<b>46</b>	<b>Quantity:</b>	<b>Under 10 LF</b>	<b>Priority:</b>	<b>First Year</b>
Description: Split in flashing					
Repair: Cut away loose flashing and clean and prime repair area. Apply strip in of like material centered over split extending a minimum of 4" in all directions past prepared area.

RSI recommends repairs be completed in accordance with the attached deficiency list.
