Roof Inspection Report

Twin Ridge Elementary
1400 Sunbury Drive
Bellevue, NE 68005

Date of Last Inspection: Mar 17, 2017

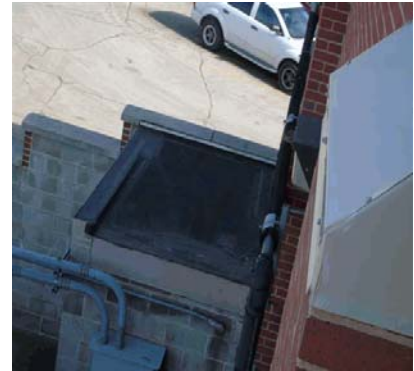
Facility personnel reported a past leak issue with repairs performed and he was not sure if the leak was still active.

- One (1) reported past leak issue at a corner of the building
- EPDM repair attempts observed near the reported leak location

Overall, the roof system is in poor condition due to its age. The EPDM membrane has surpassed its design service life by approximately five (5) years. RSI recommends the roof system be replaced with a new twenty (20) year design life roof system.

RSI recommends the installation of a new twenty (20) year design life roof system. We further recommend installation of new perimeter metal and projection details per the SMACNA Architectural Sheet Metal Manual.

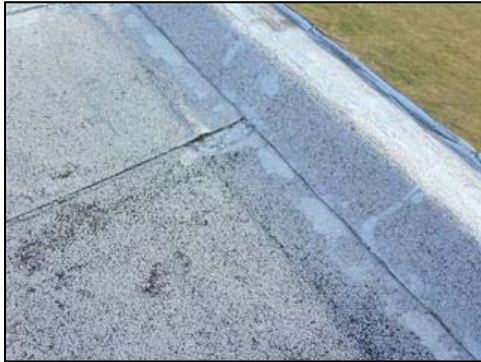
Defect Code:	2	Quantity:	Under 10 LF	Priority:	First Year
Description: Fishmouth in field or flashing seam.					
Repair: Cut away fishmouth and lay material flat. Apply repair of like material and extend onto existing roof surface a minimum of 4". Complete laps per manufacturer's requirements. On asphalt systems, apply three-course of mastic and fabric over lap. Resurface membrane with ballast, gravel, or granules.

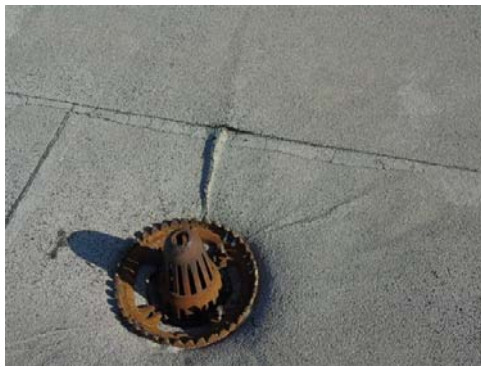
Defect Code:	3	Quantity:	Under 10 LF	Priority:	First Year
Description: Open lap in field membrane.					
Repair: Clean lap of all dirt and close seam. Overlay edge of affected seam with strip-in of new membrane of like material. Extend a minimum of 4" in all directions past seam edges and repair areas.

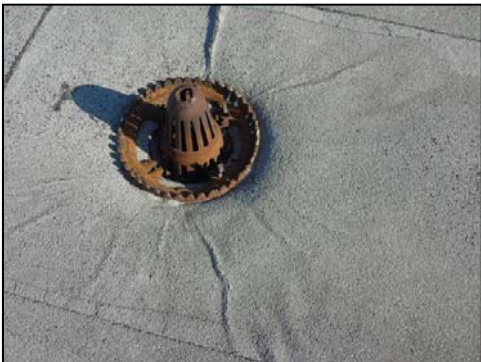
Defect Code:	7	Quantity:	10 LF	Priority:	Monitor
Description: Wrinkle in membrane.					
Repair: Cut out wrinkles and loose membrane. Apply new membrane of like material and plies to cover cuts and extend repairs a minimum of 6" in all directions past cut out areas.

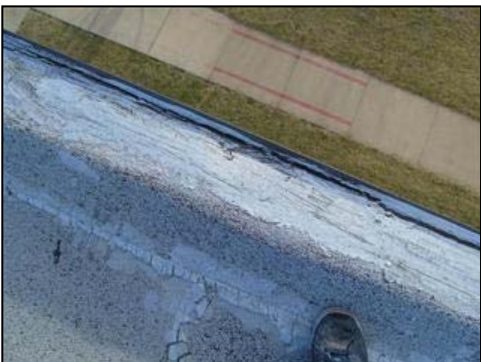
Defect Code:	46	Quantity:	400 LF	Priority:	First Year
Description: Split in flashing					
Repair: Cut away loose flashing and clean and prime repair area. Apply strip in of like material centered over split extending a minimum of 4" in all directions past prepared area.

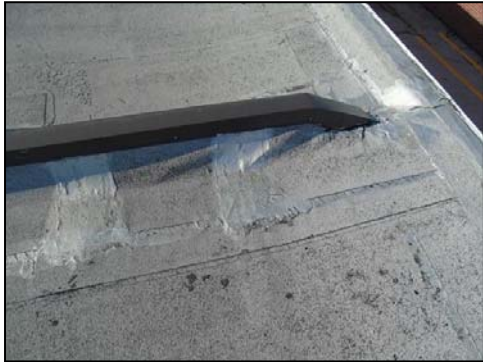
Defect Code:	47	Quantity:	10 SF	Priority:	Monitor
Description: Racked flashings					
Repair: Monitor flashings and repair when identified as deteriorated.

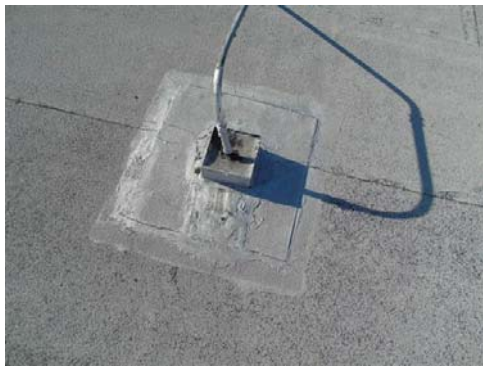
Defect Code:	55	Quantity:	2	Priority:	First Year
Description: Deteriorated or shrunken pitch pan filler.					
Repair: Clean pocket and penetrations of all dirt, insulation, and other materials and debris. Install manufacturer's recommended sealant in prepared pitch pan.

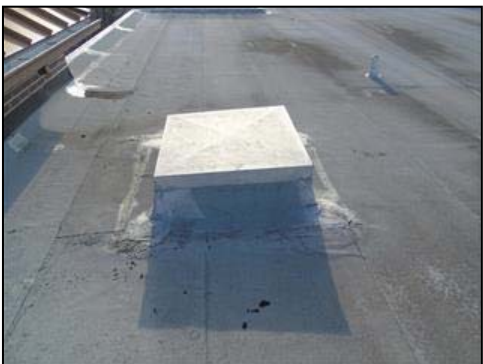
Defect Code:	56	Quantity:	1	Priority:	Monitor
Description: Abandoned and obsolete equipment.					
Repair: Monitor for leaks. Check systems are abandoned and disconnected and will not be used in the future. Remove abandoned equipment and repair deck at scheduled roof replacement.

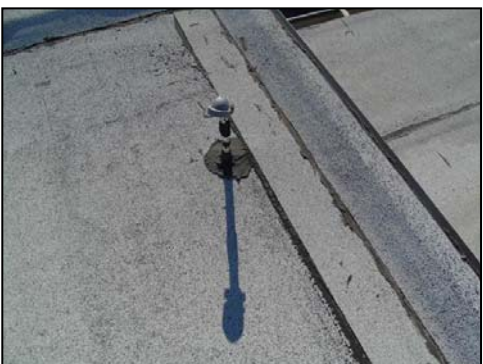
Defect Code:	58	Quantity:	1	Priority:	First Year
Description: Inadequate, incomplete, nonconforming membrane flashings or flashing details.					
Repair: Complete membrane flashing repairs in accordance with NRCA recommendations and good roofing practices. Follow manufacturer requirements on warranted systems.

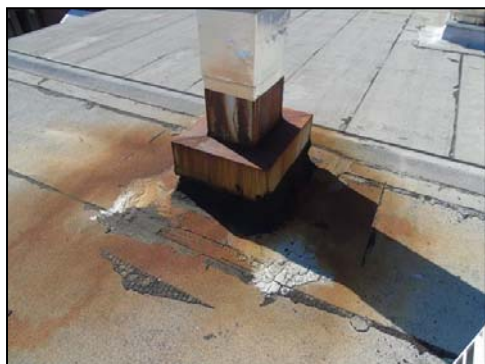
Defect Code:	86	Quantity:	2	Priority:	Monitor
Description: Corrosion or rust					
Repair: Remove rusted components and replace with similar metal fabricated and installed per SMACNA requirements.

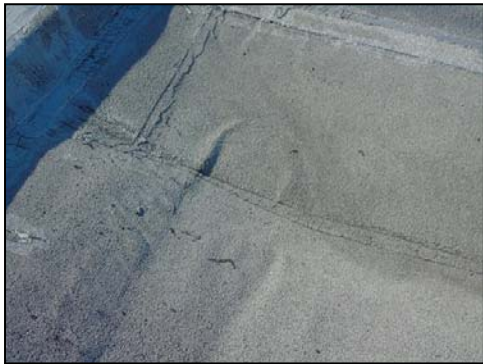
Defect Code:	2	Quantity:	Under 10 LF	Priority:	First Year
Description: Fishmouth in field or flashing seam.					
Repair: Cut away fishmouth and lay material flat. Apply repair of like material and extend onto existing roof surface a minimum of 4". Complete laps per manufacturer's requirements. On asphalt systems, apply three-course of mastic and fabric over lap. Resurface membrane with ballast, gravel, or granules.

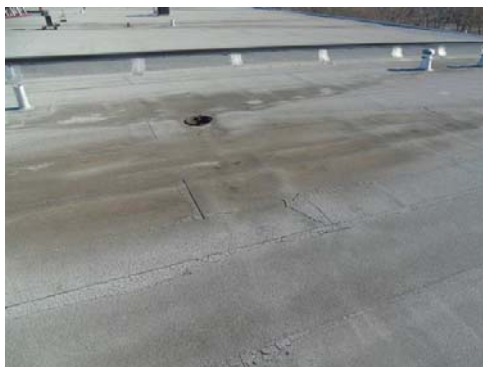
Defect Code:	15	Quantity:	Widespread	Priority:	Monitor
Description: Ponding of water.					
Repair: Monitor areas for severe or chronic ponding. Provide sacrificial membrane ply in ponded areas where existing membrane is deteriorated. Install additional drain or scupper including collectors and drain piping where ponding conditions are severe and chronic.

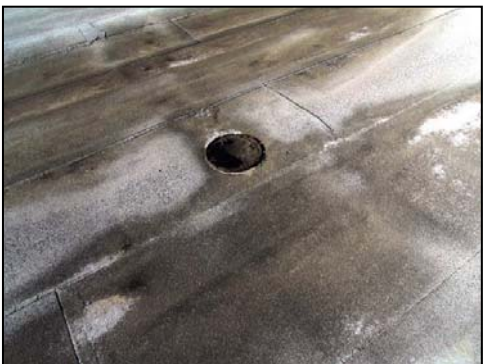
Defect Code:	17	Quantity:	1	Priority:	First Year
Description: Missing or damaged drain/scupper strainer					
Repair: Replace damaged or missing strainer with a new cast iron strainer sized to fit the drain assembly or scupper opening. Lock in place to prevent loss.

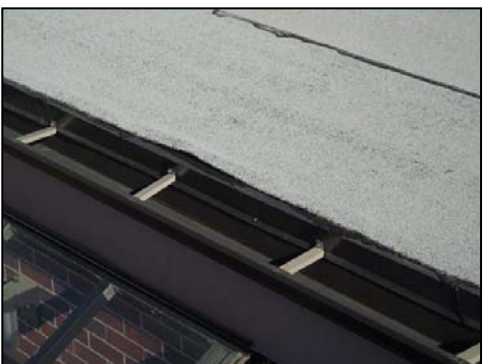
Defect Code:	45	Quantity:	Random	Priority:	First Year
Description: Open flashing lap					
Repair: Open loose lap area and clean thoroughly. Prime and reseat or reweld lap per the manufacturer's requirements. Strip-in defective lap with mimum 6" wide membrane on single ply systems or 6" wide fabric and mastic three-course application on asphalt systems. Regranulate or coat flashing repairs.

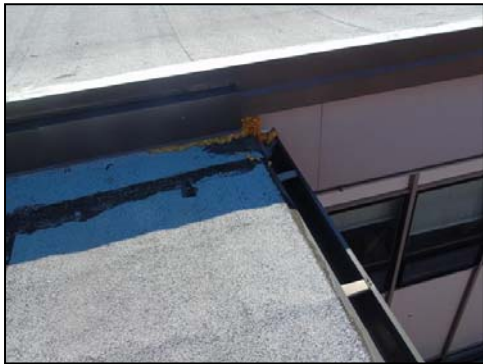
Defect Code:	73	Quantity:	Under 10 SF	Priority:	First Year
Description: Improper sheet metal detail.					
Repair: Remove sheet metal and fabricate new metal per SMACNA requirements. Solder all joints in drainage systems, scuppers, etc., and seal all other sheet metal joints with polyurethane sealant.

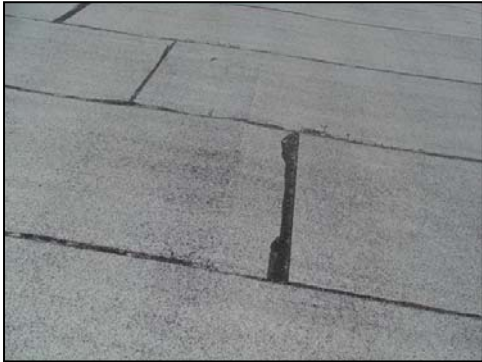
Defect Code:	5	Quantity:	Random	Priority:	Monitor
Description: Buckling or ridging of membrane.					
Repair: Cut out deteriorated buckles and ridges and repair membrane with similar membrane material. Extend repair material a minimum of 6" in all directions past repair areas.

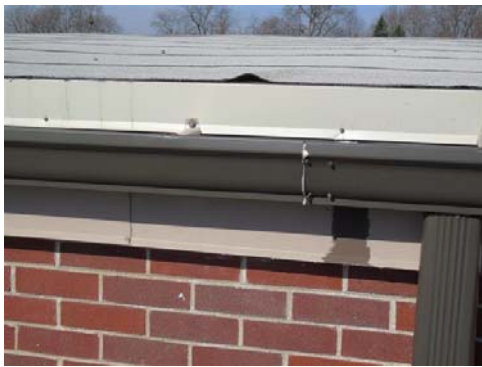
Defect Code:	45	Quantity:	200 LF	Priority:	First Year
Description: Open flashing lap					
Repair: Open loose lap area and clean thoroughly. Prime and reseam or reweld lap per the manufacturer's requirements. Strip-in defective lap with mimum 6" wide membrane on single ply systems or 6" wide fabric and mastic three-course application on asphalt systems. Regranulate or coat flashing repairs.

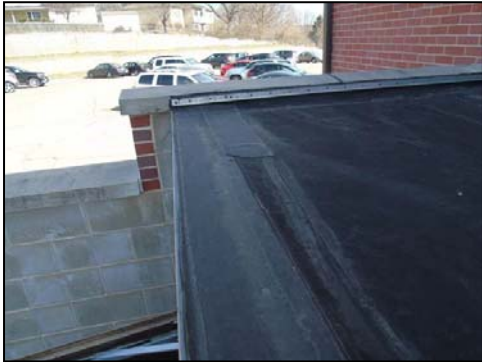
Defect Code:	24	Quantity:	Random	Priority:	Monitor
Description: Evidence of past problem and previous repair.					
Repair: Investigate for chronic leak problems and repair any areas that are suspect.

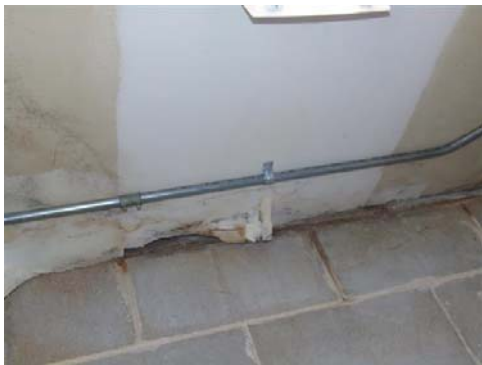
Defect Code:	28	Quantity:	1	Priority:	Monitor
Description: Reported leak location					
Repair: Investigate leak and determine source. Repair areas with like materials of appropriate gauge and plies.

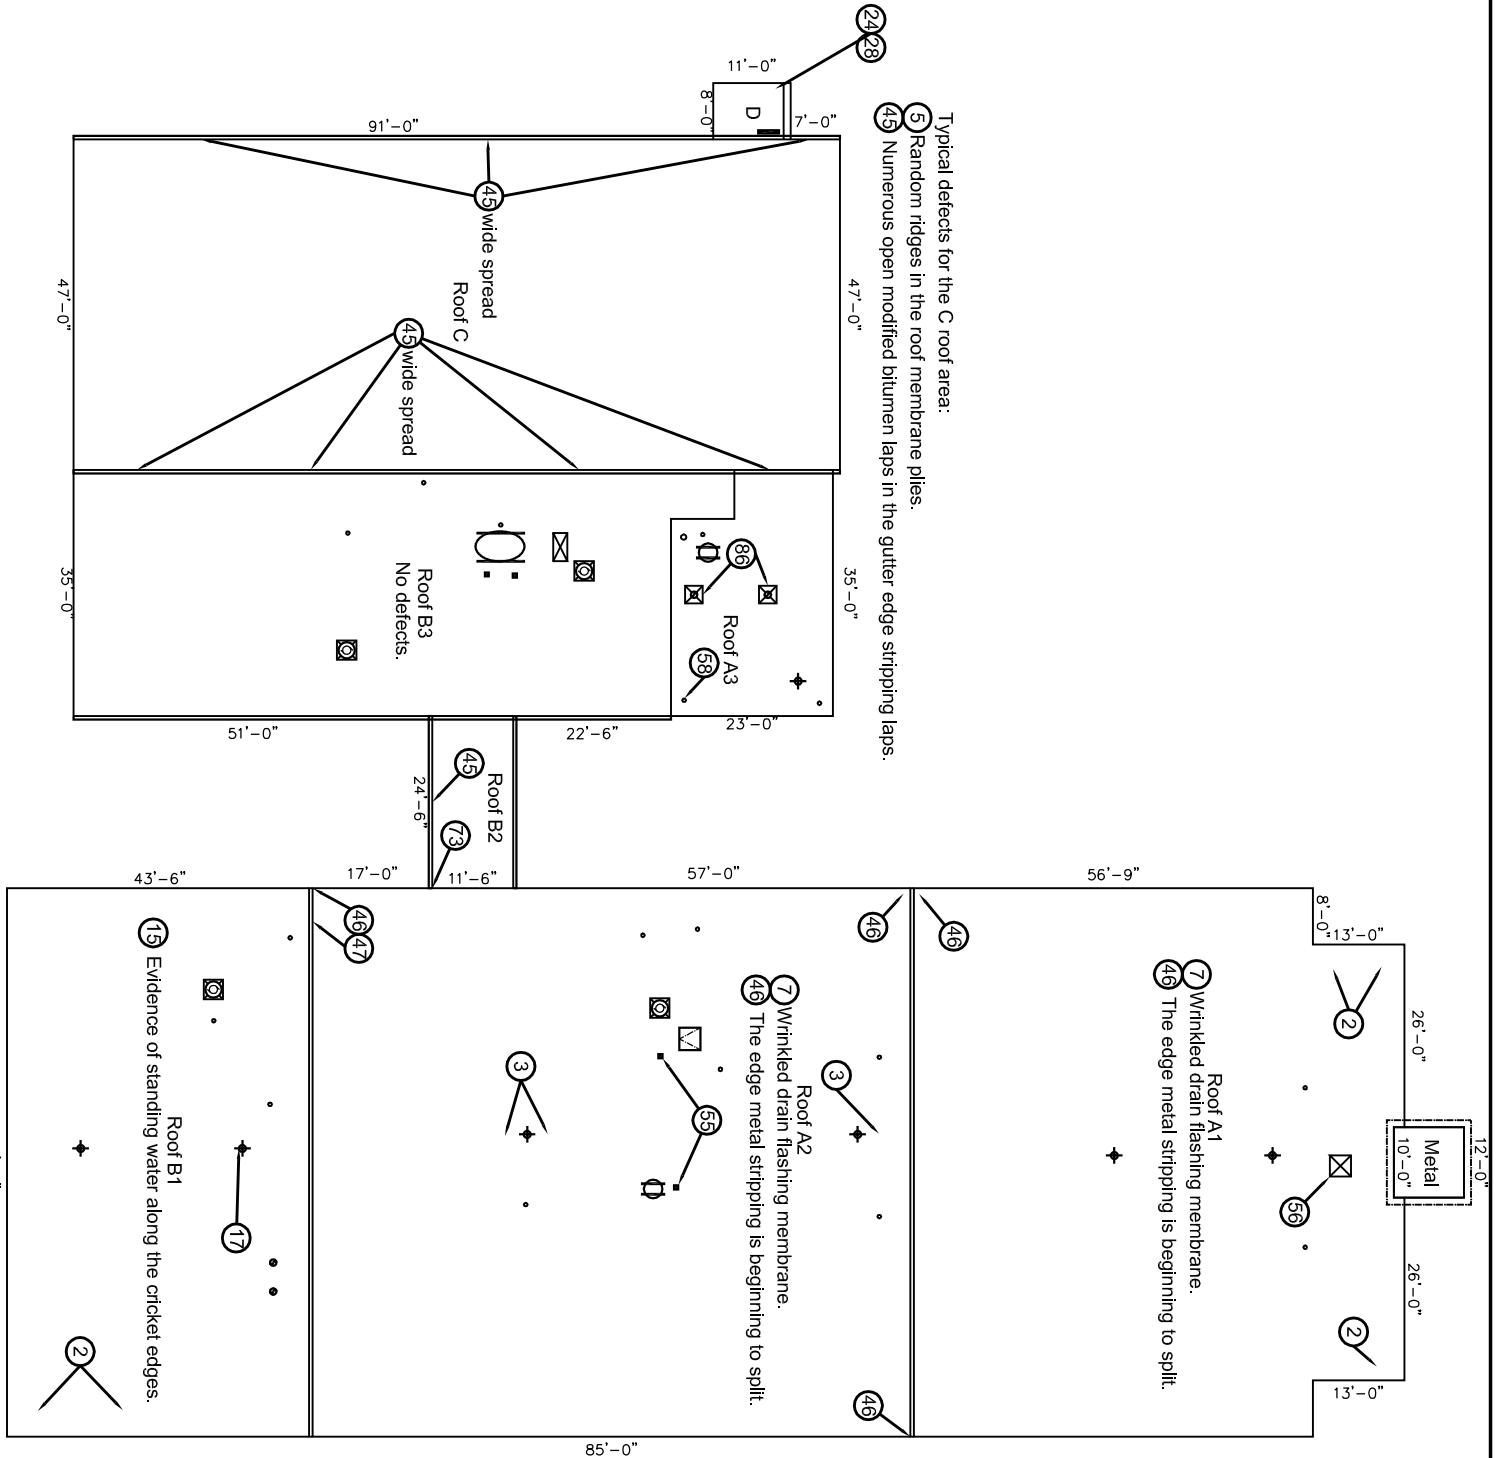
Project Number: 00-000000 **Sheet Title:** A,B,C&D-Roof Plan

Typical defects for the C roof area:
 (5) Random ridges in the roof membrane plies.
 (45) Numerous open modified bitumen laps in the gutter edge stripping laps.
