# Roof Inspection Report

Two Springs Elementary  
3001 Spring Boulevard  
Bellevue, NE 68123

Date	Inspection Type	Inspecting Company	Inspector
Mar 09, 2017	Phase 1 Roof Inspection	Roofing Solutions, Inc.	Garry Hendrickson

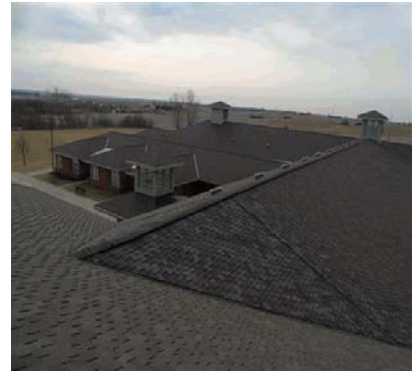
- Random areas with splits in the shingles observed
- Damaged or missing shingles observed
- Numerous torn shingles observed along the recent EPDM lining replacement areas
- There are what appears to be hail dents on the metal roof areas
- There have been shingles replaced at the northern valley areas
- Roof mastic repair attempts observed around the pipe penetration details
- Broken, missing and/or loose ridge cap shingles observed

Overall, the roof system is in poor condition due to its age and the above referenced defects. With the aforementioned defects addressed, in addition to routine maintenance and regular inspection, the roof system should remain effective for the duration of its assessed service life, approximately two (2) years. There was no warranty information available for this roof section at the time of inspection.

Budget Year	Activity Type	Action Item ?	Allocation	Urgency	Quotation \$
2017	Repair	Yes	Expense	Moderate	\$1,500
RSI recommends leak repairs be performed only as needed until the roofs recommended replacement in 2019.					
2019	Replacement	Yes	Capital	Moderate	\$305,712
RSI recommends the installation of a new twenty (20) year design life roof system. We further recommend the replacement of all perimeter coping cap and projection details per SMACNA Architectural Sheet Metal Manual.					
					<b>\$307,212</b>

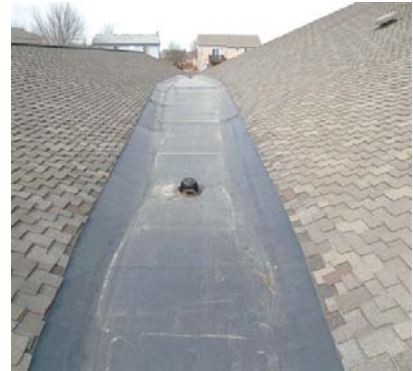
Roof Section B refers to the EPDM valley roofs at the Two Springs Elementary School. The roof system is a recently installed, fully-adhered, .060 mil. EPDM. The roof section includes the B-1 thru B-5 roof areas. The B-1 thru B-4 areas were replaced. The B-5 roof area has the original EPDM membrane still in place. The EPDM membrane extends under the shingles on the sides of the areas. The drainage ends of the roofs have the EPDM membrane adhered to the valley metal on the shingle roof areas.

Overall, the roof system is in very good working condition with no defects observed at the time of the inspection. With routine maintenance and regular inspection, the roof system should remain effective for the duration of its assessed service life. RSI recommends the B-5 roof area be partially removed and replaced with a new twenty (20) year design life roof system in 2019, in conjunction with the Roof Section A roof replacement. There was no warranty information available for this roof section at the time of inspection.

RSI recommends a partial tear-off of the B-5 roof system, leaving the existing insulation in place, and installation of a new twenty (20) year design life roof system. We further recommend installation of new perimeter metal and projection details per SMACNA Architectural Sheet Metal Manual. Roof Area B-5 measures approximately 135 square feet.

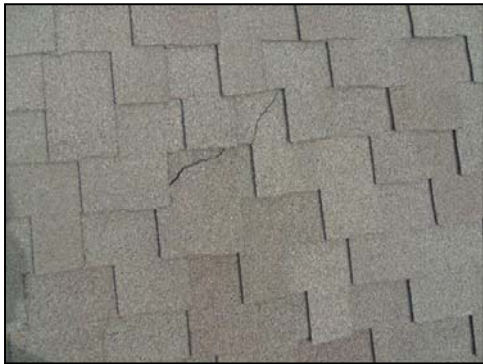
Defect Code:	6	Quantity:	Random	Priority:	Monitor
Description: Split in membrane.					
Repair: Cut out splits and repair membrane with similar membrane material. Extend repair material a minimum of 6" in all directions past repair areas.

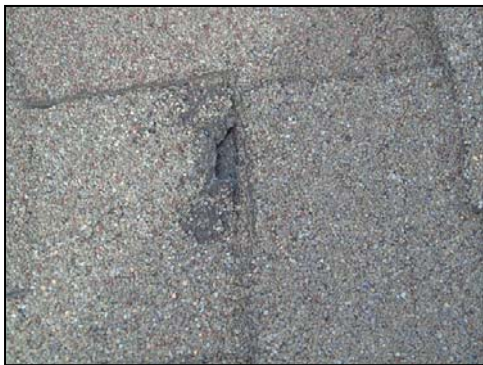
Defect Code:	23	Quantity:	Random	Priority:	Monitor
Description: Physical damage to membrane including cuts, holes, tears, scrapes, scuffs, or abrasions.					
Repair: Apply repair membrane over damaged area, extending repair material a minimum 6" past damage.

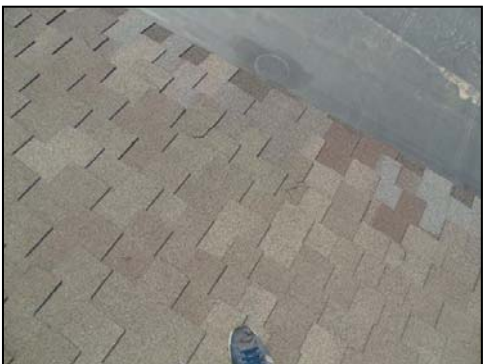
Defect Code:	23	Quantity:	Widespread	Priority:	Monitor
Description: Physical damage to membrane including cuts, holes, tears, scrapes, scuffs, or abrasions.					
Repair: Apply repair membrane over damaged area, extending repair material a minimum 6" past damage.

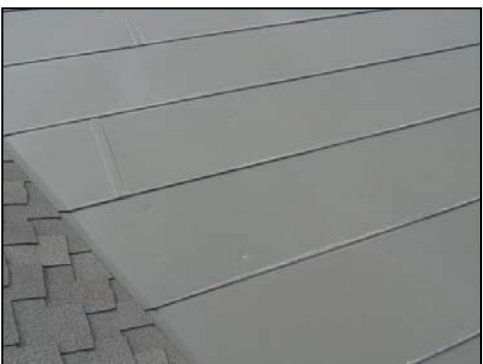
Defect Code:	23	Quantity:	Numerous	Priority:	Monitor
Description: Physical damage to membrane including cuts, holes, tears, scrapes, scuffs, or abrasions.					
Repair: Apply repair membrane over damaged area, extending repair material a minimum 6" past damage.

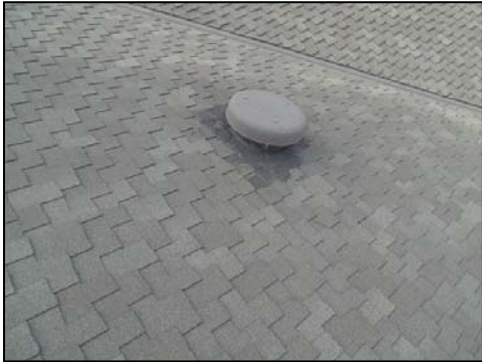
Defect Code:	24	Quantity:	Random	Priority:	Monitor
Description: Evidence of past problem and previous repair.					
Repair: Investigate for chronic leak problems and repair any areas that are suspect.

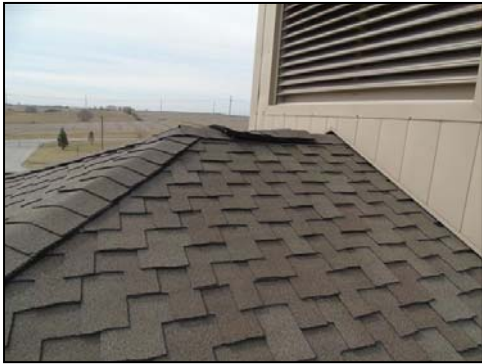
Defect Code:	29	Quantity:	Random	Priority:	Monitor
Description: Missing, loose, or broken shingles					
Repair: Remove all damaged shingles and replace all damaged and missing shingles with shingles of like kind and color.

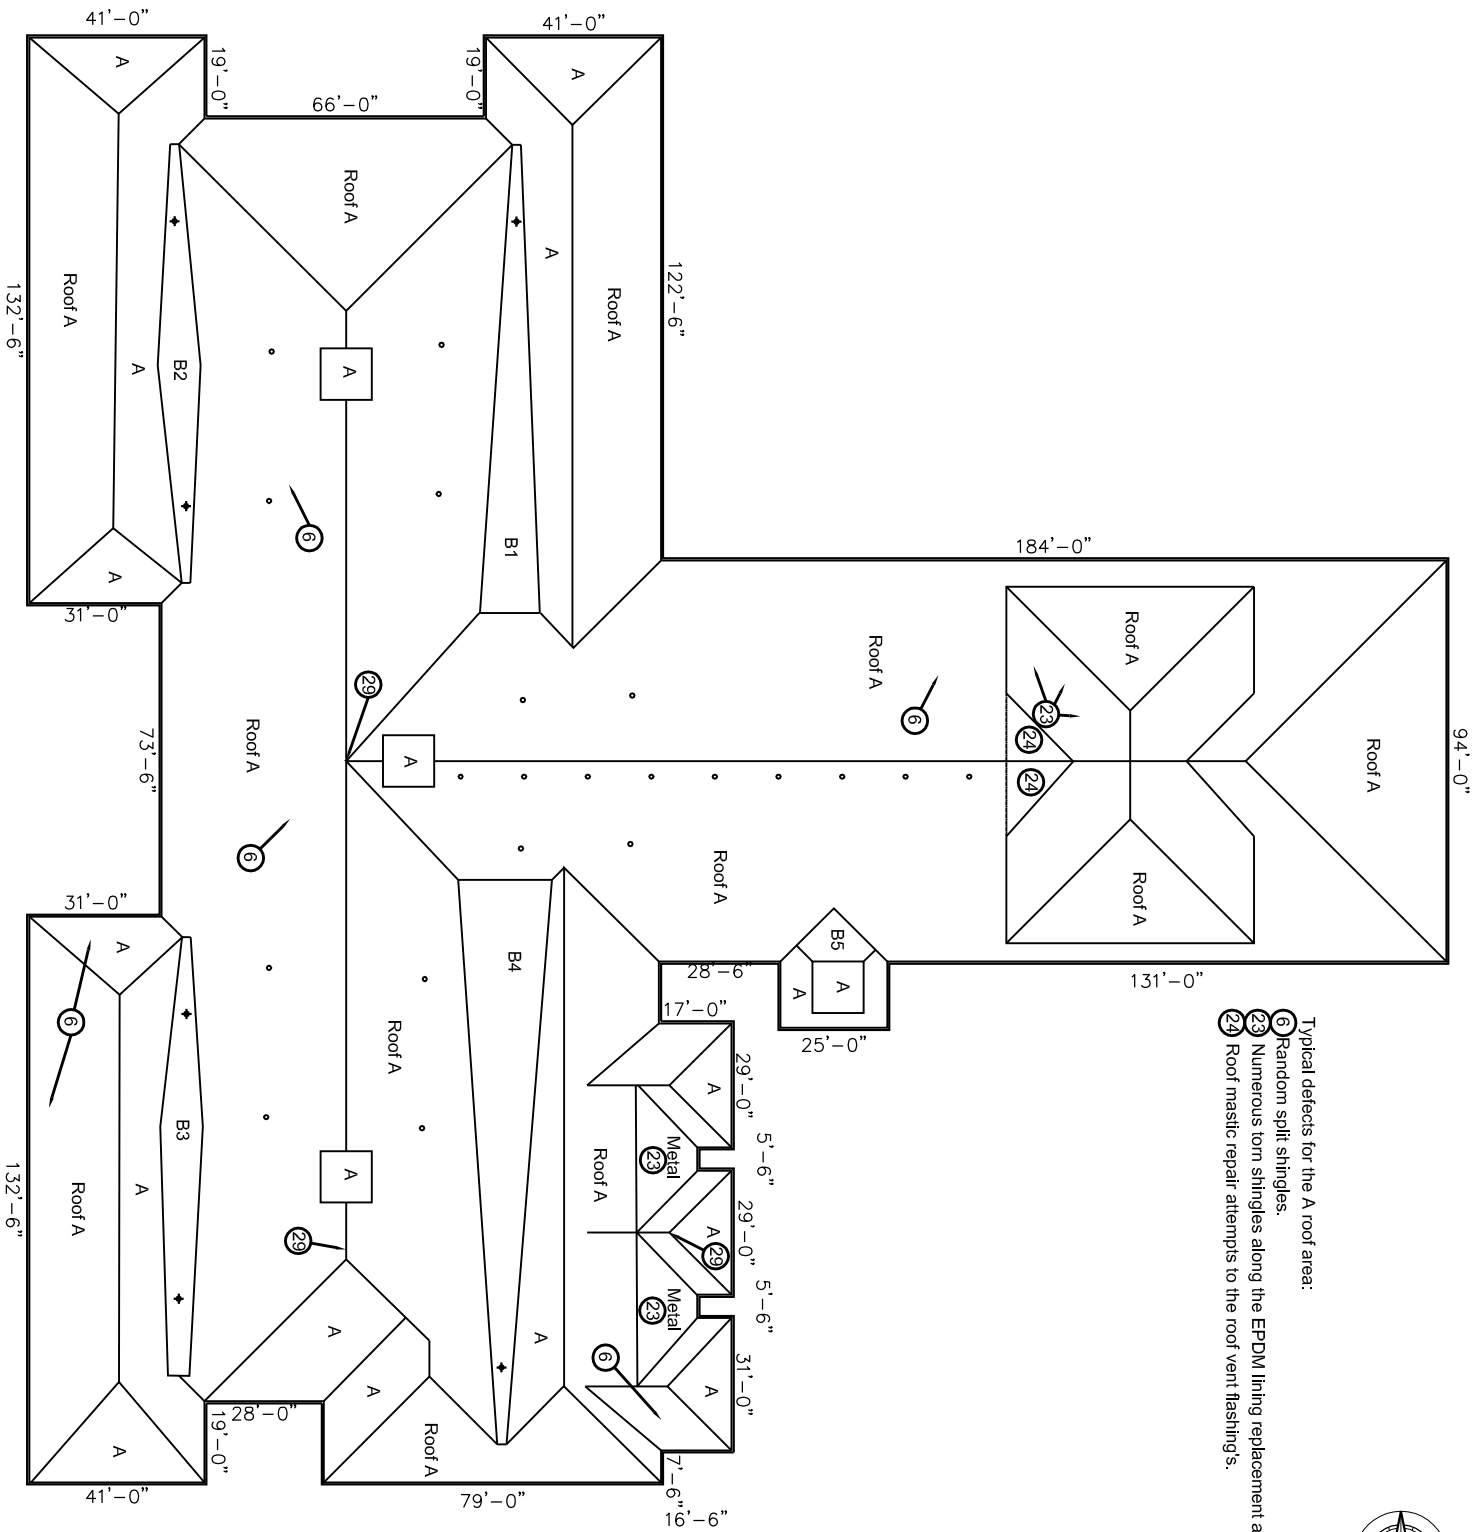
**Sheet Title:**  
**A&B-Roof Plan**

- Typical defects for the A roof area:
- ⑥ Random split shingles.
  - ②③ Numerous torn shingles along the EPDM lining replacement areas.
  - ②④ Roof mastic repair attempts to the roof vent flashings.
