# Roof Inspection Report

## Project Location

Wake Robin School  
700 Lincoln Road  
Bellevue, NE 68005

Date	Inspection Type	Inspecting Company	Inspector
Mar 22, 2017	Phase 1 Roof Inspection	Roofing Solutions, Inc.	Garry Hendrickson

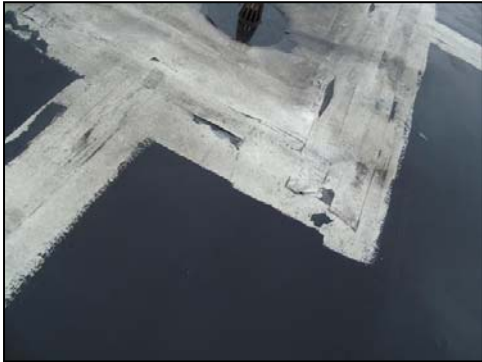
<b>Defect Code:</b>	<b>3</b>	<b>Quantity:</b>	<b>Widespread</b>	<b>Priority:</b>	<b>Monitor</b>
Description: Open lap in field membrane.					
Repair: Clean lap of all dirt and close seam. Overlay edge of affected seam with strip-in of new membrane of like material. Extend a minimum of 4" in all directions past seam edges and repair areas.

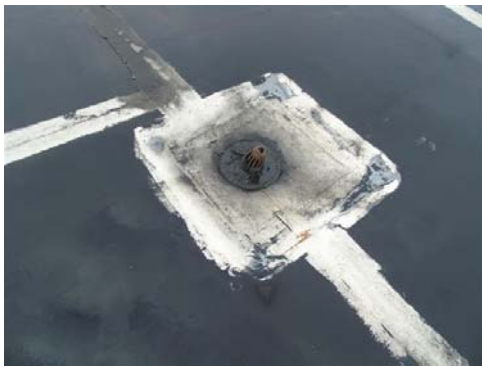
<b>Defect Code:</b>	<b>22</b>	<b>Quantity:</b>	<b>3</b>	<b>Priority:</b>	<b>First Year</b>
Description: Debris, trash, construction materials, HVAC equipment, filters, motors, etc. on roof surface.					
Repair: Remove all trash and debris from roof. Clean and inspect surfaces and repair any damages to the membrane or flashings.

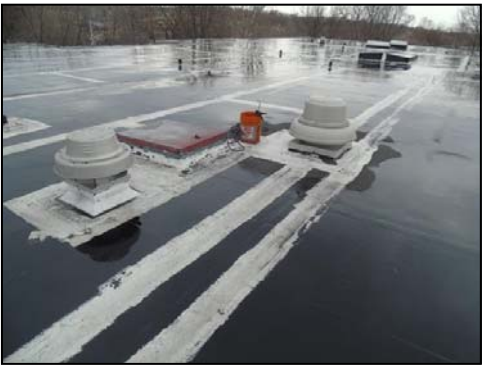
<b>Defect Code:</b>	<b>24</b>	<b>Quantity:</b>	<b>Widespread</b>	<b>Priority:</b>	<b>Monitor</b>
Description: Evidence of past problem and previous repair.					
Repair: Investigate for chronic leak problems and repair any areas that are suspect.

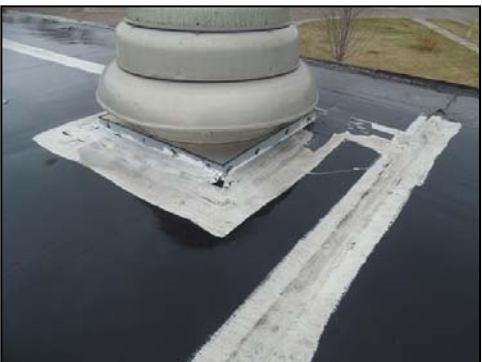
<b>Defect Code:</b>	<b>40</b>	<b>Quantity:</b>	<b>1</b>	<b>Priority:</b>	<b>Monitor</b>
Description: Low flashing height.					
Repair: Raise flashing height to a minimum of 8" above finished roof surface. Provide appropriate termination of flashings with metal copings or counterflashings. Provide a compression bar termination of flashings to concrete or block surface if flashings cannot be maintained at 8" minimum height.

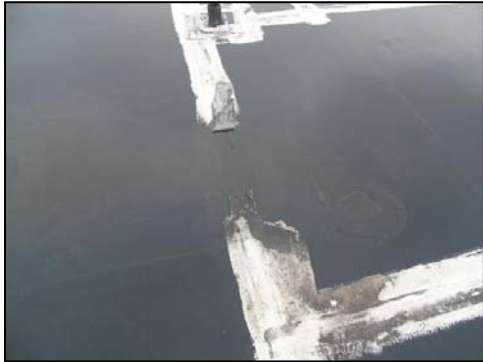
<b>Defect Code:</b>	<b>3</b>	<b>Quantity:</b>	<b>Widespread</b>	<b>Priority:</b>	<b>Monitor</b>
Description: Open lap in field membrane.					
Repair: Clean lap of all dirt and close seam. Overlay edge of affected seam with strip-in of new membrane of like material. Extend a minimum of 4" in all directions past seam edges and repair areas.

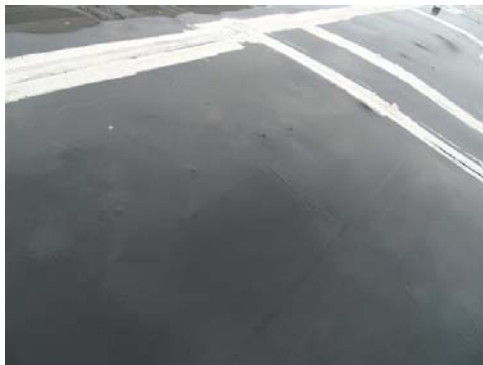
<b>Defect Code:</b>	<b>10</b>	<b>Quantity:</b>	<b>Random</b>	<b>Priority:</b>	<b>Monitor</b>
Description: Tented membrane at fastener.					
Repair: Remove fasteners that are loose or not flush with the substrate. Remove underlying substrate materials including insulation and coverboard and replace with matching materials of similar thicknesses to provide for a smooth flush surface.. Install new fasteners and plates per manufacturer's recommendations for system type and apply new membrane repair materials of similar type, gauge, and plies as existing roof system.

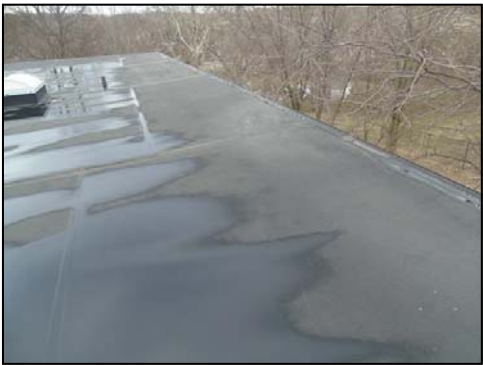
<b>Defect Code:</b>	<b>18</b>	<b>Quantity:</b>	<b>Widespread</b>	<b>Priority:</b>	<b>Monitor</b>
Description: Unadhered membrane or inadequate membrane attachment.					
Repair: At unadhered areas, cut open membrane and readhere to substrate with manufacturer's approved adhesive. At areas with missing securement, provide securement in the form of screws and plates installed a maximum of 12" O.C. Overlay repaired areas with new membrane of similar gauge, type, and plies and extend repairs a minimum of 4" past cut areas or edges of plates.

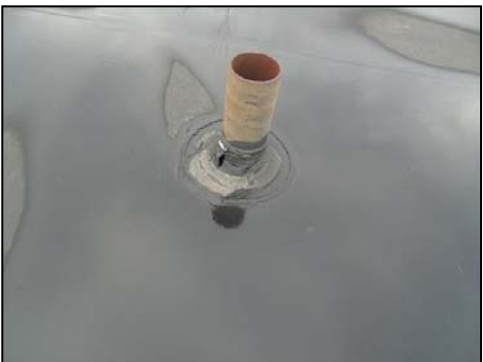
<b>Defect Code:</b>	<b>23</b>	<b>Quantity:</b>	<b>Under 10 LF</b>	<b>Priority:</b>	<b>First Year</b>
Description: Physical damage to membrane including cuts, holes, tears, scrapes, scuffs, or abrasions.					
Repair: Apply repair membrane over damaged area, extending repair material a minimum 6" past damage.

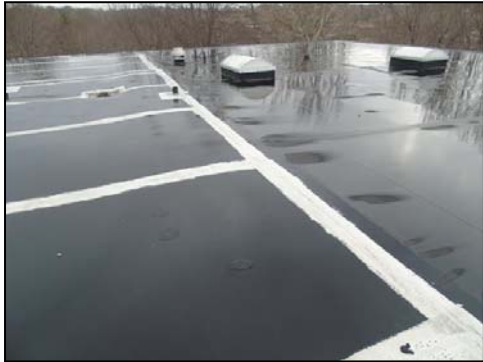
Defect Code:	24	Quantity:	Widespread	Priority:	Monitor
Description: Evidence of past problem and previous repair.					
Repair: Investigate for chronic leak problems and repair any areas that are suspect.

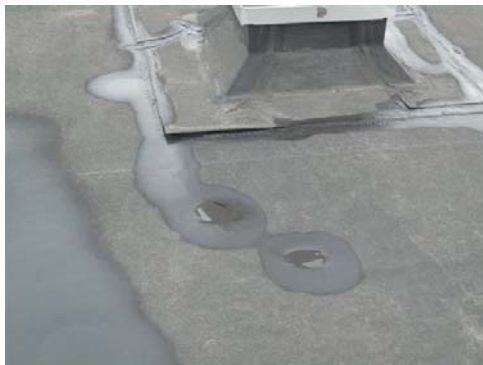
Defect Code:	45	Quantity:	Widespread	Priority:	Monitor
Description: Open flashing lap					
Repair: Open loose lap area and clean thoroughly. Prime and reseam or reweld lap per the manufacturer's requirements. Strip-in defective lap with mimum 6" wide membrane on single ply systems or 6" wide fabric and mastic three-course application on asphalt systems. Regranulate or coat flashing repairs.

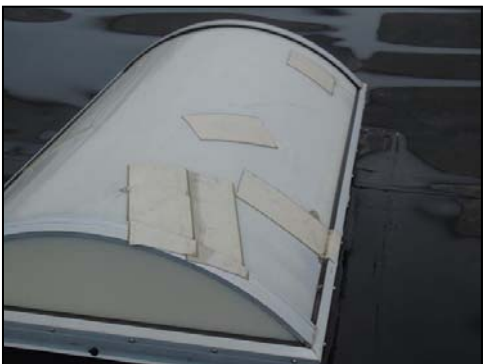
Defect Code:	88	Quantity:	1	Priority:	First Year
Description: Skylight defect/cracked/deteriorated					
Repair: Remove and replace affected components.

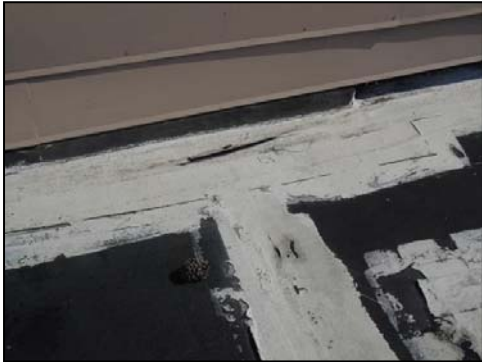
Defect Code:	3	Quantity:	Widespread	Priority:	Monitor
Description: Open lap in field membrane.					
Repair: Clean lap of all dirt and close seam. Overlay edge of affected seam with strip-in of new membrane of like material. Extend a minimum of 4" in all directions past seam edges and repair areas.

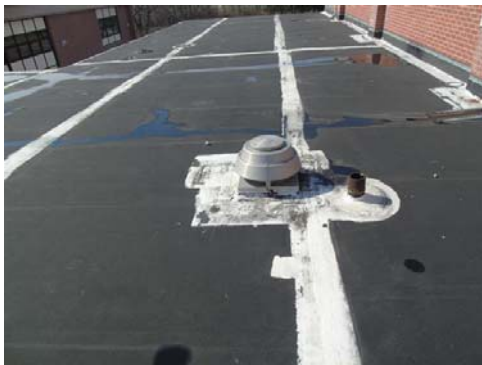
Defect Code:	24	Quantity:	Widespread	Priority:	Monitor
Description: Evidence of past problem and previous repair.					
Repair: Investigate for chronic leak problems and repair any areas that are suspect.

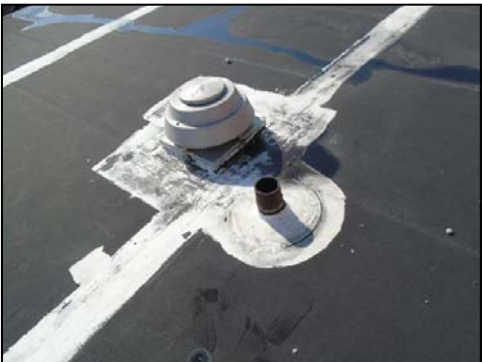
Defect Code:	40	Quantity:	1	Priority:	Monitor
Description: Low flashing height.					
Repair: Raise flashing height to a minimum of 8" above finished roof surface. Provide appropriate termination of flashings with metal copings or counterflashings. Provide a compression bar termination of flashings to concrete or block surface if flashings cannot be maintained at 8" minimum height.

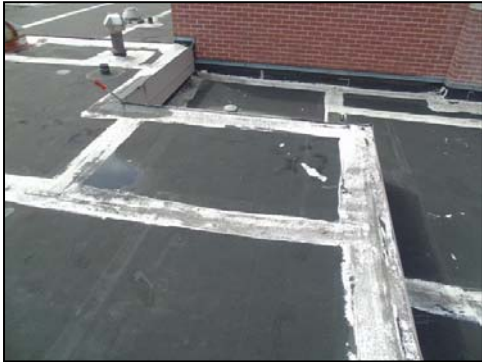
<b>Defect Code:</b>	<b>3</b>	<b>Quantity:</b>	<b>Widespread</b>	<b>Priority:</b>	<b>Monitor</b>
Description: Open lap in field membrane.					
Repair: Clean lap of all dirt and close seam. Overlay edge of affected seam with strip-in of new membrane of like material. Extend a minimum of 4" in all directions past seam edges and repair areas.

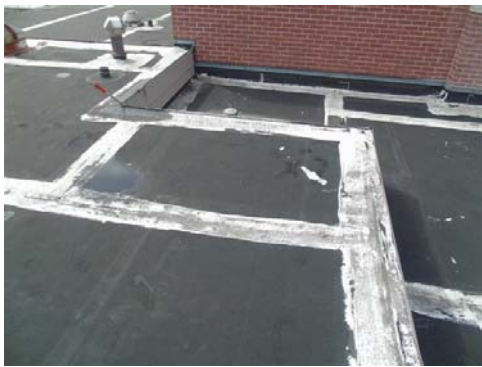
<b>Defect Code:</b>	<b>24</b>	<b>Quantity:</b>	<b>Widespread</b>	<b>Priority:</b>	<b>Monitor</b>
Description: Evidence of past problem and previous repair.					
Repair: Investigate for chronic leak problems and repair any areas that are suspect.

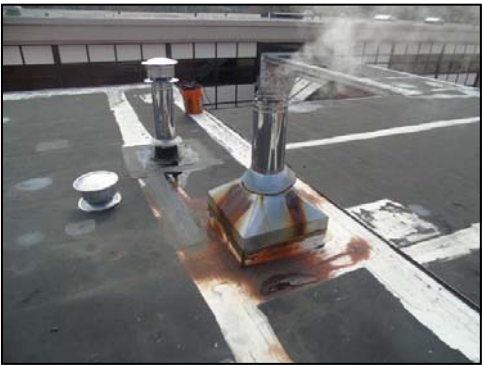
<b>Defect Code:</b>	<b>52</b>	<b>Quantity:</b>	<b>1</b>	<b>Priority:</b>	<b>First Year</b>
Description: Missing rain cap, rain collar, or hood.					
Repair: Install rain cap, hood, or collar and secure and seal to pipe.

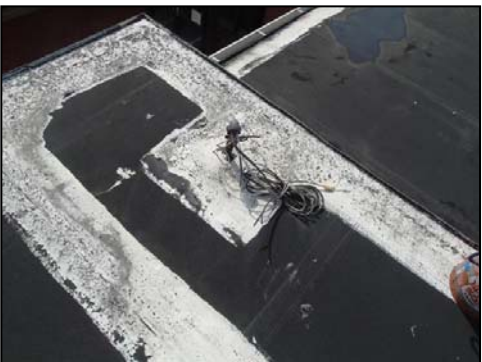
<b>Defect Code:</b>	<b>56</b>	<b>Quantity:</b>	<b>1</b>	<b>Priority:</b>	<b>Monitor</b>
Description: Abandoned and obsolete equipment.					
Repair: Monitor for leaks. Check systems are abandoned and disconnected and will not be used in the future. Remove abandoned equipment and repair deck at scheduled roof replacement.

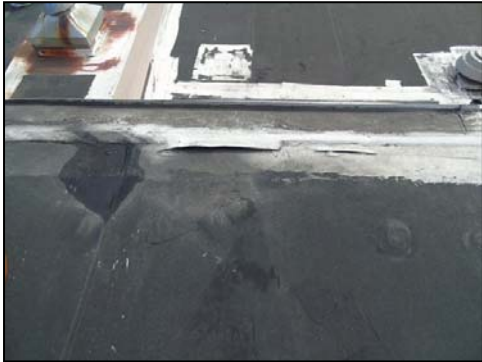
Defect Code:	3	Quantity:	Widespread	Priority:	Monitor
Description: Open lap in field membrane.					
Repair: Clean lap of all dirt and close seam. Overlay edge of affected seam with strip-in of new membrane of like material. Extend a minimum of 4" in all directions past seam edges and repair areas.

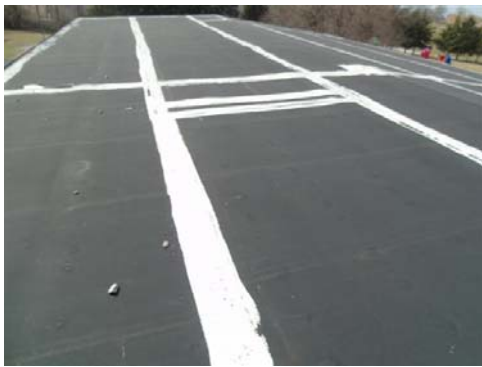
Defect Code:	24	Quantity:	Widespread	Priority:	Monitor
Description: Evidence of past problem and previous repair.					
Repair: Investigate for chronic leak problems and repair any areas that are suspect.
