# Roof Inspection Report

Prepared for:

Prepared by:

West High School  
1501 Thurston Avenue  
Bellevue, NE 68123

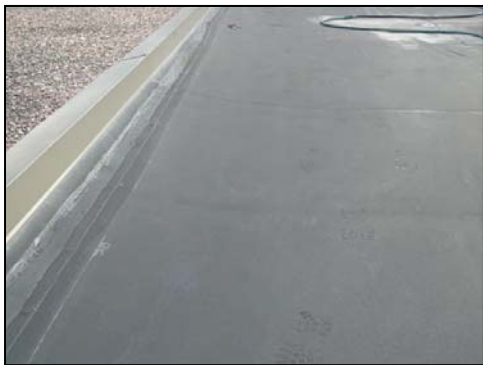
Defect Code:	18	Quantity:	Widespread	Priority:	Monitor
Description: Unadhered membrane or inadequate membrane attachment.					
Repair: At unadhered areas, cut open membrane and readhere to substrate with manufacturer's approved adhesive. At areas with missing securement, provide securement in the form of screws and plates installed a maximum of 12" O.C. Overlay repaired areas with new membrane of similar gauge, type, and plies and extend repairs a minimum of 4" past cut areas or edges of plates.

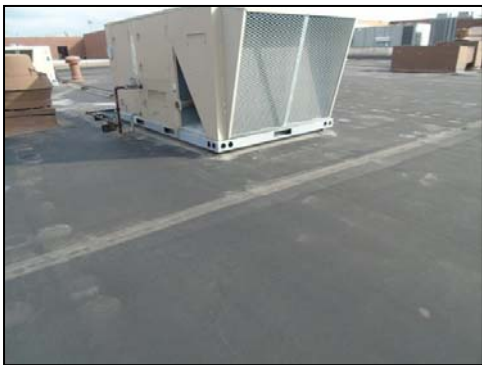
<b>Defect Code:</b>	<b>40</b>	<b>Quantity:</b>	<b>Random</b>	<b>Priority:</b>	<b>Monitor</b>
Description: Low flashing height.					
Repair: Raise flashing height to a minimum of 8" above finished roof surface. Provide appropriate termination of flashings with metal copings or counterflashings. Provide a compression bar termination of flashings to concrete or block surface if flashings cannot be maintained at 8" minimum height.

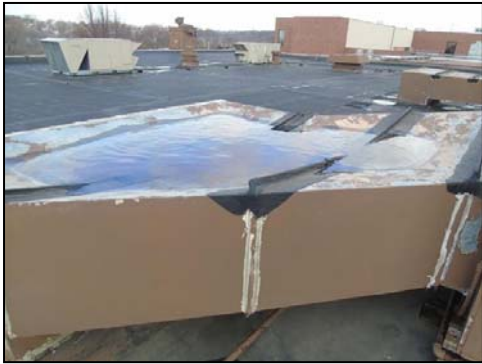
Defect Code:	87	Quantity:	Random	Priority:	Monitor
Description: Mechanical defect					
Repair: Repair mechanical defect. Replace or reinstall missing access doors and panels. Reseal rooftop unit, pans, ducts, curbs, etc.

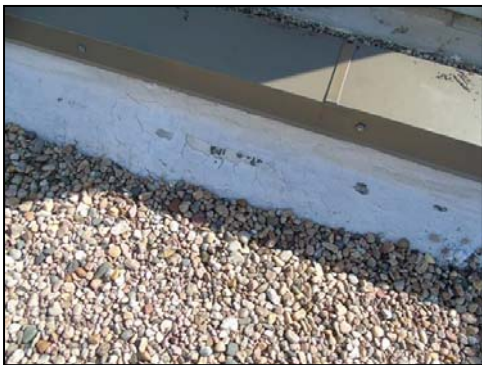
<b>Defect Code:</b>	<b>43</b>	<b>Quantity:</b>	<b>Widespread</b>	<b>Priority:</b>	<b>First Year</b>
Description: Weathered and deteriorated flashing					
Repair: Clean and prepare surfaces by removing loose granules, dirt, and other debris. Apply two coats of elastomeric coating compatible with the flashing materials.

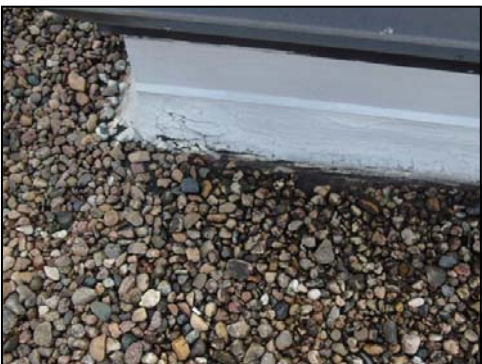
<b>Defect Code:</b>	<b>46</b>	<b>Quantity:</b>	<b>Random</b>	<b>Priority:</b>	<b>First Year</b>
Description: Split in flashing					
Repair: Cut away loose flashing and clean and prime repair area. Apply strip in of like material centered over split extending a minimum of 4" in all directions past prepared area.

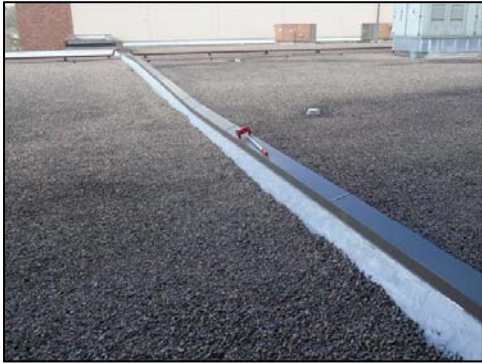
Defect Code:	57	Quantity:	Widespread	Priority:	Monitor
Description: Expansion joint deficiencies.					
Repair: Repair defects in rubber expansion joint or joint covers with two layers of flashing with the second layer being 3" larger in all directions than the first. Install flashing with manufacturer's recommended cleaners and primers.

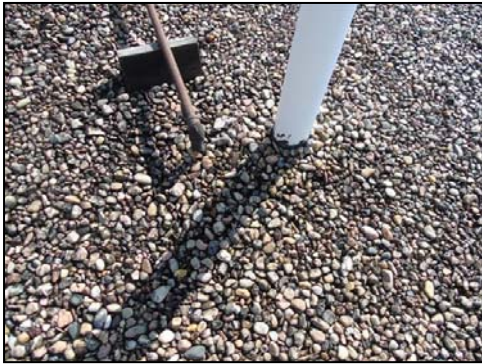
Defect Code:	58	Quantity:	3	Priority:	Monitor
Description: Inadequate, incomplete, nonconforming membrane flashings or flashing details.					
Repair: Complete membrane flashing repairs in accordance with NRCA recommendations and good roofing practices. Follow manufacturer requirements on warranted systems.

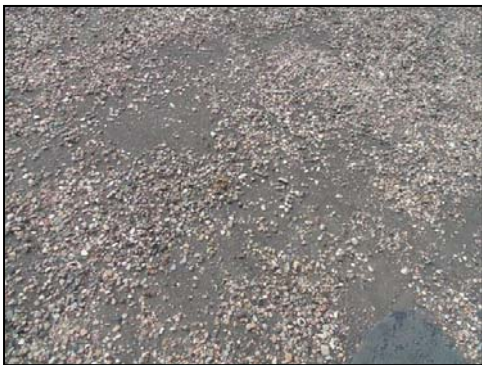
<b>Defect Code:</b>	<b>8</b>	<b>Quantity:</b>	<b>Widespread</b>	<b>Priority:</b>	<b>Monitor</b>
Description: Surface erosion.					
Repair: Prepare membrane surface by thoroughly cleaning and priming. Apply new surfacing of like materials to eroded areas. On gravel surfaced systems apply gravel in hot asphalt or recommended cold adhesive. Apply granulated fiberglass cap sheet or modified bitumen membrane on like systems. Apply coating system on smooth asphalt surfaces. Transition surfacing to provide for a smooth and neat finished appearance to match the existing surfacing.

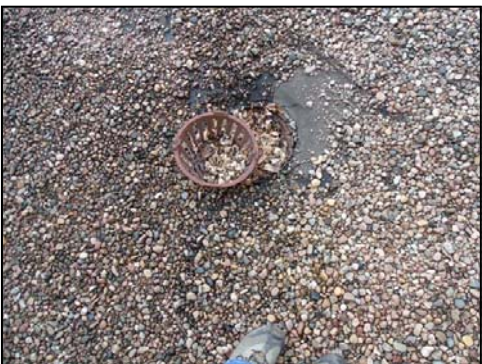
<b>Defect Code:</b>	<b>16</b>	<b>Quantity:</b>	<b>1</b>	<b>Priority:</b>	<b>First Year</b>
Description: Blocked drain, scupper, or downspout.					
Repair: Remove all debris from drainage system and ensure drain or scupper is free flowing without restrictions at strainer or piping.

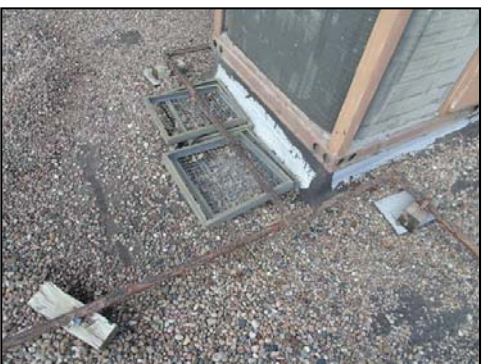
<b>Defect Code:</b>	<b>22</b>	<b>Quantity:</b>	<b>Random</b>	<b>Priority:</b>	<b>First Year</b>
Description: Debris, trash, construction materials, HVAC equipment, filters, motors, etc. on roof surface.					
Repair: Remove all trash and debris from roof. Clean and inspect surfaces and repair any damages to the membrane or flashings.

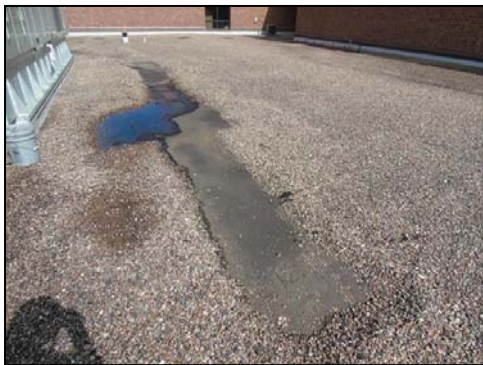
<b>Defect Code:</b>	<b>24</b>	<b>Quantity:</b>	<b>Widespread</b>	<b>Priority:</b>	<b>Monitor</b>
Description: Evidence of past problem and previous repair.					
Repair: Investigate for chronic leak problems and repair any areas that are suspect.

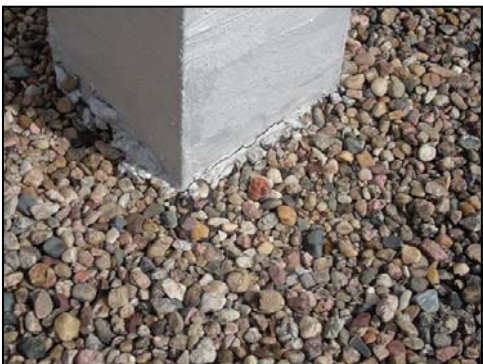
<b>Defect Code:</b>	<b>46</b>	<b>Quantity:</b>	<b>Random</b>	<b>Priority:</b>	<b>First Year</b>
Description: Split in flashing					
Repair: Cut away loose flashing and clean and prime repair area. Apply strip in of like material centered over split extending a minimum of 4" in all directions past prepared area.

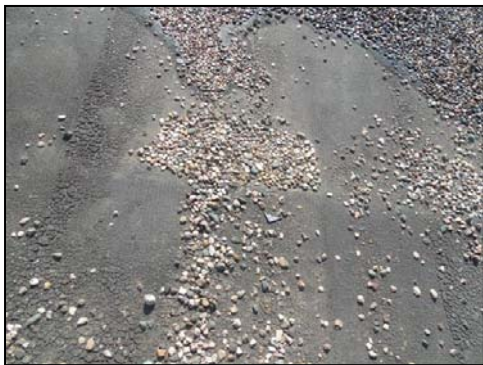
<b>Defect Code:</b>	<b>8</b>	<b>Quantity:</b>	<b>Widespread</b>	<b>Priority:</b>	<b>Monitor</b>
Description: Surface erosion.					
Repair: Prepare membrane surface by thoroughly cleaning and priming. Apply new surfacing of like materials to eroded areas. On gravel surfaced systems apply gravel in hot asphalt or recommended cold adhesive. Apply granulated fiberglass cap sheet or modified bitumen membrane on like systems. Apply coating system on smooth asphalt surfaces. Transition surfacing to provide for a smooth and neat finished appearance to match the existing surfacing.

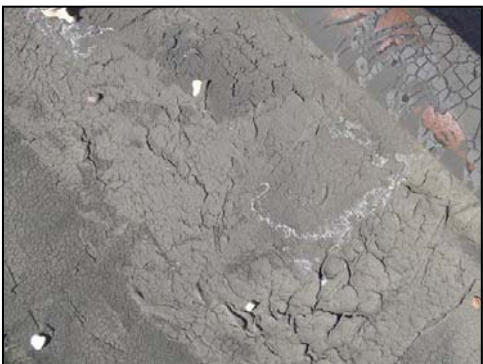
<b>Defect Code:</b>	<b>9</b>	<b>Quantity:</b>	<b>Random</b>	<b>Priority:</b>	<b>First Year</b>
Description: Membrane deterioration.					
Repair: Replace all deteriorated membrane with new membrane of similar type, gauge, and plies.

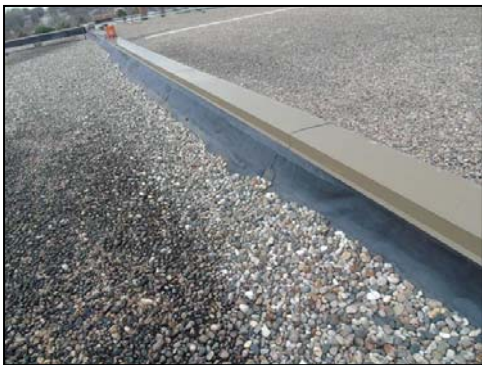
<b>Defect Code:</b>	<b>44</b>	<b>Quantity:</b>	<b>Widespread</b>	<b>Priority:</b>	<b>Monitor</b>
Description: Bridged flashing					
Repair: Cut out all bridged flashings. Clean area thoroughly and apply new flashings. Apply corner flashings and overlay all T-laps, flashings laps, and splice intersections.

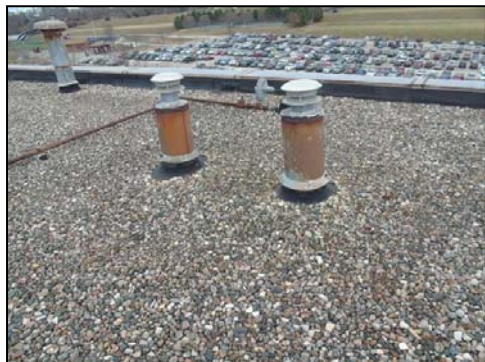
Defect Code:	86	Quantity:	2	Priority:	Monitor
Description: Corrosion or rust					
Repair: Remove rusted components and replace with similar metal fabricated and installed per SMACNA requirements.

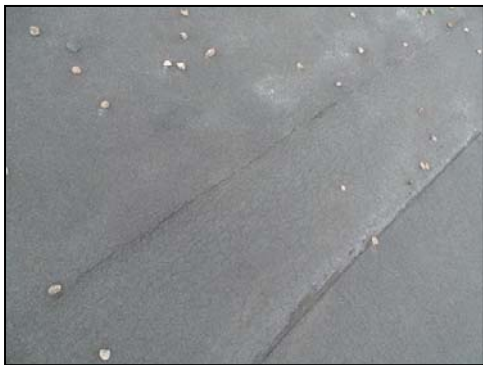
Defect Code:	6	Quantity:	Widespread	Priority:	Monitor
Description: Split in membrane.					
Repair: Cut out splits and repair membrane with similar membrane material. Extend repair material a minimum of 6" in all directions past repair areas.

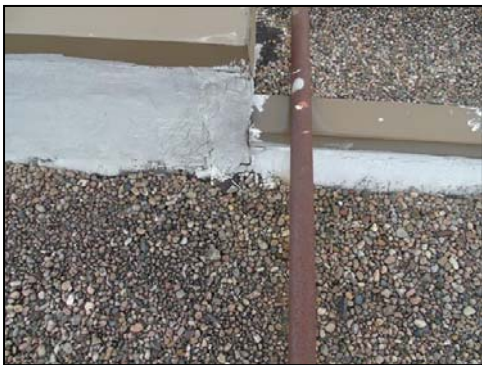
<b>Defect Code:</b>	<b>46</b>	<b>Quantity:</b>	<b>Random</b>	<b>Priority:</b>	<b>First Year</b>
Description: Split in flashing					
Repair: Cut away loose flashing and clean and prime repair area. Apply strip in of like material centered over split extending a minimum of 4" in all directions past prepared area.

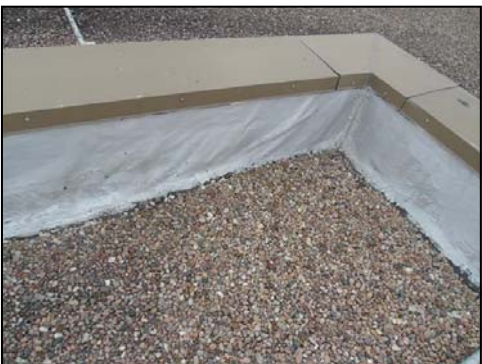
<b>Defect Code:</b>	<b>47</b>	<b>Quantity:</b>	<b>Random</b>	<b>Priority:</b>	<b>Monitor</b>
Description: Racked flashings					
Repair: Monitor flashings and repair when identified as deteriorated.

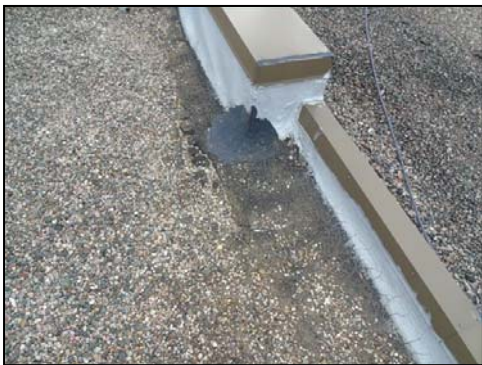
<b>Defect Code:</b>	<b>24</b>	<b>Quantity:</b>	<b>Random</b>	<b>Priority:</b>	<b>Monitor</b>
Description: Evidence of past problem and previous repair.					
Repair: Investigate for chronic leak problems and repair any areas that are suspect.

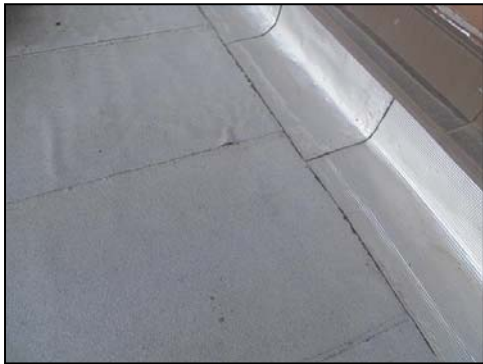
<b>Defect Code:</b>	<b>2</b>	<b>Quantity:</b>	<b>Under 10 LF</b>	<b>Priority:</b>	<b>First Year</b>
Description: Fishmouth in field or flashing seam.					
Repair: Cut away fishmouth and lay material flat. Apply repair of like material and extend onto existing roof surface a minimum of 4". Complete laps per manufacturer's requirements. On asphalt systems, apply three-course of mastic and fabric over lap. Resurface membrane with ballast, gravel, or granules.

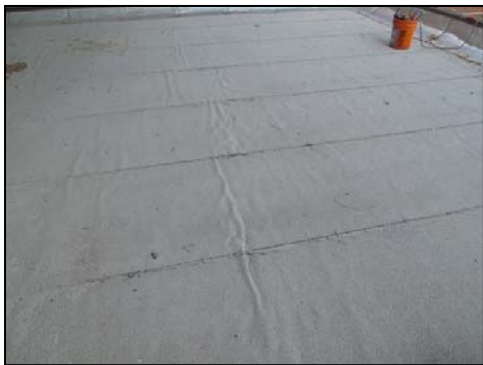
<b>Defect Code:</b>	<b>5</b>	<b>Quantity:</b>	<b>40 LF</b>	<b>Priority:</b>	<b>Monitor</b>
Description: Buckling or ridging of membrane.					
Repair: Cut out deteriorated buckles and ridges and repair membrane with similar membrane material. Extend repair material a minimum of 6" in all directions past repair areas.

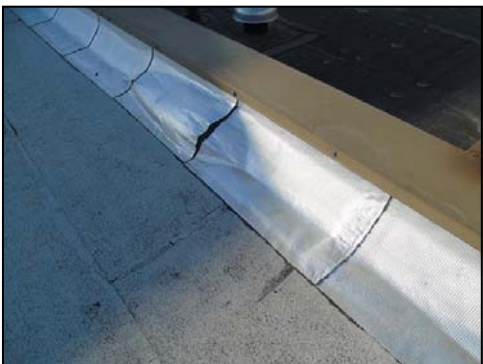
<b>Defect Code:</b>	<b>11</b>	<b>Quantity:</b>	<b>20 SF</b>	<b>Priority:</b>	<b>First Year</b>
Description: Blister in field membrane or flashing.					
Repair: Monitor blisters that are not broken. Repair any broken blisters or blisters in traffic areas or those applying stress to seams or flashings. Cut out blistered membrane and remove wet materials. Apply new membrane and extend a minimum of 6" on

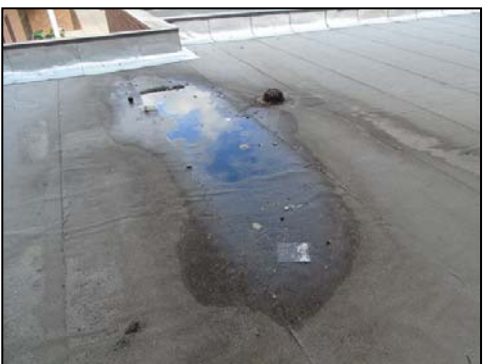
<b>Defect Code:</b>	<b>15</b>	<b>Quantity:</b>	<b>2</b>	<b>Priority:</b>	<b>Monitor</b>
Description: Ponding of water.					
Repair: Monitor areas for severe or chronic ponding. Provide sacrificial membrane ply in ponded areas where existing membrane is deteriorated. Install additional drain or scupper including collectors and drain piping where ponding conditions are severe and chronic.

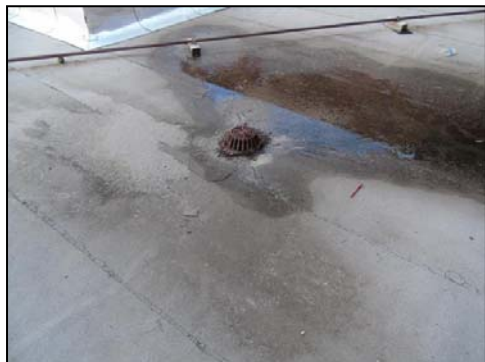
<b>Defect Code:</b>	<b>22</b>	<b>Quantity:</b>	<b>Random</b>	<b>Priority:</b>	<b>First Year</b>
Description: Debris, trash, construction materials, HVAC equipment, filters, motors, etc. on roof surface.					
Repair: Remove all trash and debris from roof. Clean and inspect surfaces and repair any damages to the membrane or flashings.

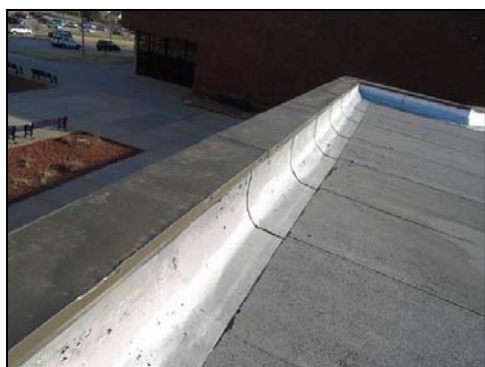
<b>Defect Code:</b>	<b>23</b>	<b>Quantity:</b>	<b>Random</b>	<b>Priority:</b>	<b>Monitor</b>
Description: Physical damage to membrane including cuts, holes, tears, scrapes, scuffs, or abrasions.					
Repair: Apply repair membrane over damaged area, extending repair material a minimum 6" past damage.

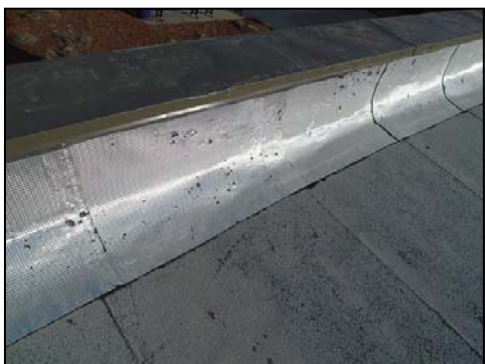
<b>Defect Code:</b>	<b>43</b>	<b>Quantity:</b>	<b>Random</b>	<b>Priority:</b>	<b>Monitor</b>
Description: Weathered and deteriorated flashing					
Repair: Clean and prepare surfaces by removing loose granules, dirt, and other debris. Apply two coats of elastomeric coating compatible with the flashing materials.

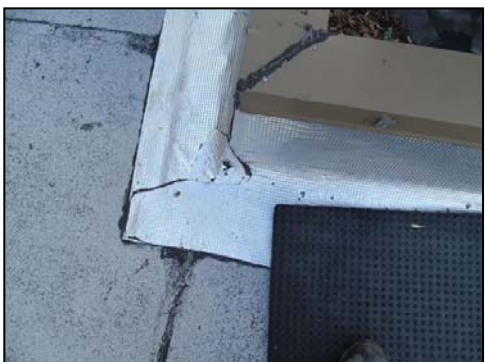
<b>Defect Code:</b>	<b>45</b>	<b>Quantity:</b>	<b>Under 10 LF</b>	<b>Priority:</b>	<b>First Year</b>
Description: Open flashing lap					
Repair: Open loose lap area and clean thoroughly. Prime and re seam or reweld lap per the manufacturer's requirements. Strip-in defective lap with mimum 6" wide membrane on single ply systems or 6" wide fabric and mastic three-course application on asphalt systems. Regranulate or coat flashing repairs.

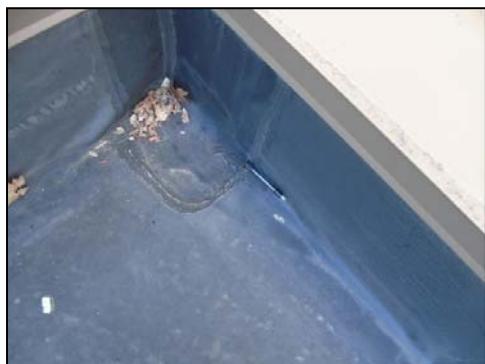
<b>Defect Code:</b>	<b>45</b>	<b>Quantity:</b>	<b>10 LF</b>	<b>Priority:</b>	<b>First Year</b>
Description: Open flashing lap					
Repair: Open loose lap area and clean thoroughly. Prime and reseam or reweld lap per the manufacturer's requirements. Strip-in defective lap with mimum 6" wide membrane on single ply systems or 6" wide fabric and mastic three-course application on asphalt systems. Regranulate or coat flashing repairs.

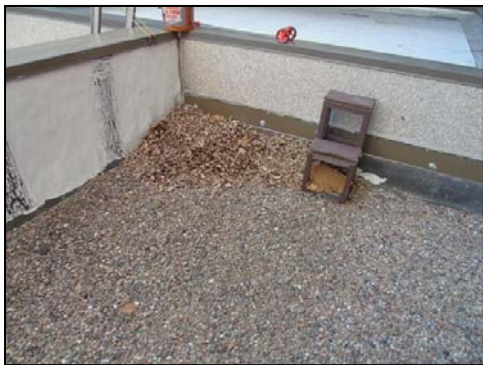
<b>Defect Code:</b>	<b>22</b>	<b>Quantity:</b>	<b>Random</b>	<b>Priority:</b>	<b>First Year</b>
Description: Debris, trash, construction materials, HVAC equipment, filters, motors, etc. on roof surface.					
Repair: Remove all trash and debris from roof. Clean and inspect surfaces and repair any damages to the membrane or flashings.

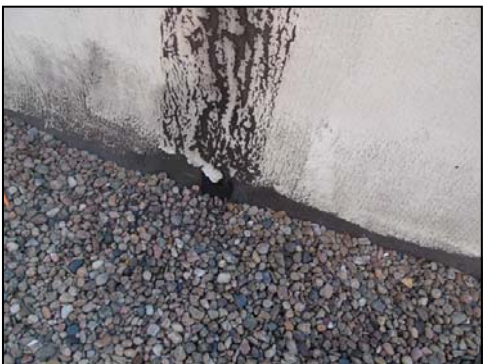
<b>Defect Code:</b>	<b>23</b>	<b>Quantity:</b>	<b>Under 10 LF</b>	<b>Priority:</b>	<b>First Year</b>
Description: Physical damage to membrane including cuts, holes, tears, scrapes, scuffs, or abrasions.					
Repair: Apply repair membrane over damaged area, extending repair material a minimum 6" past damage.

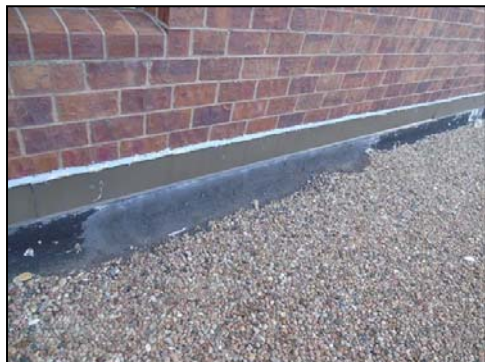
Defect Code:	24	Quantity:	Random	Priority:	Monitor
Description: Evidence of past problem and previous repair.					
Repair: Investigate for chronic leak problems and repair any areas that are suspect.

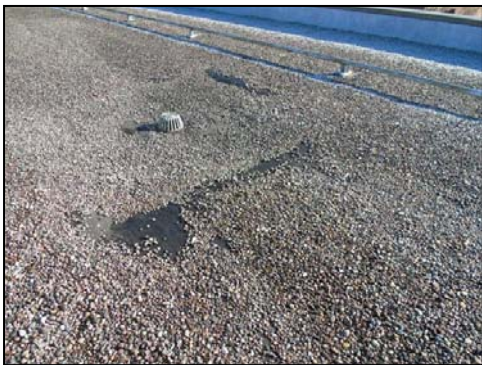
<b>Defect Code:</b>	<b>8</b>	<b>Quantity:</b>	<b>Widespread</b>	<b>Priority:</b>	<b>Monitor</b>
Description: Surface erosion.					
Repair: Prepare membrane surface by thoroughly cleaning and priming. Apply new surfacing of like materials to eroded areas. On gravel surfaced systems apply gravel in hot asphalt or recommended cold adhesive. Apply granulated fiberglass cap sheet or modified bitumen membrane on like systems. Apply coating system on smooth asphalt surfaces. Transition surfacing to provide for a smooth and neat finished appearance to match the existing surfacing.

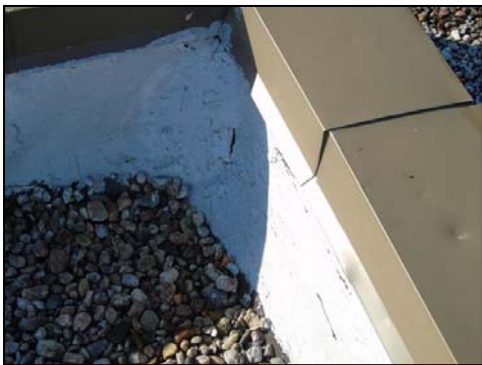
<b>Defect Code:</b>	<b>46</b>	<b>Quantity:</b>	<b>Random</b>	<b>Priority:</b>	<b>First Year</b>
Description: Split in flashing					
Repair: Cut away loose flashing and clean and prime repair area. Apply strip in of like material centered over split extending a minimum of 4" in all directions past prepared area.

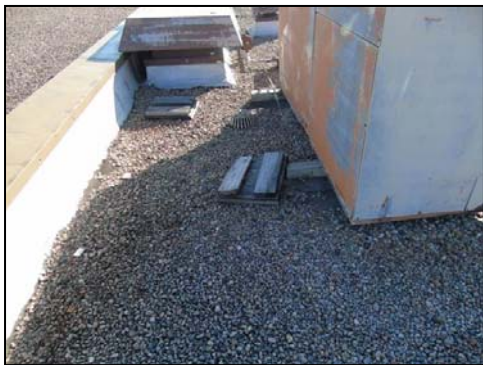
<b>Defect Code:</b>	<b>22</b>	<b>Quantity:</b>	<b>Random</b>	<b>Priority:</b>	<b>First Year</b>
Description: Debris, trash, construction materials, HVAC equipment, filters, motors, etc. on roof surface.					
Repair: Remove all trash and debris from roof. Clean and inspect surfaces and repair any damages to the membrane or flashings.

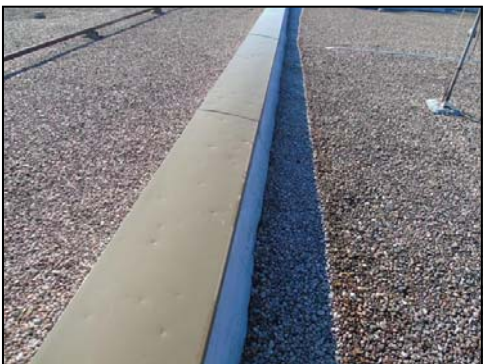
<b>Defect Code:</b>	<b>23</b>	<b>Quantity:</b>	<b>Widespread</b>	<b>Priority:</b>	<b>Monitor</b>
Description: Physical damage to membrane including cuts, holes, tears, scrapes, scuffs, or abrasions.					
Repair: Apply repair membrane over damaged area, extending repair material a minimum 6" past damage.

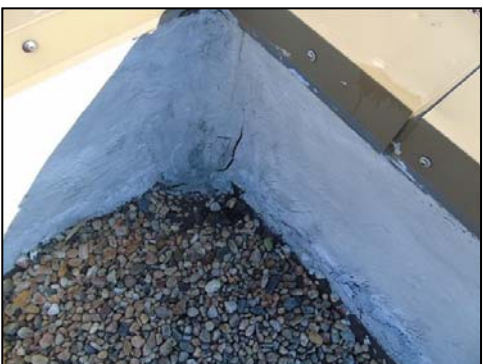
<b>Defect Code:</b>	<b>46</b>	<b>Quantity:</b>	<b>Random</b>	<b>Priority:</b>	<b>First Year</b>
Description: Split in flashing					
Repair: Cut away loose flashing and clean and prime repair area. Apply strip in of like material centered over split extending a minimum of 4" in all directions past prepared area.

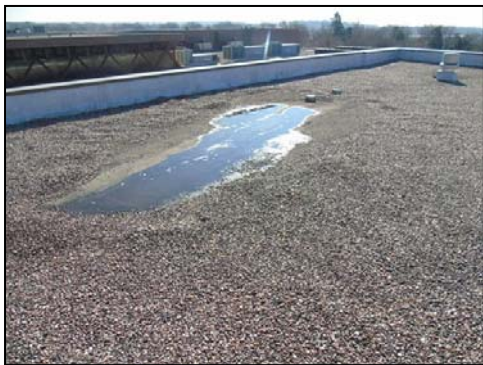
Defect Code:	15	Quantity:	1	Priority:	Monitor
Description: Ponding of water.					
Repair: Monitor areas for severe or chronic ponding. Provide sacrificial membrane ply in ponded areas where existing membrane is deteriorated. Install additional drain or scupper including collectors and drain piping where ponding conditions are severe and chronic.

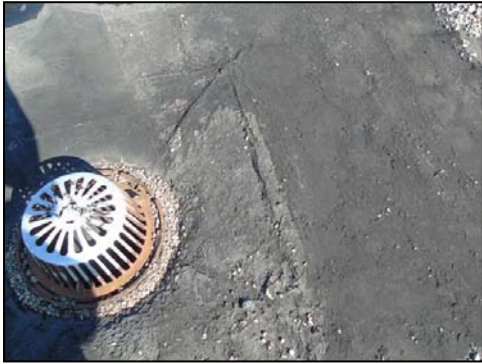
<b>Defect Code:</b>	<b>46</b>	<b>Quantity:</b>	<b>Random</b>	<b>Priority:</b>	<b>First Year</b>
Description: Split in flashing					
Repair: Cut away loose flashing and clean and prime repair area. Apply strip in of like material centered over split extending a minimum of 4" in all directions past prepared area.

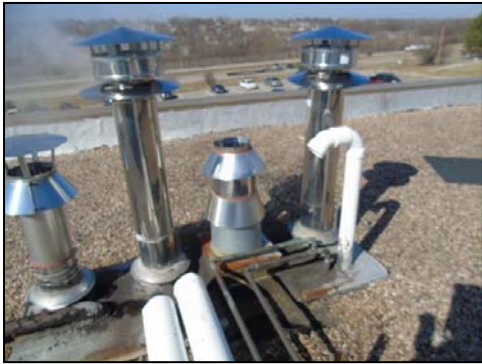
<b>Defect Code:</b>	<b>52</b>	<b>Quantity:</b>	<b>1</b>	<b>Priority:</b>	<b>First Year</b>
Description: Missing rain cap, rain collar, or hood.					
Repair: Install rain cap, hood, or collar and secure and seal to pipe.

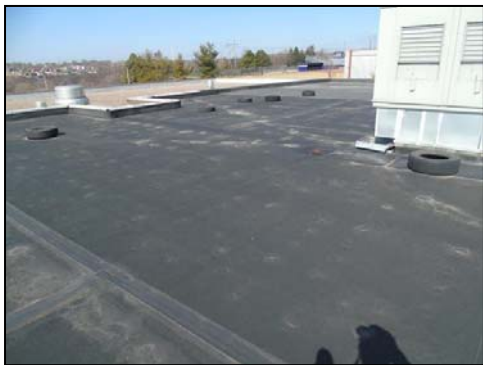
Defect Code:	18	Quantity:	Widespread	Priority:	Monitor
Description: Unadhered membrane or inadequate membrane attachment.					
Repair: At unadhered areas, cut open membrane and readhere to substrate with manufacturer's approved adhesive. At areas with missing securement, provide securement in the form of screws and plates installed a maximum of 12" O.C. Overlay repaired areas with new membrane of similar gauge, type, and plies and extend repairs a minimum of 4" past cut areas or edges of plates.

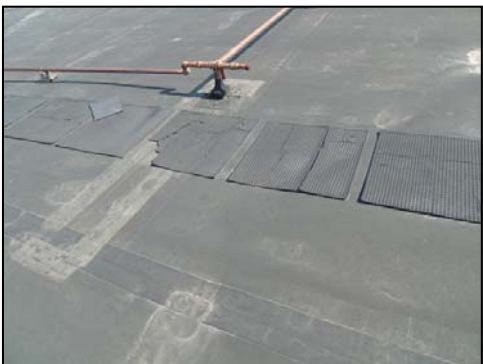
Defect Code:	21	Quantity:	Widespread	Priority:	Monitor
Description: Loose walkway pad or deteriorated paver.					
Repair: Readhere or reweld wakway pads. Provide new pads to replace damaged or missing pads. Replace deteriorated concrete pavers with pavers of like kind and weight to ensure a flush walking surface.

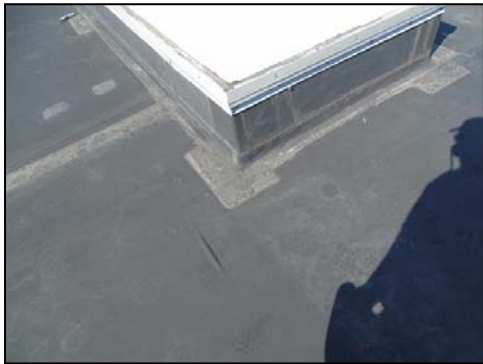
<b>Defect Code:</b>	<b>24</b>	<b>Quantity:</b>	<b>Widespread</b>	<b>Priority:</b>	<b>Monitor</b>
Description: Evidence of past problem and previous repair.					
Repair: Investigate for chronic leak problems and repair any areas that are suspect.

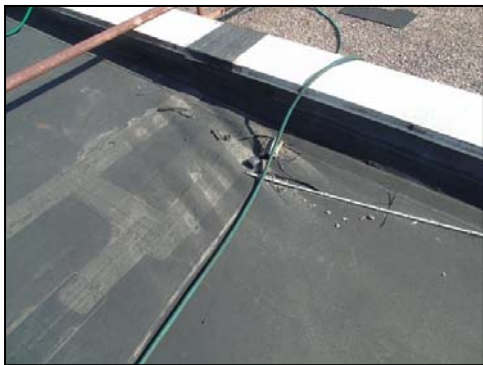
<b>Defect Code:</b>	<b>26</b>	<b>Quantity:</b>	<b>Random</b>	<b>Priority:</b>	<b>Monitor</b>
Description: Membrane shrinkage					
Repair: Investigate and repair cause of shrinkage. Cut away affected areas and prepare to receive new membrane. Install new membrane and secure at base flashings. Adhere to walls and substrates and reinstall metal copings, counterflashings, and termination bars to complete the repair. On ballasted systems redistribute ballast evenly.

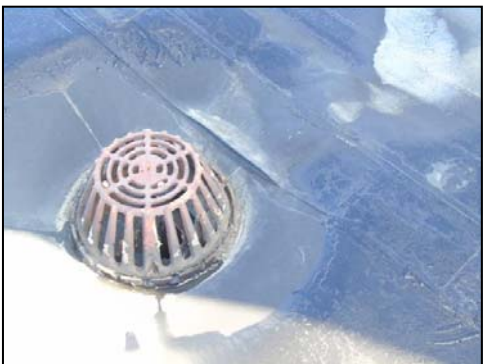
<b>Defect Code:</b>	<b>45</b>	<b>Quantity:</b>	<b>Widespread</b>	<b>Priority:</b>	<b>Monitor</b>
Description: Open flashing lap					
Repair: Open loose lap area and clean thoroughly. Prime and reseat or reweld lap per the manufacturer's requirements. Strip-in defective lap with minimum 6" wide membrane on single ply systems or 6" wide fabric and mastic three-course application on asphalt systems. Regranulate or coat flashing repairs.

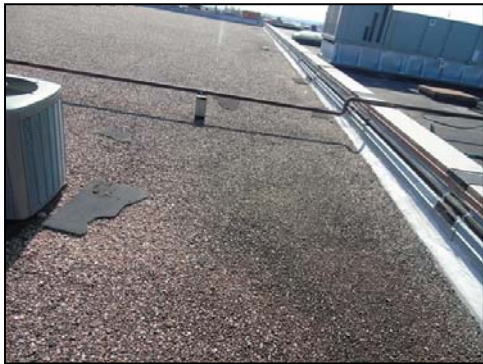
<b>Defect Code:</b>	<b>22</b>	<b>Quantity:</b>	<b>Random</b>	<b>Priority:</b>	<b>First Year</b>
Description: Debris, trash, construction materials, HVAC equipment, filters, motors, etc. on roof surface.					
Repair: Remove all trash and debris from roof. Clean and inspect surfaces and repair any damages to the membrane or flashings.

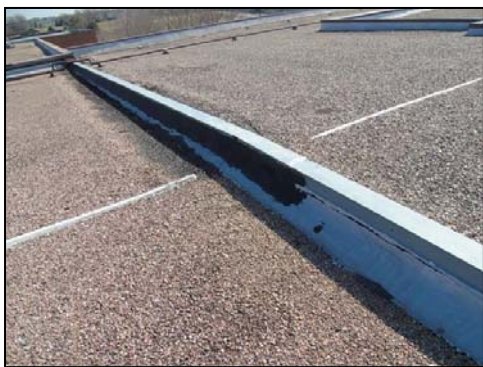
<b>Defect Code:</b>	<b>24</b>	<b>Quantity:</b>	<b>Random</b>	<b>Priority:</b>	<b>Monitor</b>
Description: Evidence of past problem and previous repair.					
Repair: Investigate for chronic leak problems and repair any areas that are suspect.

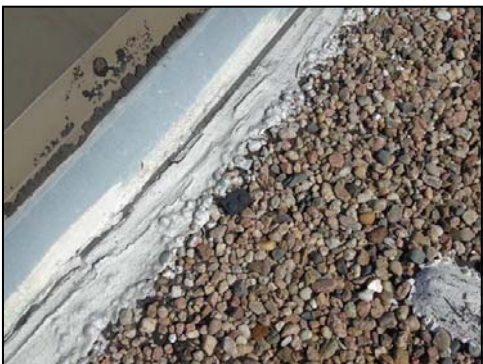
<b>Defect Code:</b>	<b>46</b>	<b>Quantity:</b>	<b>Random</b>	<b>Priority:</b>	<b>First Year</b>
Description: Split in flashing					
Repair: Cut away loose flashing and clean and prime repair area. Apply strip in of like material centered over split extending a minimum of 4" in all directions past prepared area.

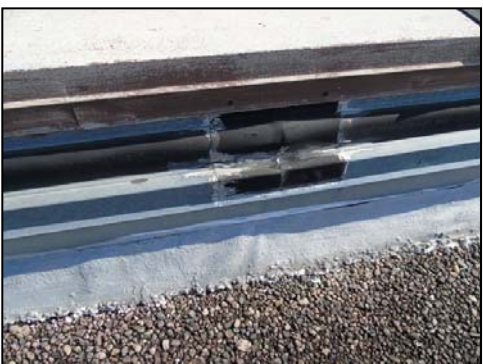
<b>Defect Code:</b>	<b>57</b>	<b>Quantity:</b>	<b>Widespread</b>	<b>Priority:</b>	<b>Monitor</b>
Description: Expansion joint deficiencies.					
Repair: Repair defects in rubber expansion joint or joint covers with two layers of flashing with the second layer being 3" larger in all directions than the first. Install flashing with manufacturer's recommended cleaners and primers.

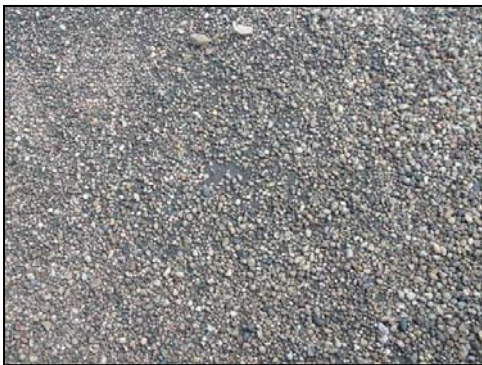
<b>Defect Code:</b>	<b>8</b>	<b>Quantity:</b>	<b>Random</b>	<b>Priority:</b>	<b>Monitor</b>
Description: Surface erosion.					
Repair: Prepare membrane surface by thoroughly cleaning and priming. Apply new surfacing of like materials to eroded areas. On gravel surfaced systems apply gravel in hot asphalt or recommended cold adhesive. Apply granulated fiberglass cap sheet or modified bitumen membrane on like systems. Apply coating system on smooth asphalt surfaces. Transition surfacing to provide for a smooth and neat finished appearance to match the existing surfacing.

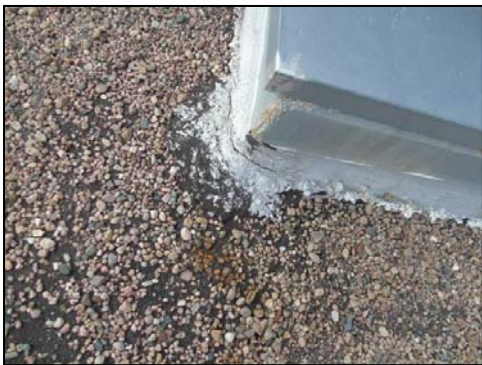
<b>Defect Code:</b>	<b>46</b>	<b>Quantity:</b>	<b>Random</b>	<b>Priority:</b>	<b>First Year</b>
Description: Split in flashing					
Repair: Cut away loose flashing and clean and prime repair area. Apply strip in of like material centered over split extending a minimum of 4" in all directions past prepared area.

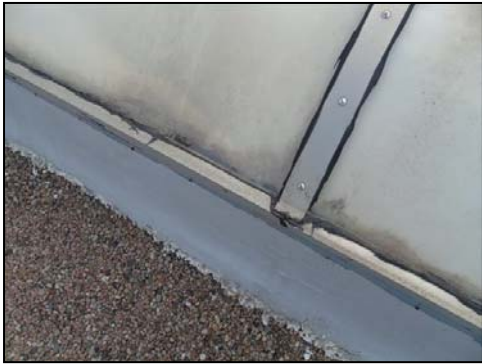
Defect Code:	88	Quantity:	Random	Priority:	Monitor
Description: Skylight defect/cracked/deteriorated					
Repair: Remove and replace affected components.
