# Roof Inspection Report

Bellevue Elementary  
12001 Timberridge Drive  
Papillion, NE 68133

Date	Inspection Type	Inspecting Company	Inspector
Mar 28, 2017	Phase 1 Roof Inspection	Roofing Solutions, Inc.	Garry Hendrickson

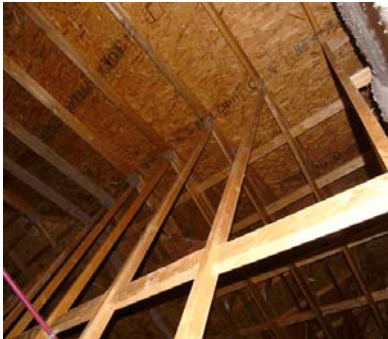
Mar 28, 2017	Deck Underside

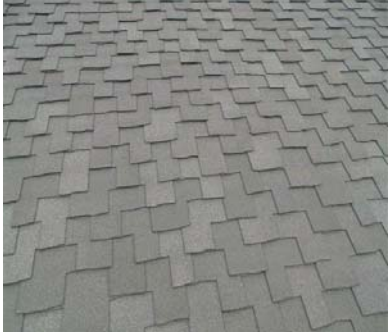
Mar 28, 2017	Membrane

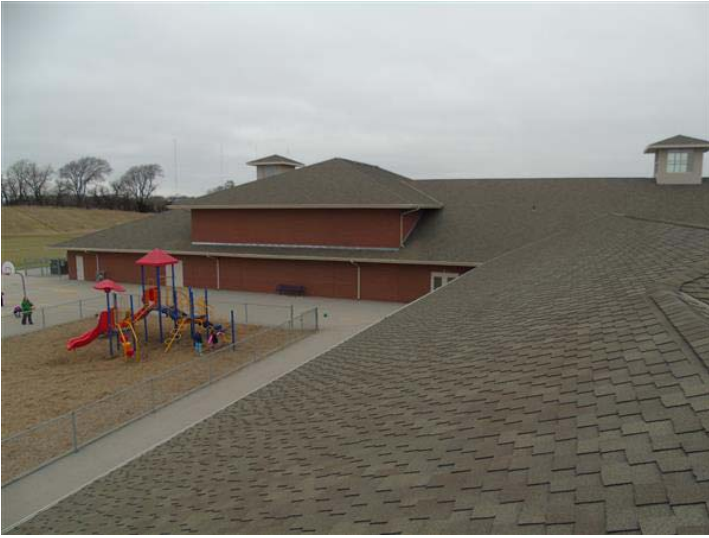
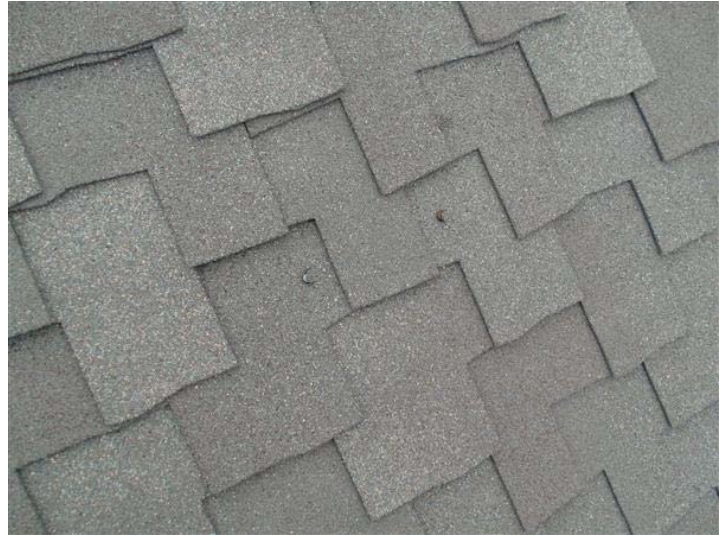
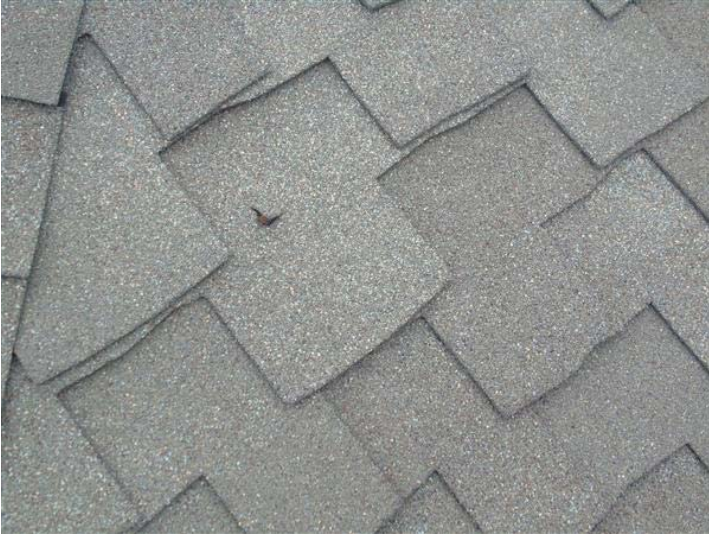
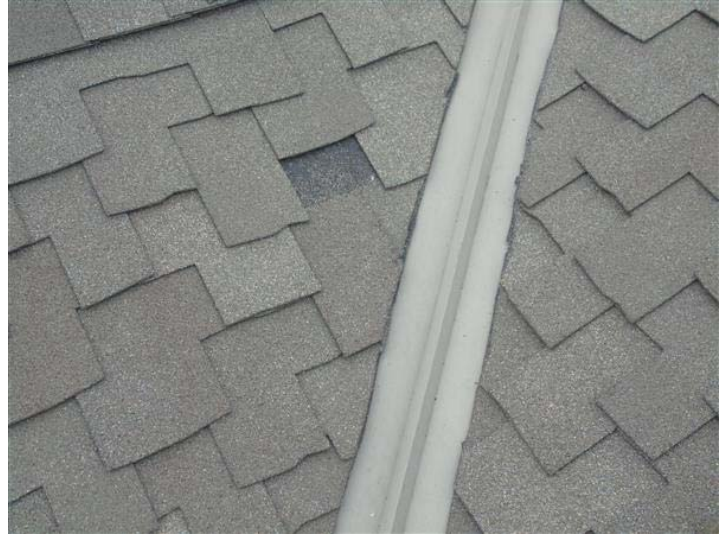
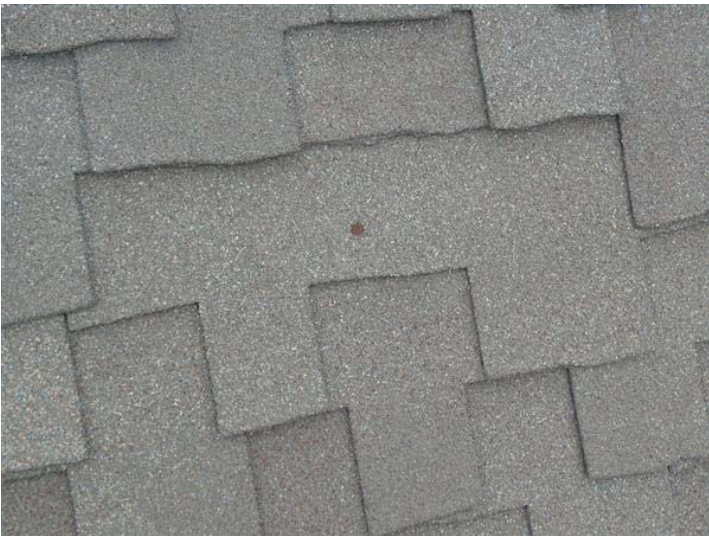
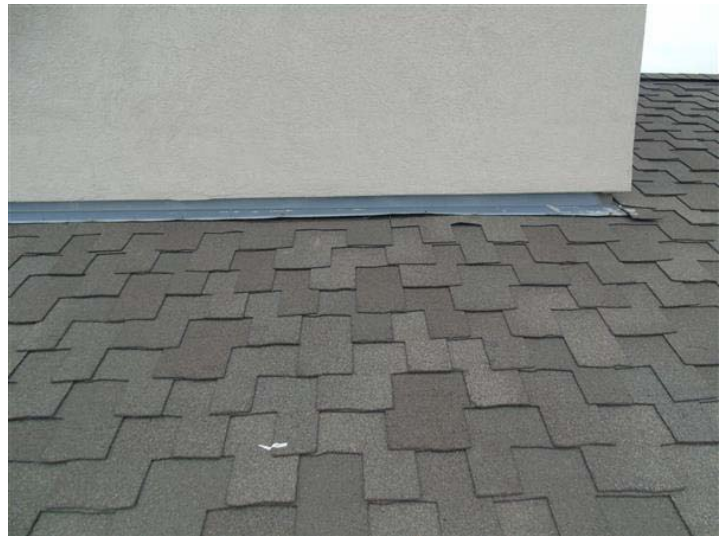
Bellevue Elementary\_Bellevue, NE  
Ph 1 Roof Inspection\_Roof A\_2017-03-28

Typical defects on the A roof area:  
 (6) Random areas with split or damage shingles.  
 (24) Random roof mastic repair attempts made to the shingles.  
 (24) Random repair attempts made to the valley and rake edge flashings.  
 (58) The roof curbs have a narrow metal flange with no additional metal flashing.  
 (59) There are missing starter rows of shingles on the dormer roofs.

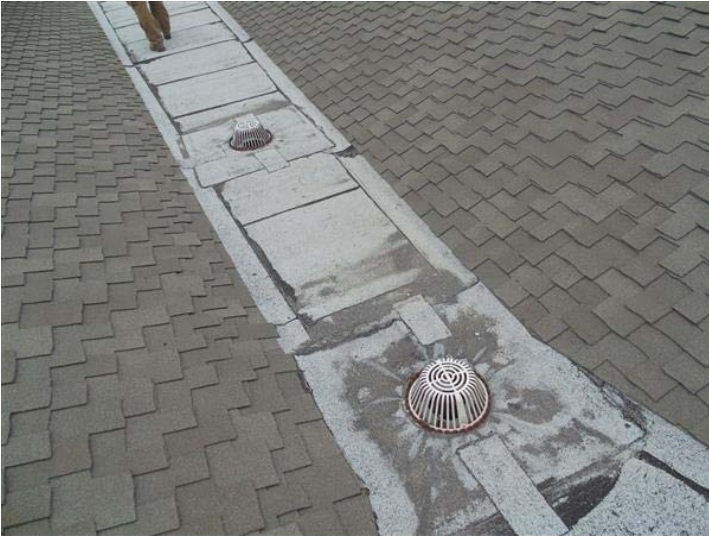
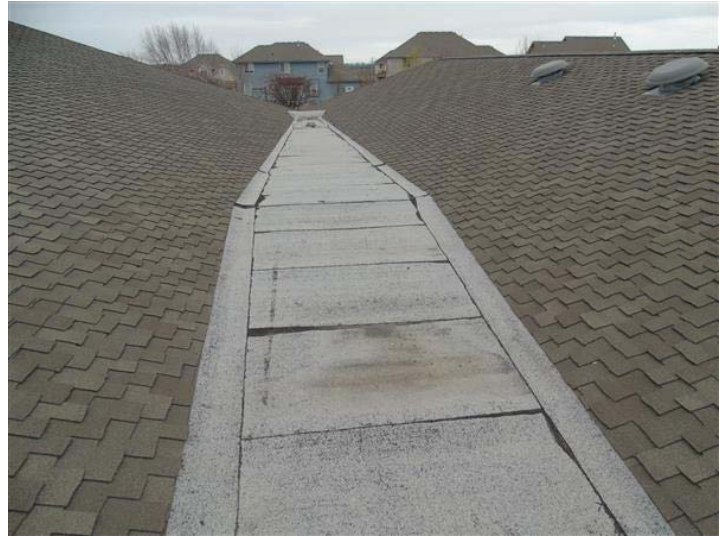
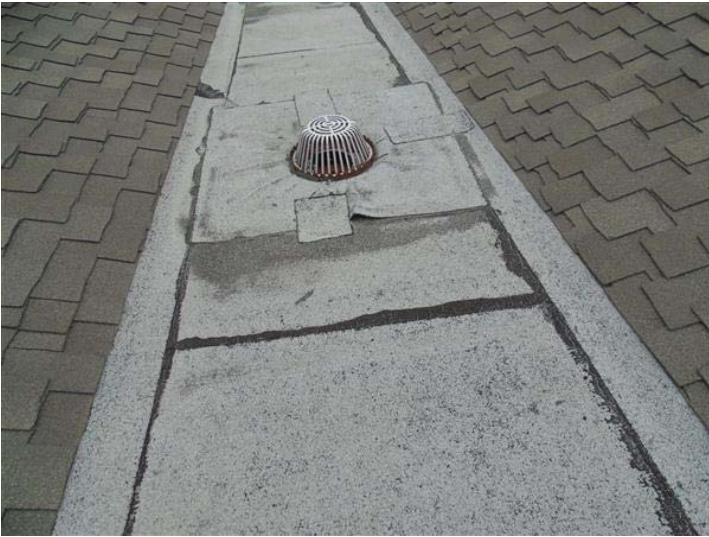
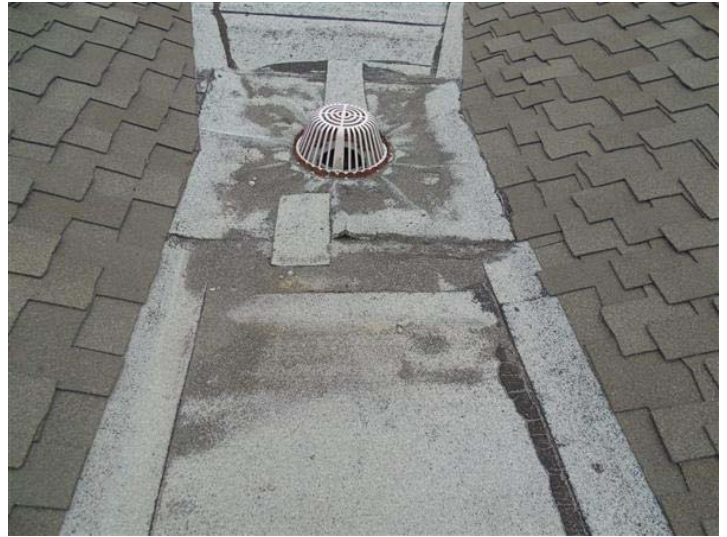
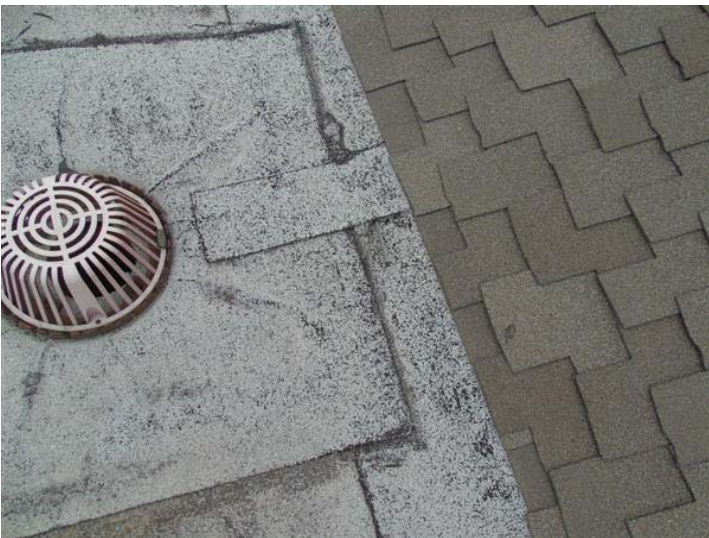
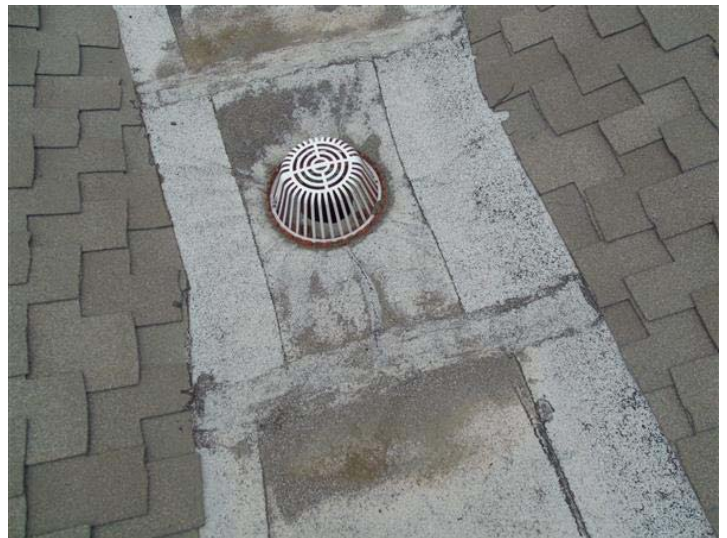
Bellevue Elementary\_Bellevue, NE  
Ph 1 Roof Inspection\_Roof B-1\_2017-03-28

Typical defects on the B roof areas:  
 (7) The drain flashings are wrinkled and buckled.  
 (49) Numerous open laps in the drain flashings.

<b>Defect Code:</b>	<b>7</b>	<b>Quantity:</b>	<b>Widespread</b>	<b>Priority:</b>	<b>First Year</b>
Description: Wrinkle in membrane.					
Repair: Cut out wrinkles and loose membrane. Apply new membrane of like material and plies to cover cuts and extend repairs a minimum of 6" in all directions past cut out areas.
