Roof Inspection Report

Bertha Barber Elementary
1402 S. Main Street
Bellevue, NE 68005

Date	Inspection Type	Inspecting Company	Inspector
Mar 07, 2017	Phase 1 Roof Inspection	Roofing Solutions, Inc.	Garry Hendrickson

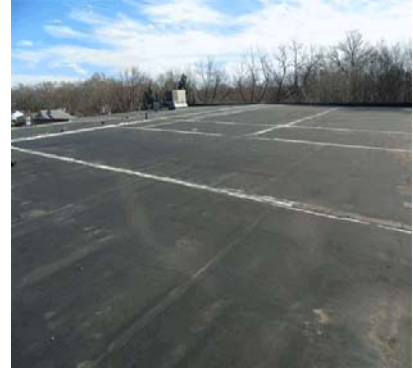
- Open EPDM laps observed along with numerous open coating repair laps
- High roof system attachment anchors observed
- Random areas with standing water observed along the gutter edge
- Numerous repair attempts to the roof system laps
- Rusted exposed duct work and rusted coping cap metal

Overall, the roof system is in poor condition due to its age and the deteriorated nature of the roof system. Given the observed conditions, it is our opinion comprehensive repairs in an effort to extend the life of the system would be neither feasible nor cost effective. We recommend the roof be replaced. There was no warranty information available for this roof section at the time of inspection.

RSI recommends a partial tear-off of the existing roof system, leaving the existing insulation in place, and installation of a new twenty (20) year design life roof system. We further recommend installation of new perimeter metal and projection details per SMACNA Architectural Sheet Metal Manual.

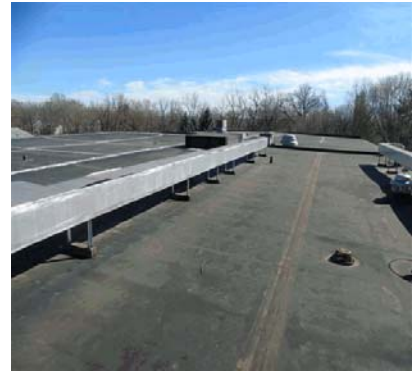
- Accumulation of debris observed around a drain strainer
- EPDM stripping repairs observed to the roof system laps
- EPDM membrane is bridging and loose along the common edges with the C & D roof areas

Overall, the roof system is in poor condition due to its age and deteriorated membrane. Given the observed conditions, it is our opinion comprehensive repairs in an effort to extend the life of the system would be neither feasible nor cost effective. We recommend the roof be replaced. There was no warranty information available for this roof section at the time of inspection.

RSI recommends a partial tear-off of the existing roof system, leaving the existing insulation in place, and installation of a new twenty (20) year design life roof system. We further recommend installation of new perimeter metal and projection details per SMACNA Architectural Sheet Metal Manual.

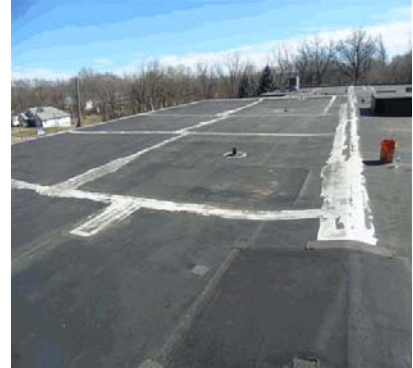
- Peeling coating lap edges and loose EPDM lap edges observed
- Loose EPDM membrane observed along the north and west sides of the roof area
- Coating repair attempts observed to the roof system laps
- The EPDM membrane is bridging and loose along the common edge with the D roof area

Overall, the roof system is in poor condition due to its age and the deteriorated nature of the roof system. Given the observed conditions, it is our opinion comprehensive repairs in an effort to extend the life of the system would be neither feasible nor cost effective. We recommend the roof be replaced. There was no warranty information available for this roof section at the time of inspection.

Budget Year	Activity Type	Action Item ?	Allocation	Urgency	Quotation \$
2017	Partial Tear-Off	Yes	Capital	High	\$30,549
RSI recommends a partial tear-off of the existing roof system, leaving the existing insulation in place, and installation of a new twenty (20) year design life roof system. We further recommend installation of new perimeter metal and projection details per SMACNA Architectural Sheet Metal Manual.					
					\$30,549

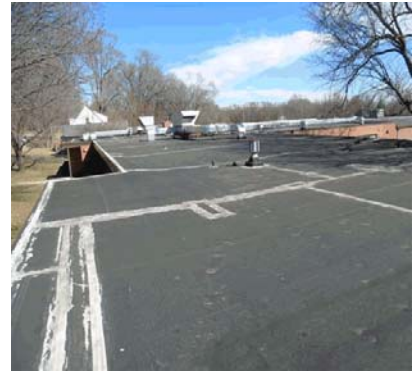
Facility personnel reported scattered leaks on this roof section at the time of inspection.

- Open coating laps and loose EPDM lap edges observed
- High roof system attachment anchors observed
- Loose EPDM membrane observed along the east side of the roof area
- Coating and EPDM patch repair attempts to the roof system laps
- EPDM membrane is bridging and loose along the common edge with the C and B roof areas
- Open EPDM flashing laps observed near the reported leak area

Overall, the roof system is in poor condition due to its age and the deteriorated nature of the roof system. Given the observed conditions, it is our opinion comprehensive repairs in an effort to extend the life of the system would be neither feasible nor cost effective. We recommend the roof be replaced. There was no warranty information available for this roof section at the time of inspection.

RSI recommends a partial tear-off of the existing roof system, leaving the existing insulation in place, and installation of a new twenty (20) year design life roof system. We further recommend installation of new perimeter metal and projection details per SMACNA Architectural Sheet Metal Manual.
