# Roof Inspection Report

LeMay Elementary  
2726 Kennedy Blvd.  
Bellevue, NE 68123

Date	Inspection Type	Inspecting Company	Inspector
Mar 20, 2017	Phase 1 Roof Inspection	Roofing Solutions, Inc.	Garry Hendrickson

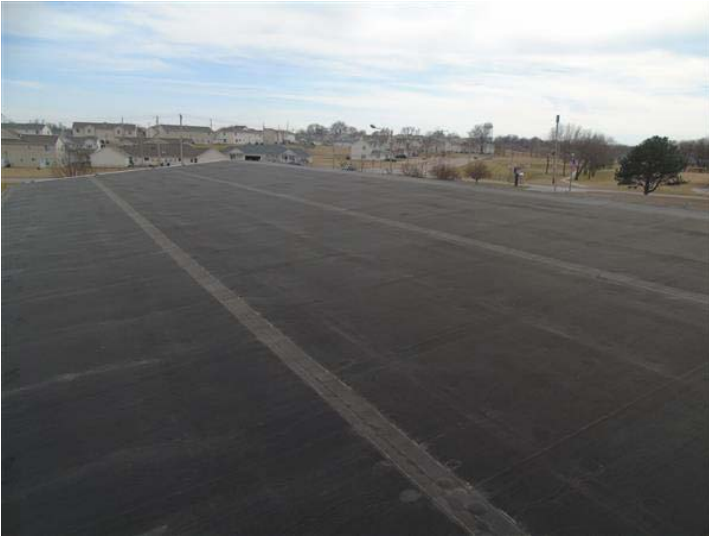
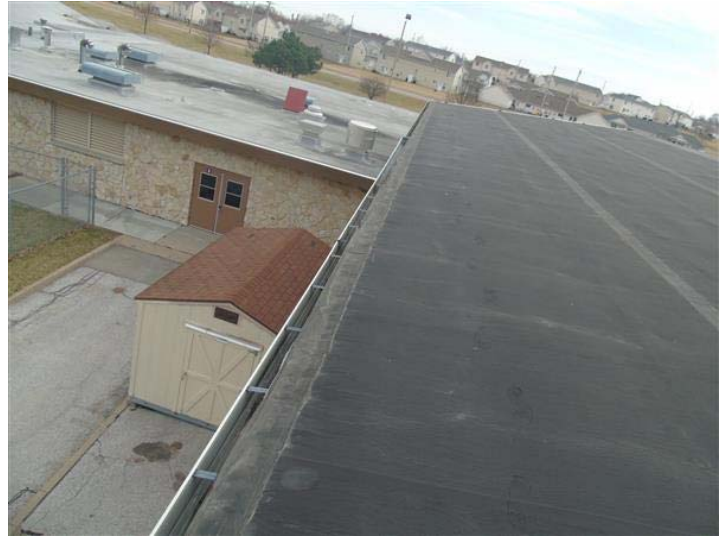
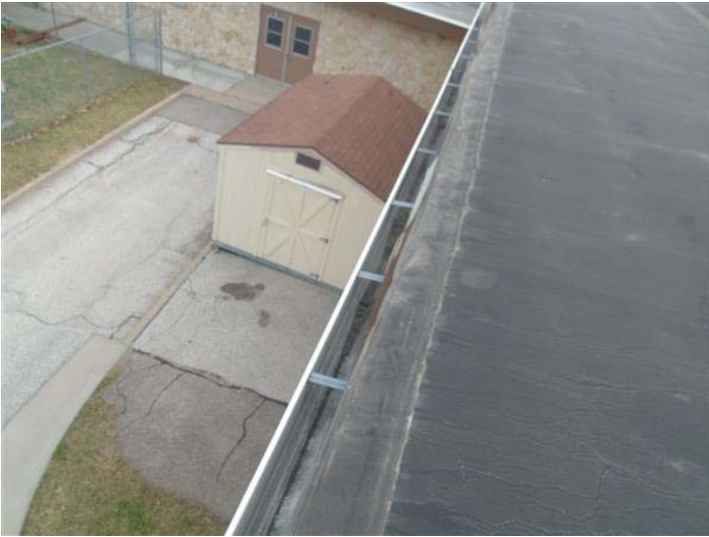
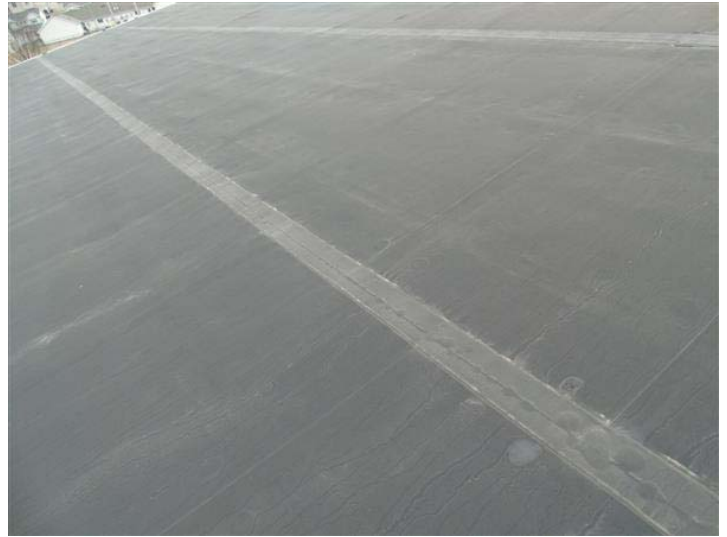
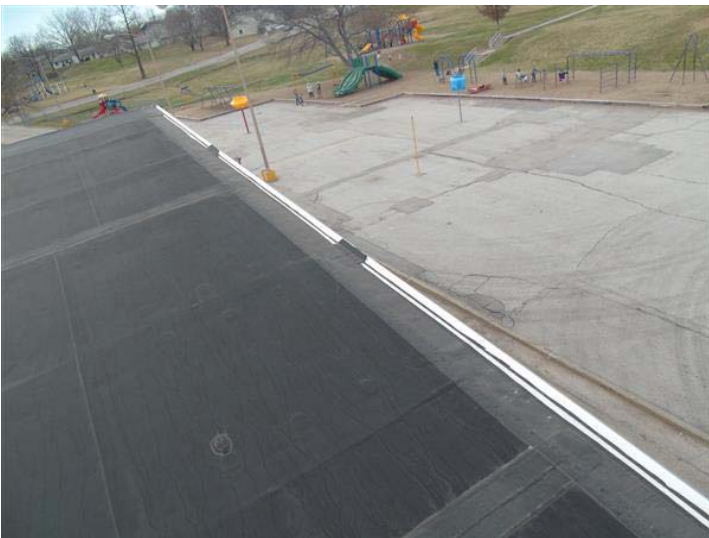
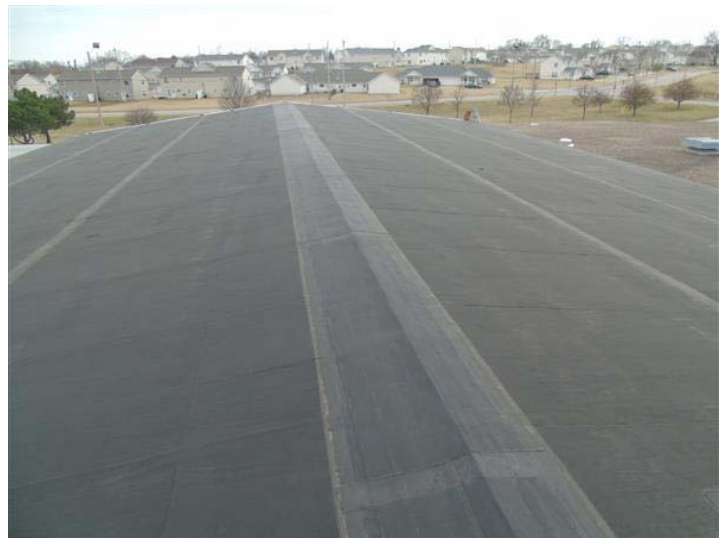
LeMay Elementary\_Bellevue, NE  
Ph 1 Roof Inspection\_Roof E\_2017-03-20

Typical defects for the E roof area:  
 24 EPDM stripping repairs to the membrane laps.  
 29 Random areas with rusted metal roofing.
