Roof Inspection Report

Mr. Greg Boettger
Bellevue Schools
&
Mr. Ralph Gladbach
GP Architecture, LLC.

Roofing Solutions, Inc.
6728 W. 153rd Street
Overland Park, KS 66223

Mission Middle School
2202 S. Washington Street
Bellevue, NE 68005

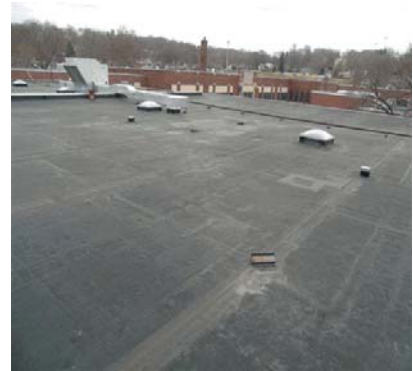
No recent leaks were reported on this roof section at the time of inspection.

- Loose EPDM lap edges observed
- Random areas with unadhered and loose EPDM membrane observed
- EPDM stripping repair attempts to the roof system laps
- Evidence of roof membrane shrinkage with pulled corner flashings observed
- The EPDM flashings are bridged
- Loose lap edges or open EPDM flashing laps observed

Overall, the roof system is in poor condition due to its age and the deteriorated nature of the roof system. Given the observed conditions, it is our opinion comprehensive repairs in an effort to extend the life of the system would be neither feasible nor cost effective. We recommend the roof be replaced. There was no warranty information available for this roof section at the time of inspection.

RSI recommends a complete tear-off of existing roof system and the installation of a new twenty (20) year design life roof system. We further recommend the replacement of all perimeter coping cap and projection details per SMACNA Architectural Sheet Metal Manual.

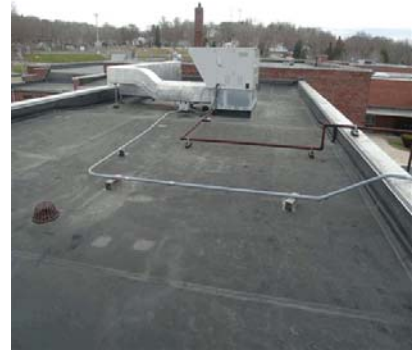
Facility personnel reported one (1) recent leak near the NE corner of the roof area.

- Loose EPDM lap edges observed
- Unadhered and loose EPDM membrane observed along the north end of the roof area
- EPDM patch repair attempts to the roof system
- Evidence of roof membrane shrinkage with pulled corner flashings
- The EPDM wall flashings are bridged
- Loose lap edges or open EPDM flashing laps observed
- One (1) split EPDM flashing corner

Overall, the roof system is in poor condition due to its age and the deteriorated nature of the roof system. Given the observed conditions, it is our opinion comprehensive repairs in an effort to extend the life of the system would be neither feasible nor cost effective. We recommend the roof be replaced. There was no warranty information available for this roof section at the time of inspection.

RSI recommends a complete tear-off of existing roof system and the installation of a new twenty (20) year design life roof system. We further recommend the replacement of all perimeter coping cap and projection details per SMACNA Architectural Sheet Metal Manual.

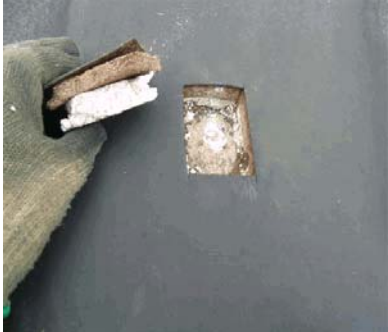
The deck is poured in place gypsum. There is one (1) layer of air-expanded polystyrene, which appears to be a tapered insulation system, and a .5" layer of wood fiber cover board with a fully-adhered, .060 mil EPDM. The wood fiber cover board was deteriorated at the core cut location.

Mar 23, 2017	Roof System Core

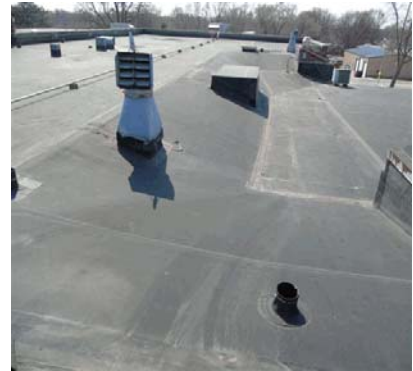
Drainage and Leak Details: The C roof areas slope to the eave edges and drain to an external guttering. No recent leaks were reported on this roof section at the time of inspection.

- Loose or open EPDM laps and loose EPDM stripping repair material observed
- Evidence of standing water on the upper portion of the C-1 roof area
- Random areas with unadhered and loose EPDM membrane observed on the C-1 area
- EPDM stripping repair attempts to the roof system laps on the C-1 roof area
- The EPDM flashings are bridged on the C-1 roof area
- Loose lap edges or open EPDM flashing laps observed
- Abandoned vent and duct units observed
- The metal flashings around the skylight are rusted
- One (1) detached wall mounted light fixture observed

Overall, the roof system is in poor condition due to its age and the deteriorated nature of the roof system. Given the observed conditions, it is our opinion comprehensive repairs in an effort to extend the life of the system would be neither feasible nor cost effective. We recommend the roof be replaced. There was no warranty information available for this roof section at the time of inspection.

RSI recommends a partial tear-off of the existing roof system, leaving the existing insulation in place, and installation of a new twenty (20) year design life roof system. We further recommend installation of new perimeter metal and projection details per SMACNA Architectural Sheet Metal Manual.

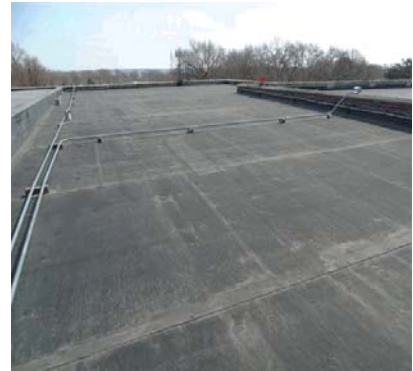
No recent leaks were reported on this roof section at the time of inspection.

- Loose EPDM lap edges observed
- Loose EPDM flashing lap edges observed

Overall, the roof system is in poor condition due to its age. With leak repairs performed only as needed, the roof system should remain effective for the duration of its assessed service life, approximately one (1) year. There was no warranty information available for this roof section at the time of inspection.

Budget Year	Activity Type	Action Item ?	Allocation	Urgency	Quotation \$
2017	Repair	Yes	Expense	High	\$1,000
RSI recommends leak repairs be performed only as needed until the roofs recommended replacement in 2018.					
2018	Replacement	Yes	Capital	Moderate	\$45,543
RSI recommends a complete tear-off of existing roof system and the installation of a new twenty (20) year design life roof system. We further recommend the replacement of all perimeter coping cap and projection details per SMACNA Architectural Sheet Metal Manual.					
					\$46,543

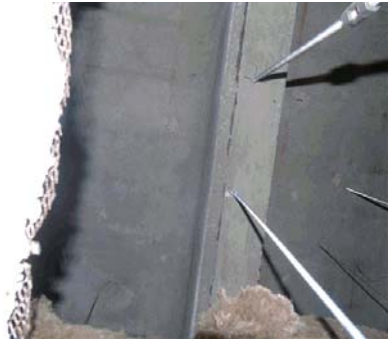
Mar 23, 2017	Deck Underside

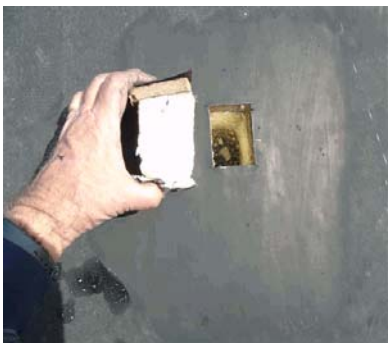
Mar 23, 2017	Roof System Core

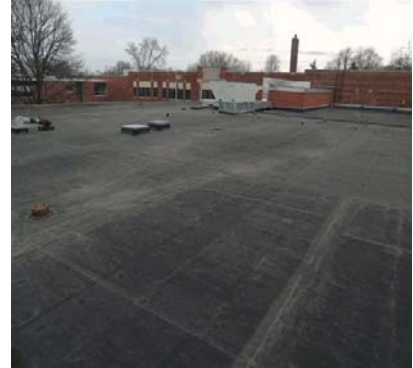
No recent leaks were reported on this roof section at the time of inspection.

- Accumulation of debris observed around a drain strainer
- EPDM stripping repair attempts observed to the roof system field laps
- Loose or open EPDM flashing laps observed
- Abandoned roof curbs have metal covers
- Deteriorated mortar observed in the brick walls located above the roof system
- Numerous cracks observed in a skylight lens

Overall, the roof system is in poor condition due to its age. With leak repairs performed only as needed, the roof system should remain effective for the duration of its assessed service life, approximately one (1) year. There was no warranty information available for this roof section at the time of inspection.

Budget Year	Activity Type	Action Item ?	Allocation	Urgency	Quotation \$
2017	Repair	Yes	Expense	High	\$1,000
RSI recommends leak repairs be performed only as needed until the roofs recommended replacement in 2018.					
2018	Replacement	Yes	Capital	Moderate	\$124,770
RSI recommends a complete tear-off of existing roof system and the installation of a new twenty (20) year design life roof system. We further recommend the replacement of all perimeter coping cap and projection details per SMACNA Architectural Sheet Metal Manual.					
					\$125,770

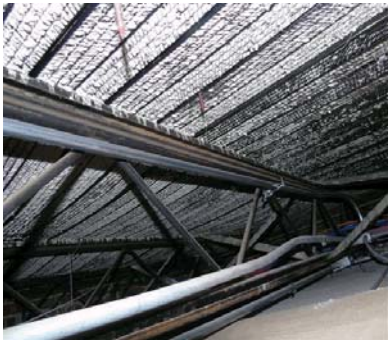
Mar 23, 2017	Deck Underside

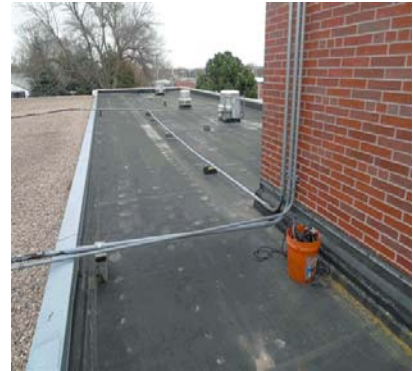
No recent leaks were reported on this roof section at the time of inspection.

- Loose EPDM lap edges observed
- One (1) drain and all scuppers are blocked with debris
- Accumulation of debris observed along the perimeter sides of the roof area
- Random areas with EPDM stripping repair attempts
- The EPDM wall flashings are bridged
- Loose lap edges or open EPDM flashing laps observed

Overall, the roof system is in poor condition due to its age and the deteriorated nature of the roof system. Given the observed conditions, it is our opinion comprehensive repairs in an effort to extend the life of the system would be neither feasible nor cost effective. We recommend the roof be replaced. There was no warranty information available for this roof section at the time of inspection.

RSI recommends a partial tear-off of the existing roof system, leaving the existing insulation in place, and installation of a new twenty (20) year design life roof system. We further recommend installation of new perimeter metal and projection details per SMACNA Architectural Sheet Metal Manual.

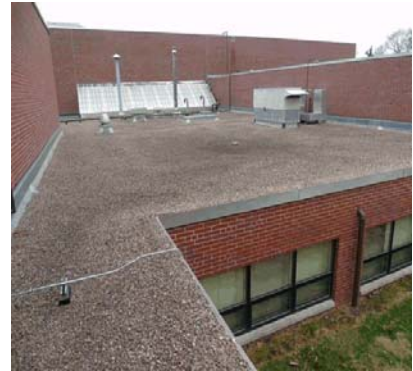
Facility personnel reported one (1) past leak issue near the SW corner of area and was not sure if the leak had been resolved.

- Deteriorated caulking observed on the top of the perimeter wall counter flashing
- Random areas with surface loss of the gravel roof surfacing
- Accumulation of debris observed around the drain strainers
- Roof mastic repair attempts observed near the past leak area
- Sunken or split pitch pocket filler observed
- There are abandoned roof curbs

Overall, the roof system is in fair working condition. With the aforementioned defects addressed, in addition to routine maintenance and regular inspection, the roof system should remain effective for the duration of its assessed service life, approximately three (3) years. There was no warranty information available for this roof section at the time of inspection.

Budget Year	Activity Type	Action Item ?	Allocation	Urgency	Quotation \$
2017	Repair	Yes	Expense	High	\$300
RSI recommends repairs be completed in accordance with the attached deficiency list.					
2020	Replacement	Yes	Capital	Moderate	\$94,875
RSI recommends a complete tear-off of existing roof system and the installation of a new twenty (20) year design life roof system. We further recommend the replacement of all perimeter coping cap and projection details per SMACNA Architectural Sheet Metal Manual.					
					\$95,175

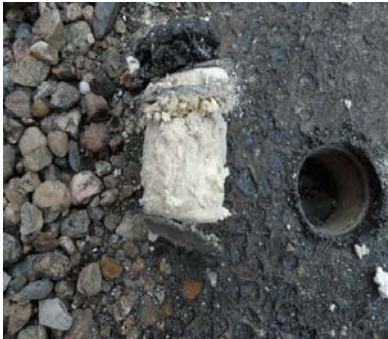
Mar 23, 2017	Roof System Core

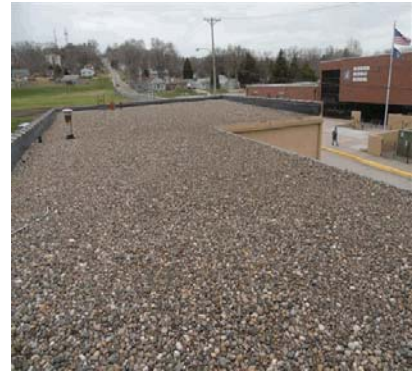
The poor condition of the roof system indicates that roof leaks are probable.

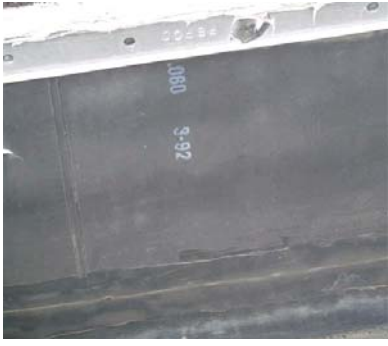
Mar 23, 2017	Membrane stamp

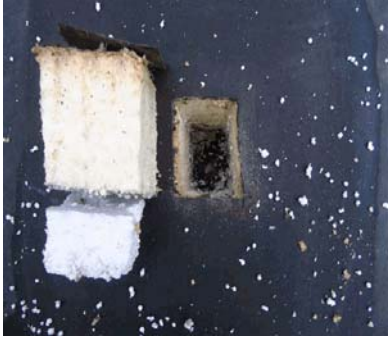
Mar 23, 2017	Roof System Core

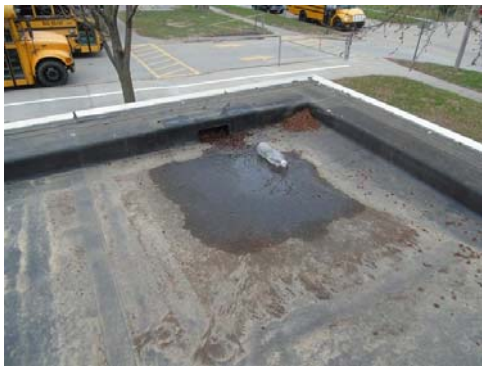
Defect Code:	22	Quantity:	Random	Priority:	First Year
Description: Debris, trash, construction materials, HVAC equipment, filters, motors, etc. on roof surface.					
Repair: Remove all trash and debris from roof. Clean and inspect surfaces and repair any damages to the membrane or flashings.

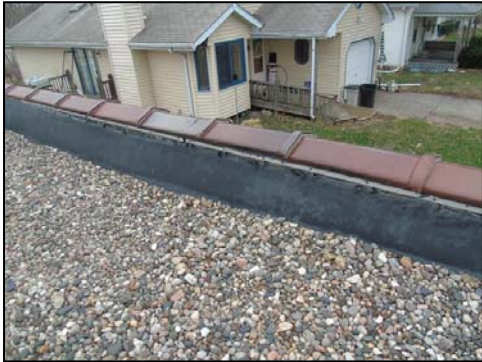
Defect Code:	26	Quantity:	Widespread	Priority:	Monitor
Description: Membrane shrinkage					
Repair: Investigate and repair cause of shrinkage. Cut away affected areas and prepare to receive new membrane. Install new membrane and secure at base flashings. Adhere to walls and substrates and reinstall metal copings, counterflashings, and termination bars to complete the repair. On ballasted systems redistribute ballast evenly.

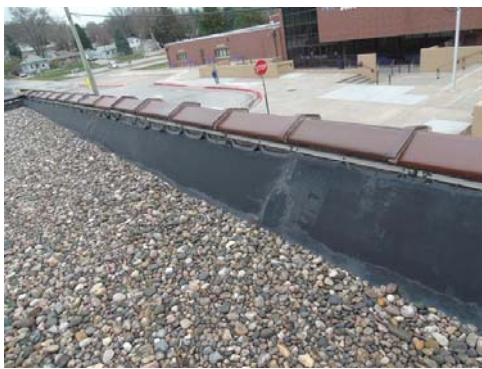
Defect Code:	41	Quantity:	Widespread	Priority:	Monitor
Description: Missing or inadequate flashing attachment.					
Repair: Mechanically attach flashings a maximum of 6" O.C using screws and plates or 1" cap nails. Terminate with metal flashings or compression bar.

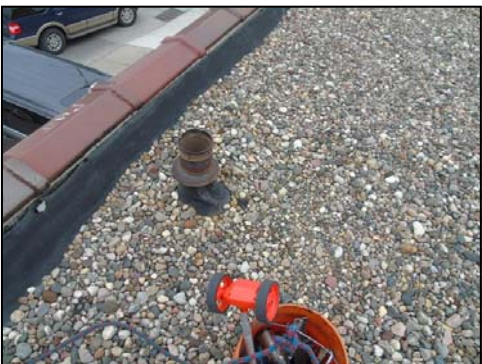
Defect Code:	52	Quantity:	1	Priority:	First Year
Description: Missing rain cap, rain collar, or hood.					
Repair: Install rain cap, hood, or collar and secure and seal to pipe.

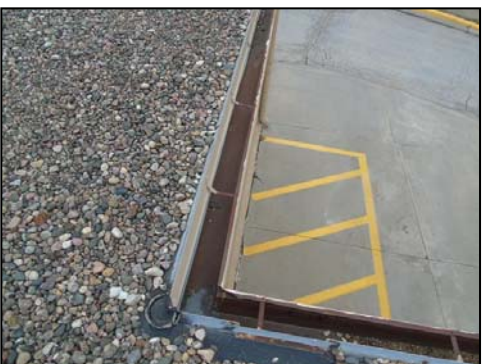
Defect Code:	86	Quantity:	Widespread	Priority:	Monitor
Description: Corrosion or rust					
Repair: Remove rusted components and replace with similar metal fabricated and installed per SMACNA requirements.

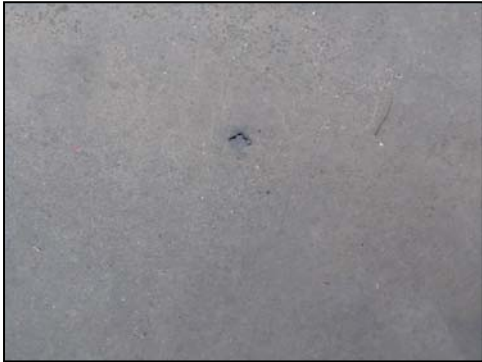
Defect Code:	23	Quantity:	Under 10 LF	Priority:	First Year
Description: Physical damage to membrane including cuts, holes, tears, scrapes, scuffs, or abrasions.					
Repair: Apply repair membrane over damaged area, extending repair material a minimum 6" past damage.

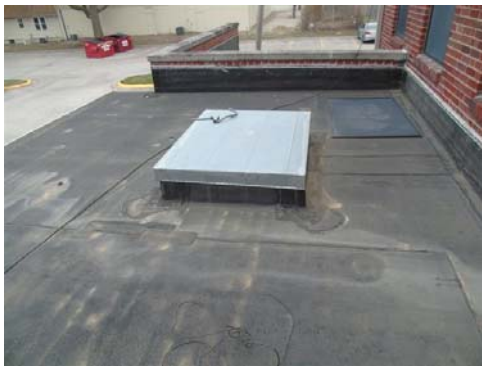
Defect Code:	56	Quantity:	1	Priority:	Monitor
Description: Abandoned and obsolete equipment.					
Repair: Monitor for leaks. Check systems are abandoned and disconnected and will not be used in the future. Remove abandoned equipment and repair deck at scheduled roof replacement.

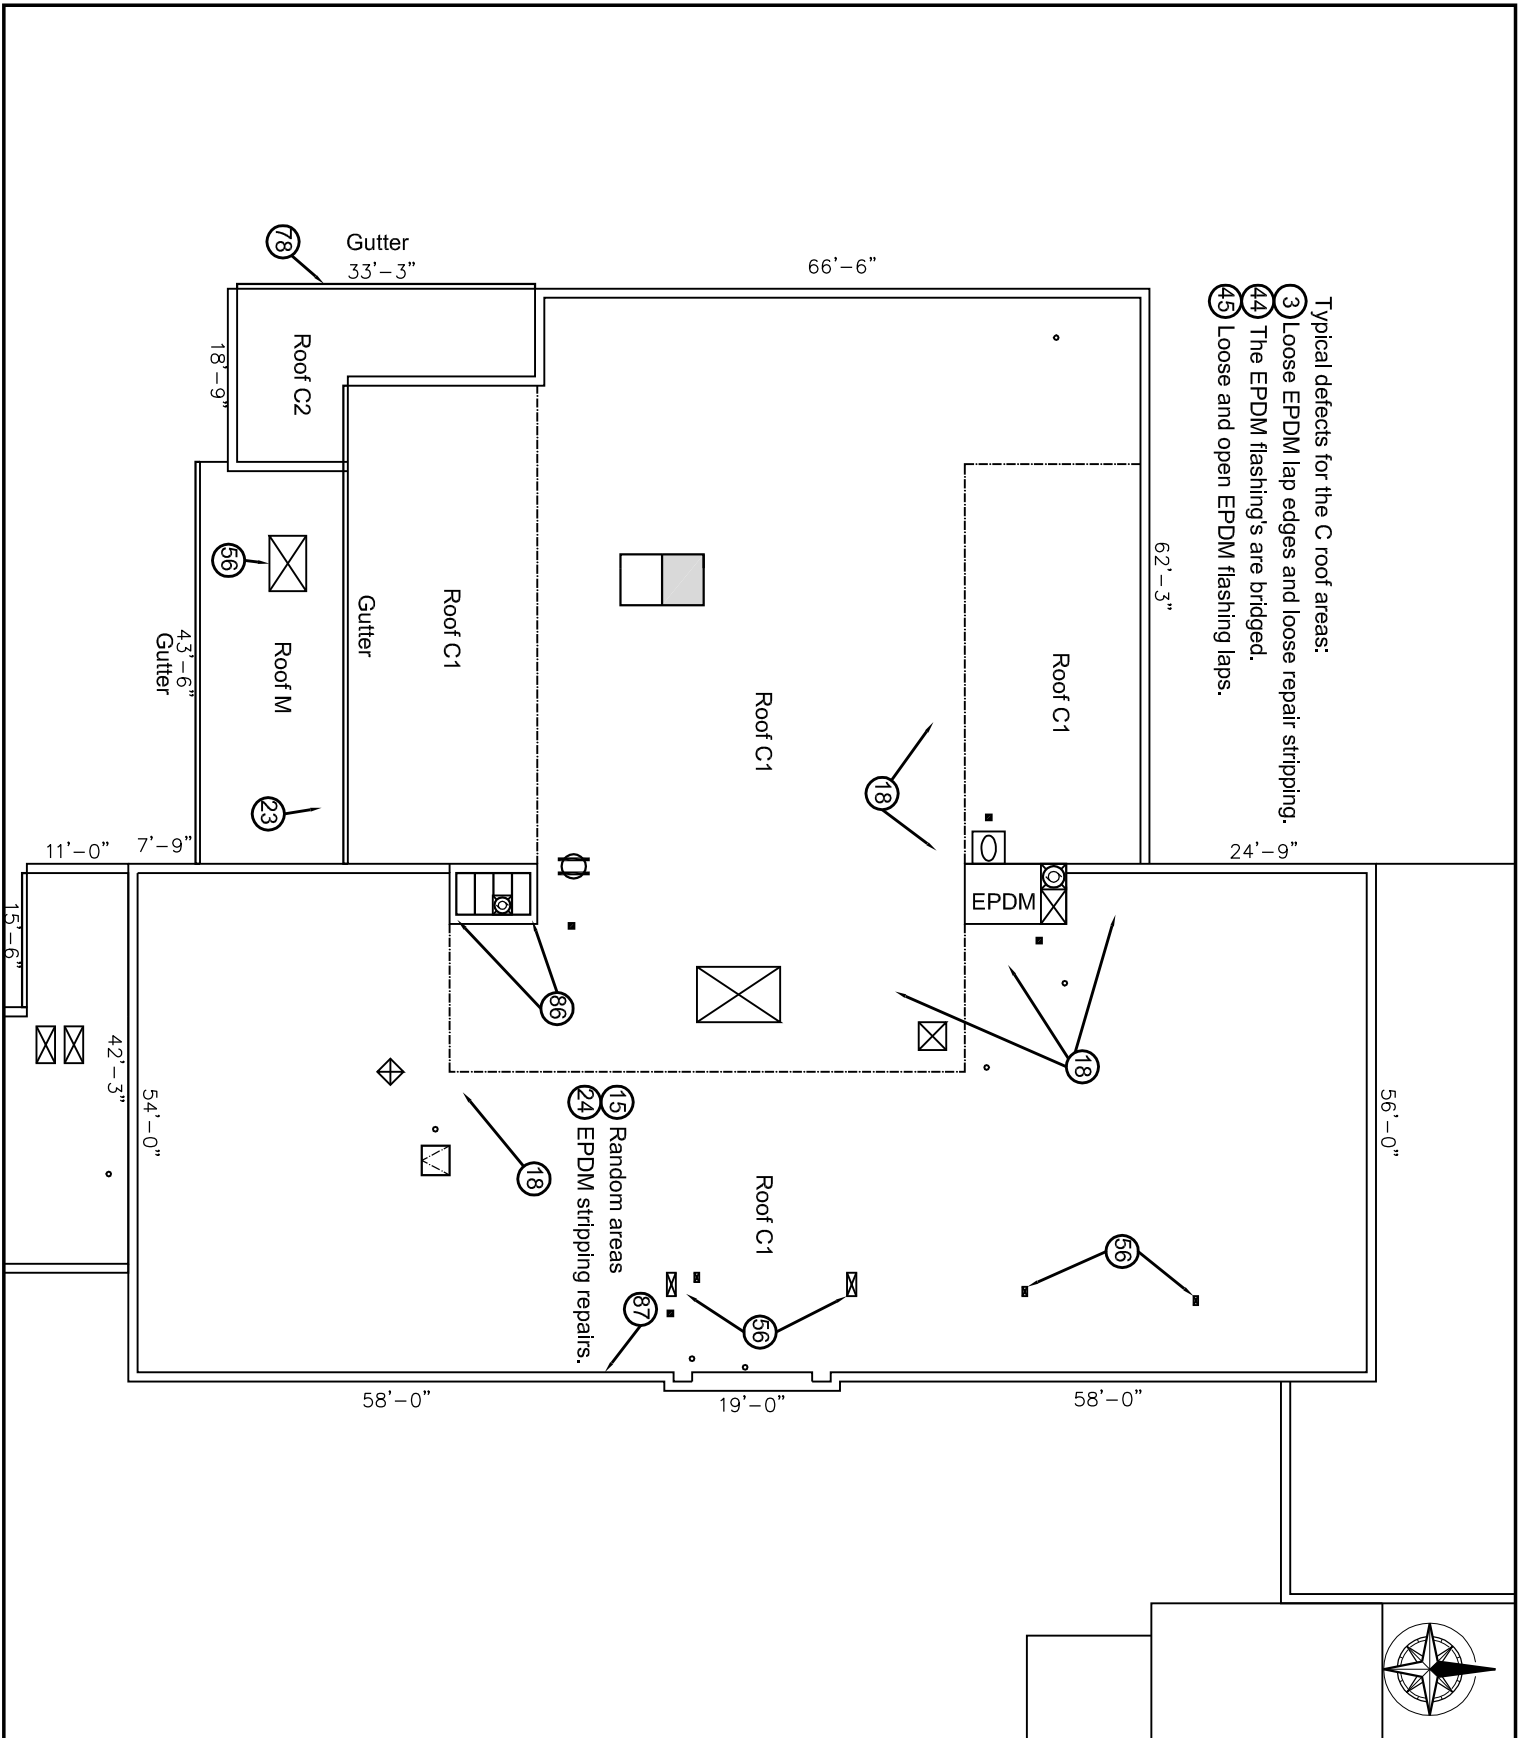
Sheet Title:
C&M-Roof Plan

Typical defects for the C roof areas:
 (3) Loose EPDM lap edges and loose repair stripping.
 (44) The EPDM flashings are bridged.
 (45) Loose and open EPDM flashing laps.

(15) Random areas
 (24) EPDM stripping repairs.

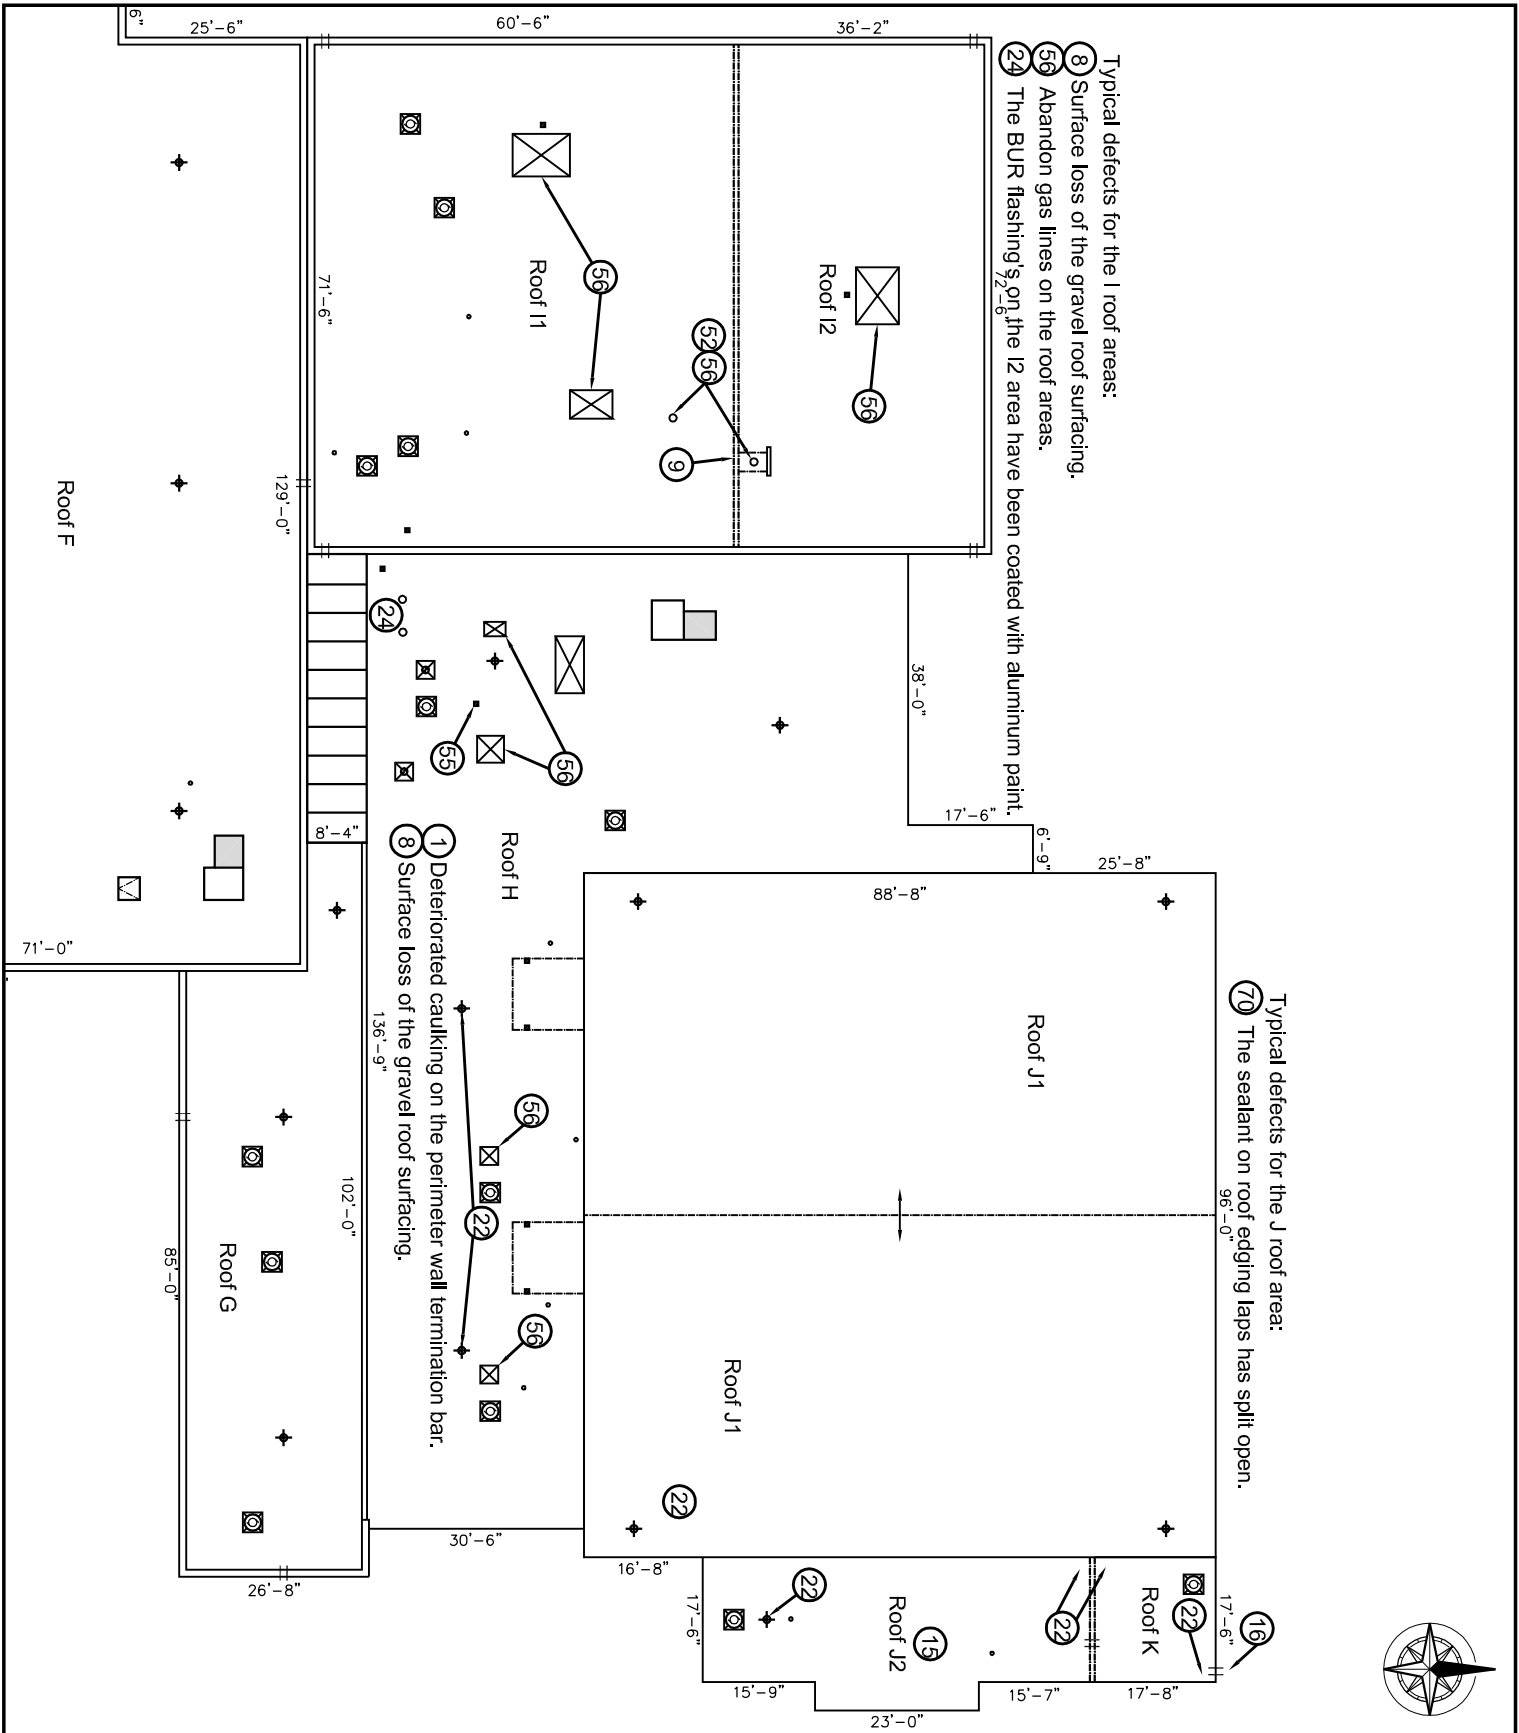
Sheet Title:
H,I,J&K-Roof Plan

Typical defects for the I roof areas:
 8 Surface loss of the gravel roof surfacing.
 59 Abandon gas lines on the roof areas.
 24 The BUR flashing's on the 12 area have been coated with aluminum paint.

Typical defects for the J roof area:
 70 The sealant on roof edging laps has split open.

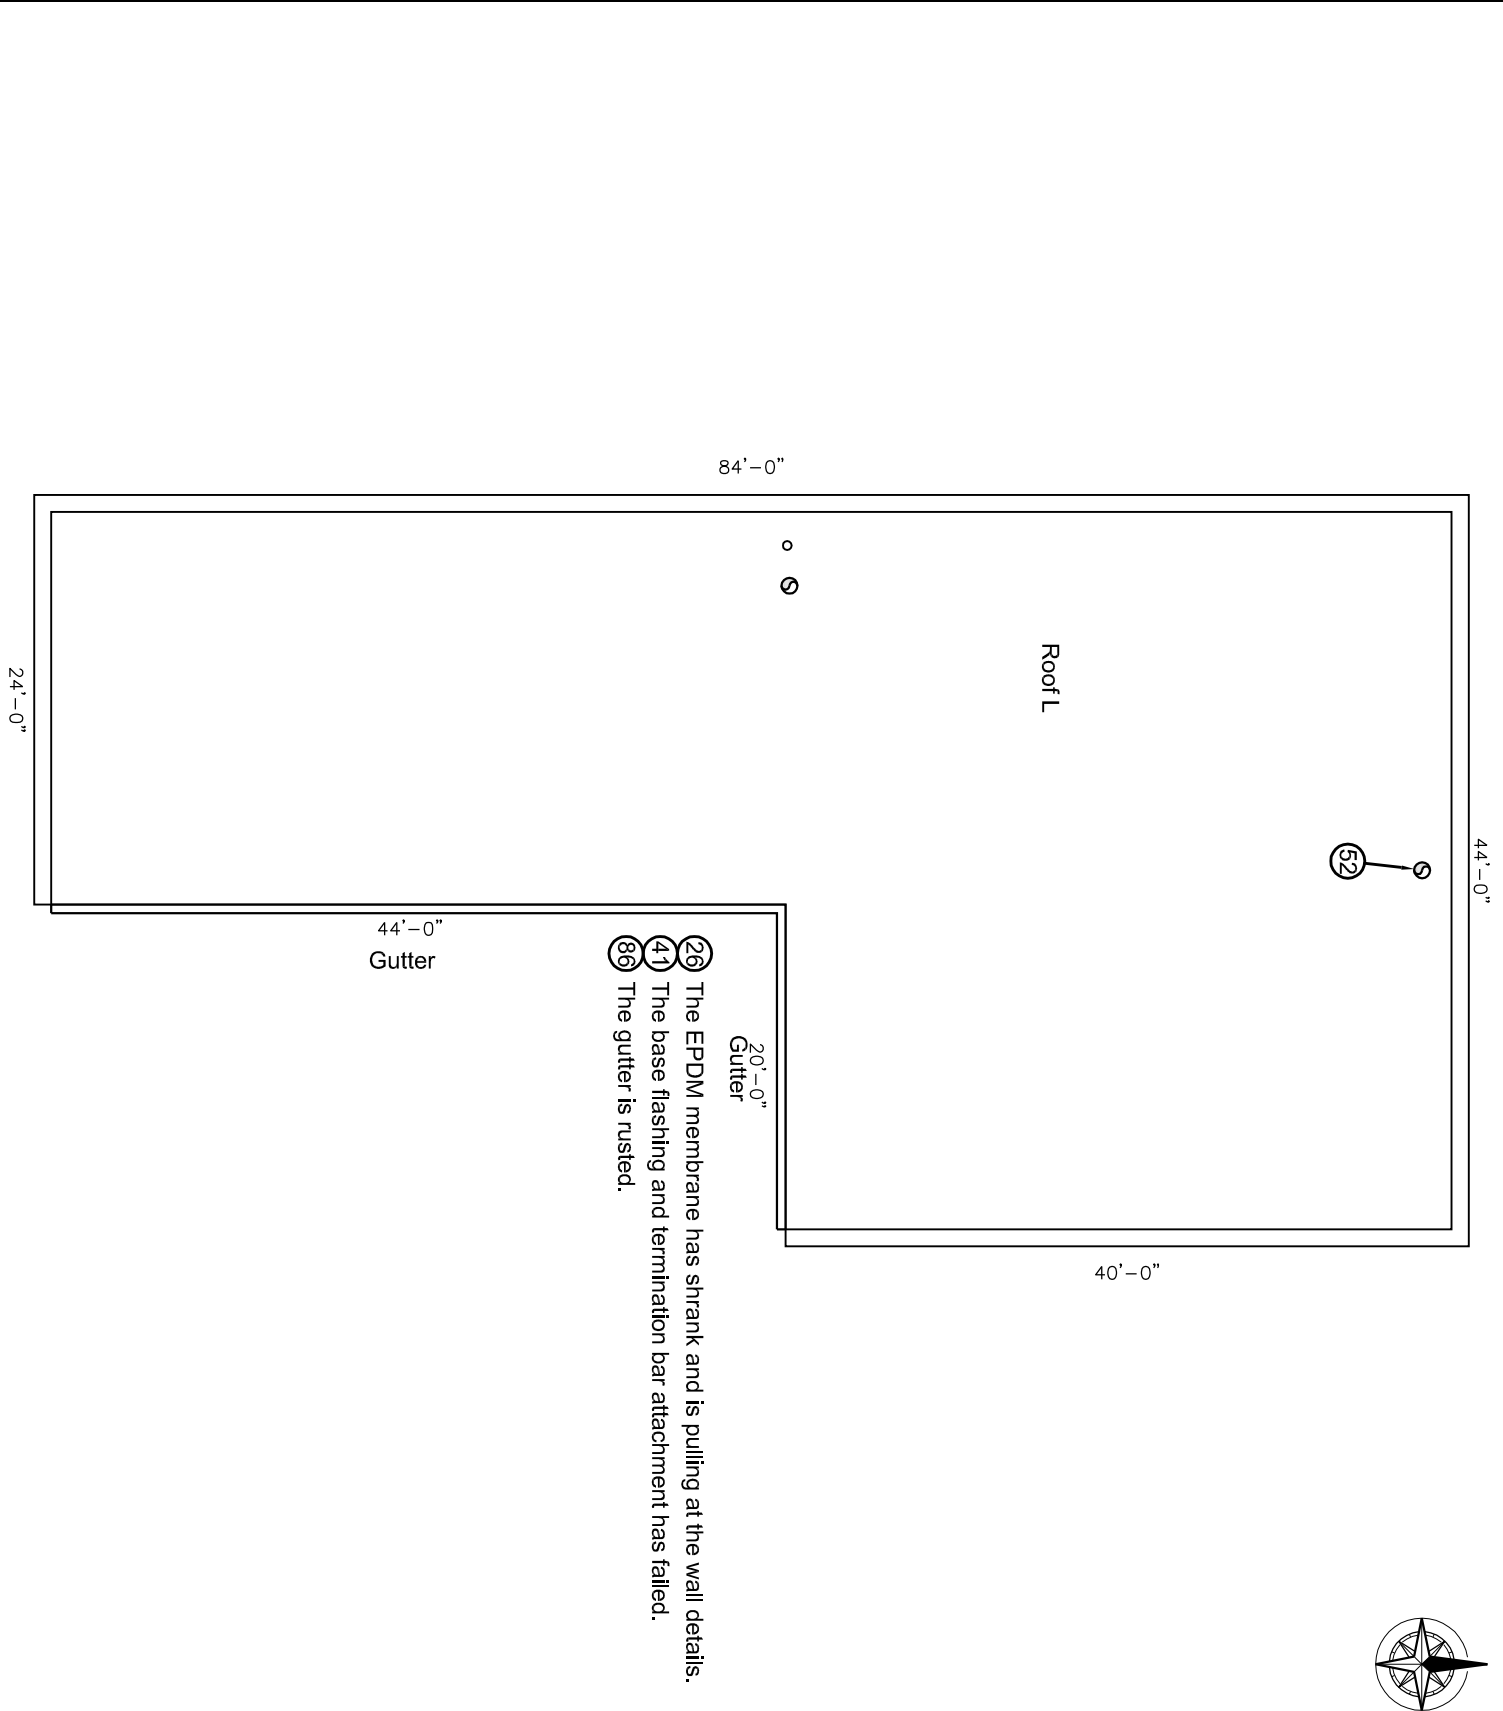
- 26 The EPDM membrane has shrank and is pulling at the wall details.
- 41 The base flashing and termination bar attachment has failed.
- 86 The gutter is rusted.
