## Roof Inspection Report

Peter Sarpy Elementary  
2908 Vandenberg Avenue  
Bellevue, NE 68123

Date	Inspection Type	Inspecting Company	Inspector
Mar 16, 2017	Phase 1 Roof Inspection	Roofing Solutions, Inc.	Garry Hendrickson

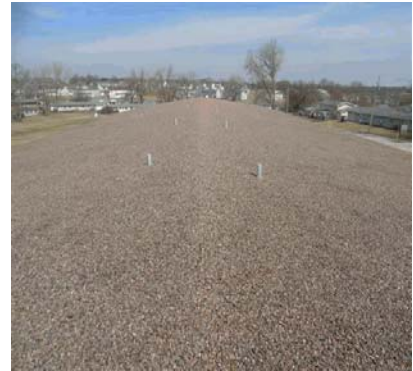
**Drainage and Leak Details:** The A roof areas slope from a central ridge line towards the north and south and drain to an external guttering.

Facility personnel reported one (1) recent leak on the A-1 roof area.

- Surface loss of the gravel roof surfacing observed
- Random areas with roof mastic repair attempts to the BUR system
- Random areas with split BUR flashing corners and pipe/curb penetration seals
- One (1) open lap on the end of the control joint curb observed
- One (1) pipe penetration with inadequate BUR flashing
- Loose or missing anchors in the control joint metal cap
- Cracks in the brick chimney observed
- Deteriorated mortar joints and spalled brick in the chimney

Overall, the roof system is in fair condition due to its age and the above referenced defects. With the aforementioned defects addressed, in addition to routine maintenance and regular inspection, the roof system should remain effective for the duration of its assessed service life, approximately three (3) years. There was no warranty information available for this roof section at the time of inspection.

Budget Year	Activity Type	Action Item ?	Allocation	Urgency	Quotation \$
2017	Repair	Yes	Expense	High	\$2,500
<p>RSI recommends repairs be completed in accordance with the attached deficiency list.</p> <p><i>*Please Note: Costs associated with repairs and/or replacement of the brick chimney and/or associated details are not included in this budget estimate.</i></p>					
2020	Infrared Scan	Yes	Expense	High	\$2,500
<p>RSI recommends an infrared scan be performed to locate any wet insulation present in the current roof system.</p>					
2020	Retrofit	Yes	Capital	High	\$315,704
<p>RSI recommends the installation of a new twenty (20) year design life roof system. We further recommend installation of new perimeter metal and projection details per the SMACNA Architectural Sheet Metal Manual.</p>					
					<b>\$320,704</b>

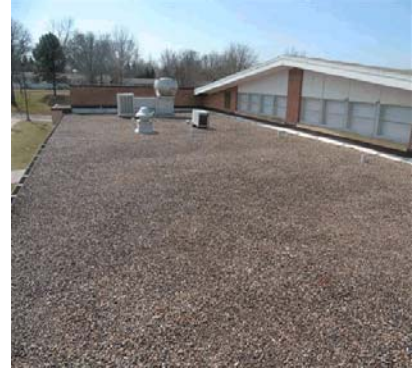
**Roof Name:** B**Roof Size:** 2,457 sq. ft.**Est. replacement Cost:** \$ 24,570.00**Existing System Type:** Built-Up Asphalt Roofing**Year Installed:** 2000**Assessed Service Life Remaining (Years) :** 3**Height:** 12 Ft.**Slope:** 1/8" per ft.**Interior Sensitivity:** Normal**Drainage:** Adequate**Currently Leaking?** No**History of Leaking?** Yes**Drainage and Leak Details:** Roof Section B slopes from west to east and drains to an external guttering.

No recent leaks were reported on this roof section at the time of inspection.

- Deteriorated caulking observed in a brick wall expansion joint
- Caulking repair attempts observed around the windows and adjoining siding joints
- Random areas with split BUR flashing corners and pipe penetration seals
- Cracks observed in the brick chimney
- Deteriorated glazing observed on the window units

Overall, the roof system is in fair condition due to its age and the above referenced defects. With the aforementioned defects addressed, in addition to routine maintenance and regular inspection, the roof system should remain effective for the duration of its assessed service life, approximately three (3) years. There was no warranty information available for this roof section at the time of inspection.

Budget Year	Activity Type	Action Item ?	Allocation	Urgency	Quotation \$
2017	Repair	Yes	Expense	High	\$1,000
<p>RSI recommends repairs be completed in accordance with the attached deficiency list.</p> <p><i>*Please Note: Costs associated with repairs and/or replacement of the brick chimney and/or windows are not included in this budget estimate.</i></p>					
2020	Infrared Scan	Yes	Expense	High	\$2,500
<p>RSI recommends an infrared scan be performed to locate any wet insulation present in the current roof system.</p>					
2020	Retrofit	Yes	Capital	High	\$24,570
<p>RSI recommends the installation of a new twenty (20) year design life roof system. We further recommend installation of new perimeter metal and projection details per the SMACNA Architectural Sheet Metal Manual.</p>					
					<b>\$28,070</b>

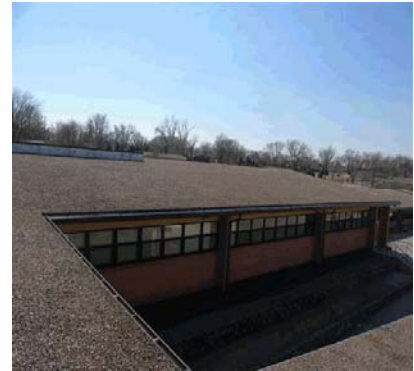
**Roof Name:** C**Roof Size:** 7,977 sq. ft.**Est. replacement Cost:** \$ 63,816.00**Existing System Type:** Built-Up Asphalt Roofing**Year Installed:** 2000**Assessed Service Life Remaining (Years) :** 3**Height:** 12 Ft.**Slope:** 02:12**Interior Sensitivity:** Normal**Drainage:** Adequate**Currently Leaking?** No**History of Leaking?** Yes**Drainage and Leak Details:** Roof Section C slopes from a central ridge line towards the north and south and drains to an external guttering.

No recent leaks were reported on this roof section at the time of inspection.

- Surface loss observed of the gravel roof surfacing
- Random areas with split BUR flashing corners
- Deteriorated glazing observed on the window units and cracks observed in the adjoining siding

Overall, the roof system is in fair condition due to its age and the above referenced defects. With the aforementioned defects addressed, in addition to routine maintenance and regular inspection, the roof system should remain effective for the duration of its assessed service life, approximately three (3) years. There was no warranty information available for this roof section at the time of inspection.

Budget Year	Activity Type	Action Item ?	Allocation	Urgency	Quotation \$
2017	Repair	Yes	Expense	High	\$500
<p>RSI recommends repairs be completed in accordance with the attached deficiency list.</p> <p><i>*Please Note: Costs associated with repairs and/or replacement of the brick chimney or windows are not included in this budget estimate.</i></p>					
2020	Infrared Scan	Yes	Expense	High	\$2,500
<p>RSI recommends an infrared scan be performed to locate any wet insulation present in the current roof system.</p>					
2020	Replacement	Yes	Capital	High	\$63,816
<p>RSI recommends the installation of a new twenty (20) year design life roof system. We further recommend installation of new perimeter metal and projection details per the SMACNA Architectural Sheet Metal Manual.</p>					
					<b>\$66,816</b>

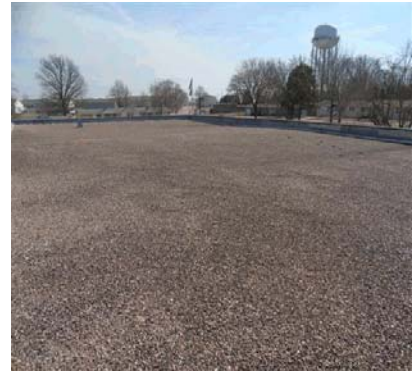
**Roof Name:** D**Roof Size:** 9,088 sq. ft.**Est. replacement Cost:** \$ 72,704.00**Existing System Type:** Built-Up Asphalt Roofing**Year Installed:** 1997**Assessed Service Life Remaining (Years) :** 0**Height:** 12 Ft.**Slope:** 1/4" per ft.**Interior Sensitivity:** Normal**Drainage:** Adequate**Currently Leaking?** Yes**History of Leaking?** Yes**Drainage and Leak Details:** Roof Section D slopes from north to south and drains to two (2) primary roof drains with two (2) overflow scuppers adjacent.

Facility personnel reported active leak issues along the common wall with the A-2 roof area.

- Surface loss of the gravel roof surfacing observed
- Hail dents observed on the metal roof area
- Roof mastic repair attempts made to the roof system
- Random areas with split BUR flashings along the common wall with the A-2 roof area
- One (1) damaged leap pipe flashing observed

Overall, the roof system is in poor condition due to its age and the above referenced defects. Given the observed conditions, it is our opinion comprehensive repairs in an effort to extend the life of the system would be neither feasible nor cost effective. We recommend the roof be replaced, pending the outcome of an infrared scan. There was no warranty information available for this roof section at the time of inspection.

Budget Year	Activity Type	Action Item ?	Allocation	Urgency	Quotation \$
2017	Infrared Scan	Yes	Expense	High	\$2,500
RSI recommends an infrared scan be performed to locate any wet insulation present in the current roof system.					
2017	Retrofit	Yes	Capital	High	\$72,704
RSI recommends the installation of a new twenty (20) year design life roof system. We further recommend installation of new perimeter metal and projection details per the SMACNA Architectural Sheet Metal Manual.					
					<b>\$75,204</b>

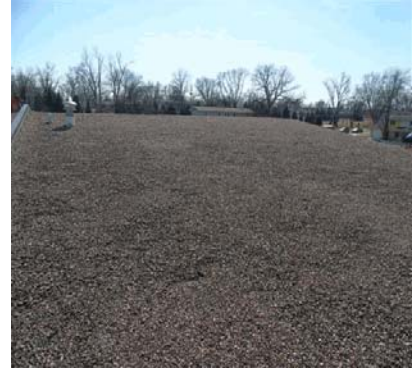
**Roof Name:** E**Roof Size:** 3,934 sq. ft.**Est. replacement Cost:** \$ 39,340.00**Existing System Type:** Built-Up Asphalt Roofing**Year Installed:** 1997**Assessed Service Life Remaining (Years) :** 0**Height:** 12 Ft.**Slope:** 02:12**Interior Sensitivity:** Normal**Drainage:** Adequate**Currently Leaking?** No**History of Leaking?** Yes**Drainage and Leak Details:** Roof Section E slopes from a central ridge line towards the north and south and drains to an external guttering.

No recent leaks were reported on this roof section at the time of inspection.

- Surface loss of the gravel roof surfacing
- BUR flashing along the control joint curb is weathered and cracking

Overall, the roof system is in poor condition due to its age and the above referenced defects. Given the observed conditions, it is our opinion comprehensive repairs in an effort to extend the life of the system would be neither feasible nor cost effective. We recommend the roof be replaced, pending the results of an infrared scan. There was no warranty information available for this roof section at the time of inspection.

Budget Year	Activity Type	Action Item ?	Allocation	Urgency	Quotation \$
2017	Infrared Scan	Yes	Expense	High	\$2,500
RSI recommends an infrared scan be performed to locate any wet insulation present in the current roof system.					
2017	Retrofit	Yes	Capital	High	\$39,340
RSI recommends the installation of a new twenty (20) year design life roof system. We further recommend installation of new perimeter metal and projection details per the SMACNA Architectural Sheet Metal Manual.					
					<b>\$41,840</b>
