# Roof Inspection Report

Prepared for:

Prepared by:

West High School  
1501 Thurston Avenue  
Bellevue, NE 68123

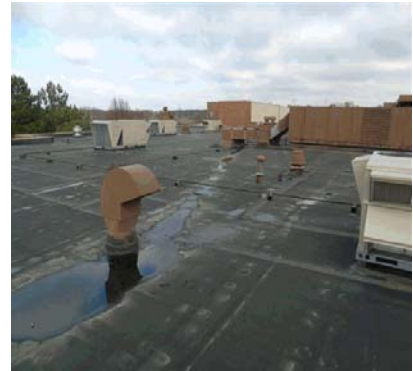
Facility personnel reported numerous active leaks on this roof section at the time of inspection.

- Open and loose EPDM lap edges observed
- Loose areas of EPDM membrane along the west and north ends of the roof area
- Loose and detached flexible walkway pads
- Accumulation of debris around drain strainers and metal filter frames have been left on the roof
- EPDM stripping repair attempts observed to the roof system laps
- Low flashing height observed on several of the HVAC units
- The EPDM flashings are bridged
- Numerous open EPDM flashing laps observed
- The exterior perimeter wall caps are rusted
- There is damage to the exposed duct work

Overall, the roof system is in poor condition due to its age and the deteriorated nature of the roof system. Given the observed conditions, it is our opinion comprehensive repairs in an effort to extend the life of the system would be neither feasible nor cost effective. We recommend the roof be replaced. There was no warranty information available for this roof section at the time of inspection.

RSI recommends a partial tear-off of the existing roof system, leaving the existing insulation in place, and installation of a new twenty (20) year design life roof system. We further recommend installation of new perimeter metal and projection details per SMACNA Architectural Sheet Metal Manual.

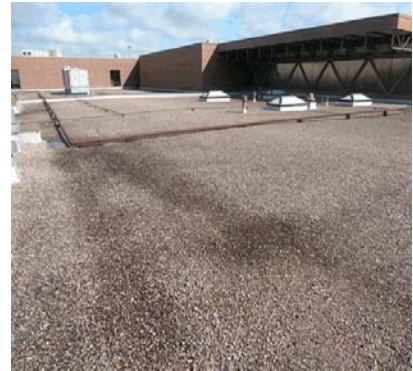
No recent leaks were reported on this roof section at the time of inspection.

- Roof mastic repair attempts observed to the BUR system
- The BUR flashings are weathered and cracking
- Random areas with split BUR flashings and corner flashings
- There is split pitch pocket filler
- The control joint metal caps appear to be pulled and uneven
- Inadequate pipe penetration flashings observed

Overall, the roof system is in poor condition due to its age and the deteriorated nature of the roof system. With the aforementioned defects addressed, in addition to routine maintenance and regular inspection, the roof system should remain effective for the duration of its assessed service life, approximately one (1) year. There was no warranty information available for this roof section at the time of inspection. In 2018, RSI recommends the installation of a new twenty (20) year design life retrofit roof system, pending the outcome of an infrared scan.

Budget Year	Activity Type	Action Item ?	Allocation	Urgency	Quotation \$
2017	Repair	Yes	Expense	High	\$1,500
RSI recommends repairs be completed in accordance with the attached deficiency list.					
2018	Retrofit	Yes	Capital	High	\$84,830
RSI recommends the installation of a new twenty (20) year design life retrofit roof system. We further recommend installation of new perimeter metal and projection details per the SMACNA Architectural Sheet Metal Manual.					
2018	Infrared Scan	Yes	Expense	High	\$667
RSI recommends an infrared scan be performed to locate any wet insulation present in the current roof system.					
					<b>\$86,997</b>

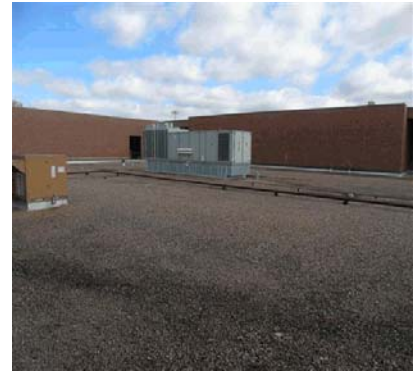
No recent leaks were reported on this roof section at the time of inspection.

- Split caulking observed in the brick wall expansion joints located above the roof system
- Surface loss observed of the gravel roof surfacing
- One (1) roof drain is blocked with debris
- Detached flexible walkway pads are scattered around on the roof area along with a steel ladder and metal filter frames which have been left on the roof area
- The metal wall caps are hail dented
- Roof mastic and modified bitumen repair attempts observed to the BUR system
- Random areas with split BUR flashings and corner flashings
- Missing gas line penetration seals on the HVAC units

Overall, the roof system is in poor condition due to its age and the deteriorated nature of the roof system. With leak repairs performed as needed, in addition to routine maintenance and regular inspection, the roof system should remain effective for the duration of its assessed service life, approximately one (1) year. There was no warranty information available for this roof section at the time of inspection.

Budget Year	Activity Type	Action Item ?	Allocation	Urgency	Quotation \$
2017	Repair	Yes	Expense	High	\$2,000
<p>RSI recommends leak repairs be performed only as needed until the roof's recommended replacement in 2018.</p> <p><i>*Please Note: Costs associated with repairs and/or replacement of HVAC units or equipment are not included in this budget estimate.</i></p>					
2018	Retrofit	Yes	Capital	High	\$118,116
<p>RSI recommends the installation of a new twenty (20) year design life retrofit roof system. We further recommend installation of new perimeter metal and projection details per the SMACNA Architectural Sheet Metal Manual.</p>					
2018	Infrared Scan	Yes	Expense	High	\$667
<p>RSI recommends an infrared scan be performed to locate any wet insulation present in the current roof system.</p>					
					<b>\$120,783</b>

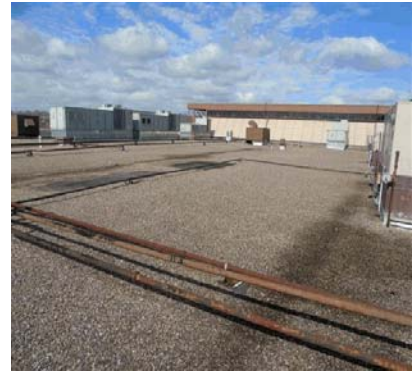
No recent leaks were reported on this roof section at the time of inspection.

- Buckling BUR flashings observed around one (1) roof drain
- Surface loss of the gravel roof surfacing observed
- Deteriorated and splitting past repair material
- Accumulation of debris around drain strainers with a wood pallet and metal filter frames have been left on the roof area
- Roof mastic and cold process repair attempts observed to the BUR system
- Open BUR flashing laps observed
- Areas with split BUR flashing seals and corner flashings
- BUR wall flashings are racked at the corners

Overall, the roof system is in poor condition due to its age and the deteriorated nature of the roof system. Given the observed conditions, it is our opinion comprehensive repairs in an effort to extend the life of the system would be neither feasible nor cost effective. We recommend the roof be replaced, pending the outcome of an infrared scan. There was no warranty information available for this roof section at the time of inspection.

Budget Year	Activity Type	Action Item ?	Allocation	Urgency	Quotation \$
2017	Retrofit	Yes	Capital	High	\$139,774
RSI recommends the installation of a new twenty (20) year design life retrofit roof system. We further recommend installation of new perimeter metal and projection details per the SMACNA Architectural Sheet Metal Manual.					
2017	Infrared Scan	Yes	Expense	High	\$1,000
RSI recommends an infrared scan be performed to locate any wet insulation present in the current roof system.					
					<b>\$140,774</b>

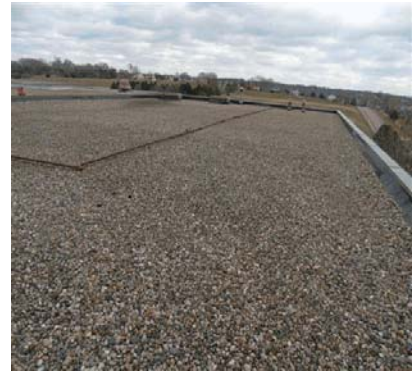
No recent leaks were reported on this roof section at the time of inspection.

- One (1) gas line penetrates the side of a metal sleeve stack, close to the roof elevation
- The EPDM flashings are bridging, typical of an aging/shrinking EPDM membrane
- Numerous open EPDM flashing laps observed
- One (1) split in an EPDM wall flashing observed
- Rusted flue stacks

Overall, the roof system is in poor condition due to its age and the deteriorated nature of the roof system. Given the observed conditions, it is our opinion comprehensive repairs in an effort to extend the life of the system would be neither feasible nor cost effective. We recommend the roof be replaced. There was no warranty information available for this roof section at the time of inspection.

RSI recommends a complete tear-off of existing roof system and the installation of a new twenty (20) year design life roof system. We further recommend the replacement of all perimeter coping cap and projection details per SMACNA Architectural Sheet Metal Manual.

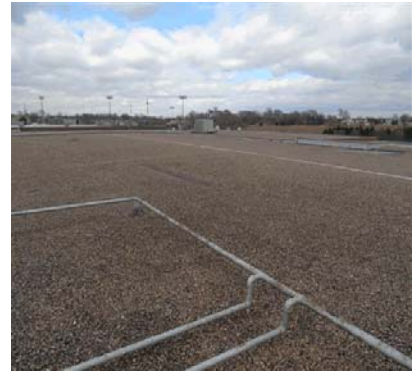
No recent leaks were reported on this roof section at the time of inspection.

- Open laps observed in a modified bitumen repair patch
- The BUR is splitting through several of the past repair attempts
- One (1) blistered BUR flashing observed
- The coping cap metal is hail dented
- Roof mastic and a modified bitumen patch repair attempt to the BUR system
- Areas with split flashings observed
- BUR wall flashings are racked at the corners
- A loose end on a metal coping cap observed

Overall, the roof system is in poor condition due to its age and the deteriorated nature of the roof system. Given the observed conditions, it is our opinion comprehensive repairs in an effort to extend the life of the system would be neither feasible nor cost effective. We recommend the roof be replaced, pending the outcome of an infrared scan. There was no warranty information available for this roof section at the time of inspection.

Budget Year	Activity Type	Action Item ?	Allocation	Urgency	Quotation \$
2017	Retrofit	Yes	Capital	High	\$180,863
RSI recommends the installation of a new twenty (20) year design life retrofit roof system. We further recommend installation of new perimeter metal and projection details per the SMACNA Architectural Sheet Metal Manual.					
2017	Infrared Scan	Yes	Expense	High	\$1,000
RSI recommends an infrared scan be performed to locate any wet insulation present in the current roof system.					
					<b>\$181,863</b>

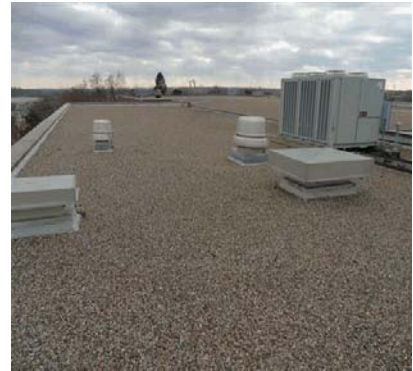
No recent leaks were reported on this roof section at the time of inspection.

- There are wrinkled BUR flashings
- Roof mastic repair attempts observed to the BUR system
- One (1) split BUR flashing corner

Overall, the roof system is in fair working condition. With the aforementioned defects addressed, in addition to routine maintenance and regular inspection, the roof system should remain effective for the duration of its assessed service life, approximately five (5) years. There was no warranty information available for this roof section at the time of inspection.

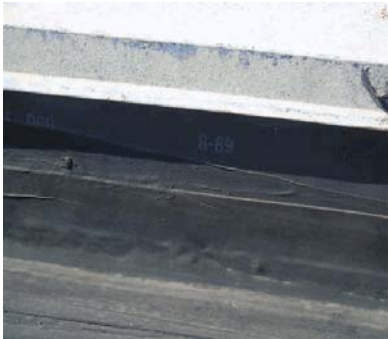
Mar 01, 2017	Membrane stamp

One (1) core cut revealed a steel decking and one (1) layer of .75" perlite. The insulation consists of one (1) layer of 4" air expanded polystyrene board and a .5" layer of wood fiber cover board. The membrane is a fully-adhered, .060 mil Firestone EPDM. The wood fiber board was partially deteriorated at the core cut location.

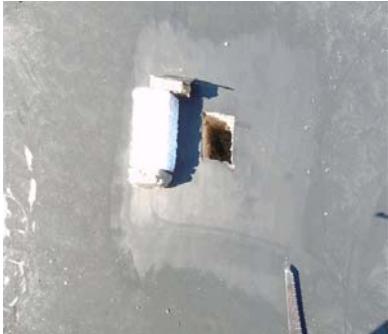
Mar 01, 2017	Roof System Core

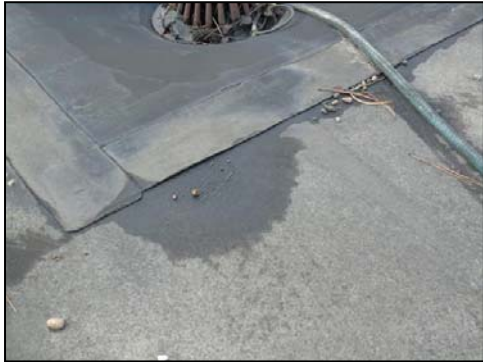
Defect Code:	3	Quantity:	Widespread	Priority:	Monitor
Description: Open lap in field membrane.					
Repair: Clean lap of all dirt and close seam. Overlay edge of affected seam with strip-in of new membrane of like material. Extend a minimum of 4" in all directions past seam edges and repair areas.

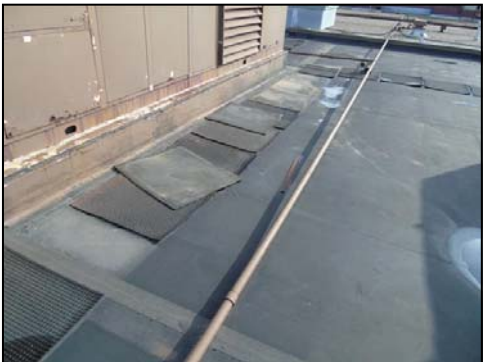
Defect Code:	21	Quantity:	Widespread	Priority:	Monitor
Description: Loose walkway pad or deteriorated paver.					
Repair: Readhere or reweld wakway pads. Provide new pads to replace damaged or missing pads. Replace deteriorated concrete pavers with pavers of like kind and weight to ensure a flush walking surface.

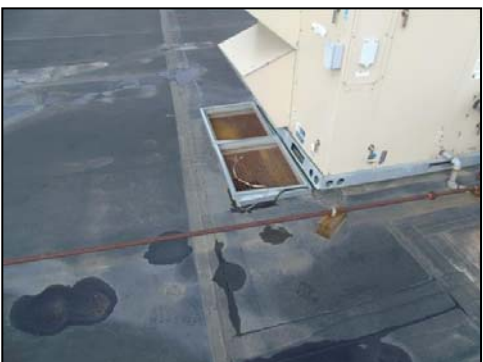
Defect Code:	22	Quantity:	Random	Priority:	Monitor
Description: Debris, trash, construction materials, HVAC equipment, filters, motors, etc. on roof surface.					
Repair: Remove all trash and debris from roof. Clean and inspect surfaces and repair any damages to the membrane or flashings.

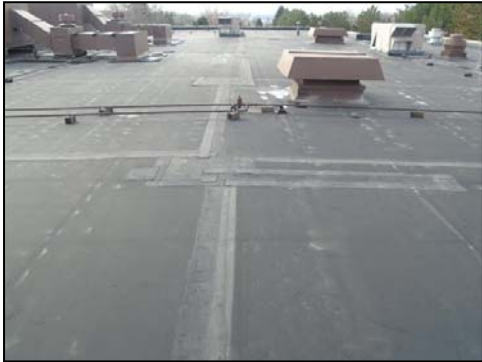
<b>Defect Code:</b>	<b>24</b>	<b>Quantity:</b>	<b>Widespread</b>	<b>Priority:</b>	<b>Monitor</b>
Description: Evidence of past problem and previous repair.					
Repair: Investigate for chronic leak problems and repair any areas that are suspect.

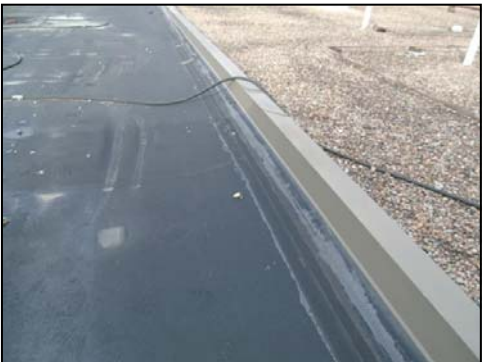
<b>Defect Code:</b>	<b>44</b>	<b>Quantity:</b>	<b>Widespread</b>	<b>Priority:</b>	<b>Monitor</b>
Description: Bridged flashing					
Cut out all bridged flashings. Clean area thoroughly and apply new flashings. Apply corner flashings and overlay all T-laps, flashings laps, and splice intersections.

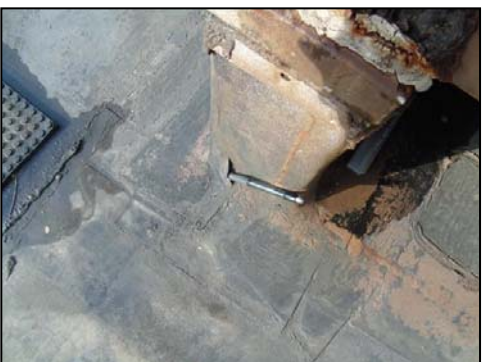
<b>Defect Code:</b>	<b>45</b>	<b>Quantity:</b>	<b>Widespread</b>	<b>Priority:</b>	<b>Monitor</b>
Description: Open flashing lap					
Repair: Open loose lap area and clean thoroughly. Prime and reseam or reweld lap per the manufacturer's requirements. Strip-in defective lap with mimum 6" wide membrane on single ply systems or 6" wide fabric and mastic three-course application on asphalt systems. Regranulate or coat flashing repairs.

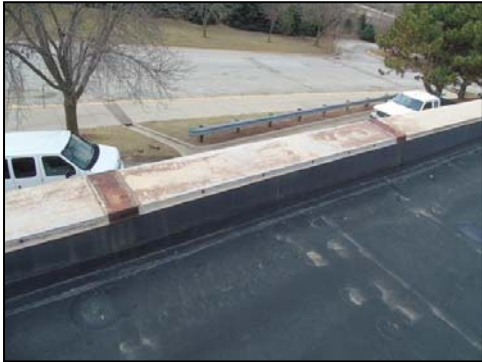
Defect Code:	86	Quantity:	Widespread	Priority:	Monitor
Description: Corrosion or rust					
Repair: Remove rusted components and replace with similar metal fabricated and installed per SMACNA requirements.

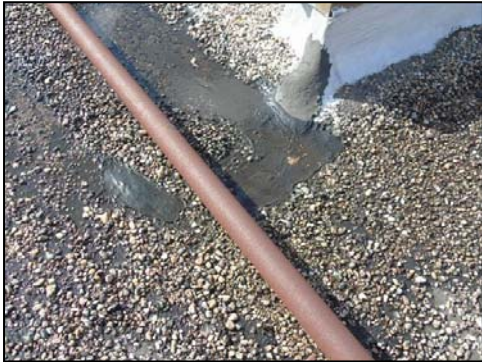
<b>Defect Code:</b>	<b>24</b>	<b>Quantity:</b>	<b>Random</b>	<b>Priority:</b>	<b>Monitor</b>
Description: Evidence of past problem and previous repair.					
Repair: Investigate for chronic leak problems and repair any areas that are suspect.

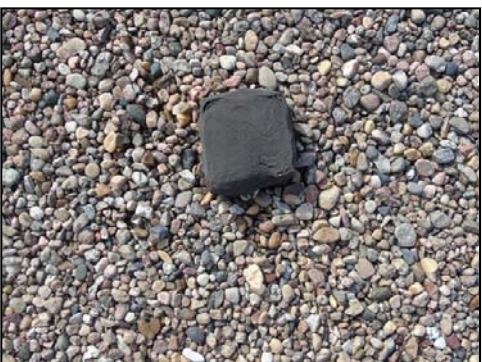
<b>Defect Code:</b>	<b>55</b>	<b>Quantity:</b>	<b>1</b>	<b>Priority:</b>	<b>First Year</b>
Description: Deteriorated or shrunken pitch pan filler.					
Repair: Clean pocket and penetrations of all dirt, insulation, and other materials and debris. Install manufacturer's recommended sealant in prepared pitch pan.

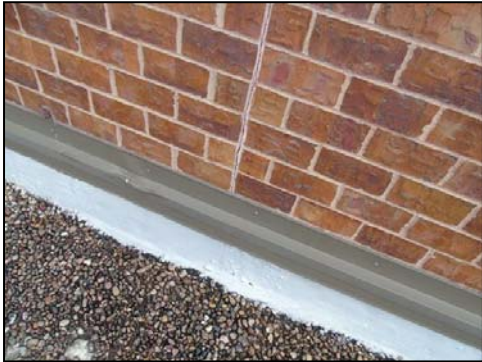
<b>Defect Code:</b>	<b>1</b>	<b>Quantity:</b>	<b>Widespread</b>	<b>Priority:</b>	<b>First Year</b>
Description: Deteriorated or missing sealant at counterflashing, termination bar, sealant lip, metal flashing, expansion joint, etc.					
Repair: Clean loose sealant and dirt from all surfaces. Apply new polyurethane sealant and tool to shed water.

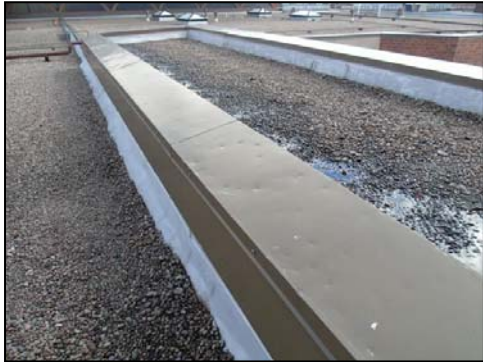
<b>Defect Code:</b>	<b>23</b>	<b>Quantity:</b>	<b>Widespread</b>	<b>Priority:</b>	<b>Monitor</b>
Description: Physical damage to membrane including cuts, holes, tears, scrapes, scuffs, or abrasions.					
Repair: Apply repair membrane over damaged area, extending repair material a minimum 6" past damage.

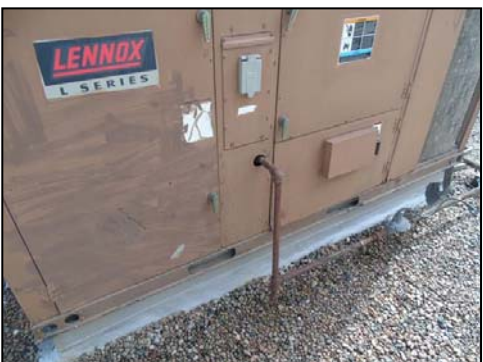
<b>Defect Code:</b>	<b>87</b>	<b>Quantity:</b>	<b>2</b>	<b>Priority:</b>	<b>Monitor</b>
Description: Mechanical defect					
Repair: Repair mechanical defect. Replace or reinstall missing access doors and panels. Reseal rooftop unit, pans, ducts, curbs, etc.

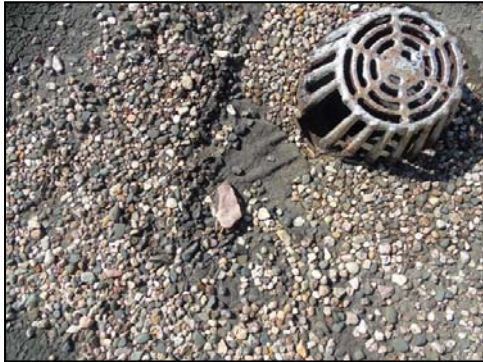
<b>Defect Code:</b>	<b>5</b>	<b>Quantity:</b>	<b>10 LF</b>	<b>Priority:</b>	<b>Monitor</b>
Description: Buckling or ridging of membrane.					
Repair: Cut out deteriorated buckles and ridges and repair membrane with similar membrane material. Extend repair material a minimum of 6" in all directions past repair areas.

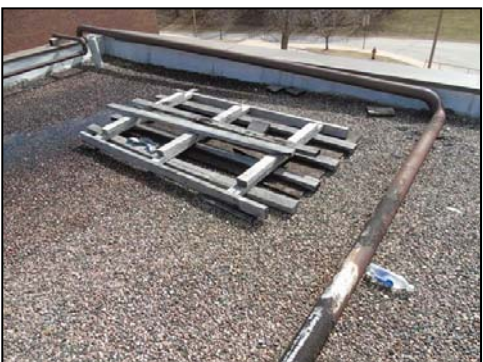
<b>Defect Code:</b>	<b>22</b>	<b>Quantity:</b>	<b>Random</b>	<b>Priority:</b>	<b>First Year</b>
Description: Debris, trash, construction materials, HVAC equipment, filters, motors, etc. on roof surface.					
Repair: Remove all trash and debris from roof. Clean and inspect surfaces and repair any damages to the membrane or flashings.

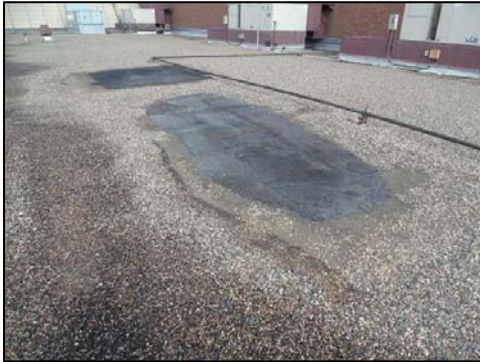
<b>Defect Code:</b>	<b>24</b>	<b>Quantity:</b>	<b>Widespread</b>	<b>Priority:</b>	<b>Monitor</b>
Description: Evidence of past problem and previous repair.					
Repair: Investigate for chronic leak problems and repair any areas that are suspect.

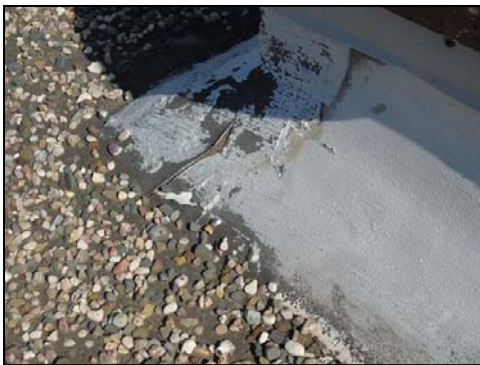
<b>Defect Code:</b>	<b>45</b>	<b>Quantity:</b>	<b>Random</b>	<b>Priority:</b>	<b>First Year</b>
Description: Open flashing lap					
Repair: Open loose lap area and clean thoroughly. Prime and reseam or reweld lap per the manufacturer's requirements. Strip-in defective lap with mimum 6" wide membrane on single ply systems or 6" wide fabric and mastic three-course application on asphalt systems. Regranulate or coat flashing repairs.

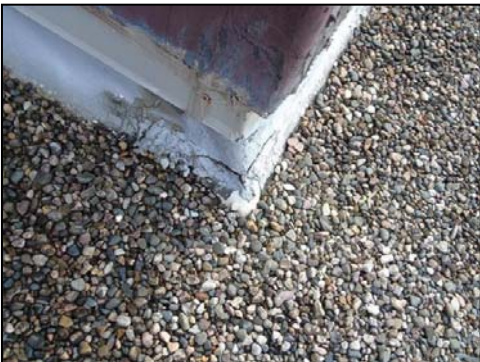
<b>Defect Code:</b>	<b>46</b>	<b>Quantity:</b>	<b>Numerous</b>	<b>Priority:</b>	<b>First Year</b>
Description: Split in flashing					
Repair: Cut away loose flashing and clean and prime repair area. Apply strip in of like material centered over split extending a minimum of 4" in all directions past prepared area.

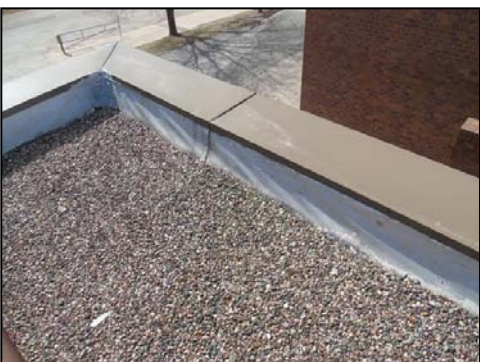
<b>Defect Code:</b>	<b>47</b>	<b>Quantity:</b>	<b>Random</b>	<b>Priority:</b>	<b>Monitor</b>
Description: Racked flashings					
Repair: Monitor flashings and repair when identified as deteriorated.

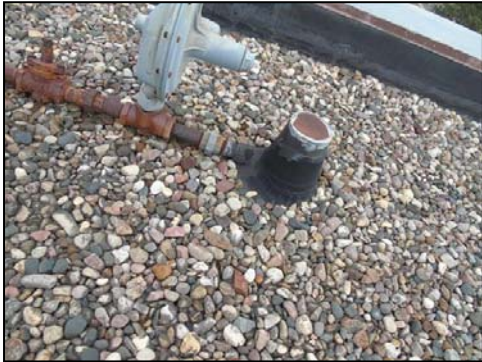
<b>Defect Code:</b>	<b>40</b>	<b>Quantity:</b>	<b>1</b>	<b>Priority:</b>	<b>Monitor</b>
Description: Low flashing height.					
Repair: Raise flashing height to a minimum of 8" above finished roof surface. Provide appropriate termination of flashings with metal copings or counterflashings. Provide a compression bar termination of flashings to concrete or block surface if flashings cannot be maintained at 8" minimum height.

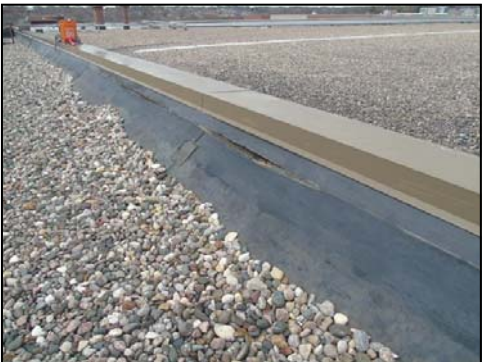
<b>Defect Code:</b>	<b>45</b>	<b>Quantity:</b>	<b>Widespread</b>	<b>Priority:</b>	<b>Monitor</b>
Description: Open flashing lap					
Repair: Open loose lap area and clean thoroughly. Prime and reseam or reweld lap per the manufacturer's requirements. Strip-in defective lap with mimum 6" wide membrane on single ply systems or 6" wide fabric and mastic three-course application on asphalt systems. Regranulate or coat flashing repairs.

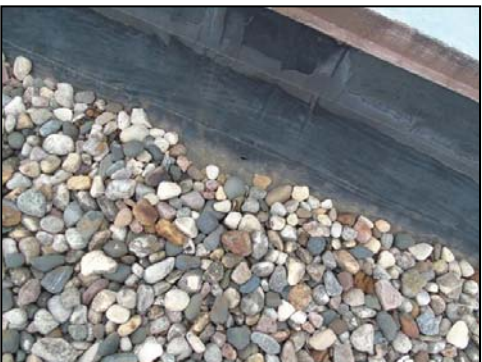
<b>Defect Code:</b>	<b>46</b>	<b>Quantity:</b>	<b>Under 10 LF</b>	<b>Priority:</b>	<b>Monitor</b>
Description: Split in flashing					
Repair: Cut away loose flashing and clean and prime repair area. Apply strip in of like material centered over split extending a minimum of 4" in all directions past prepared area.

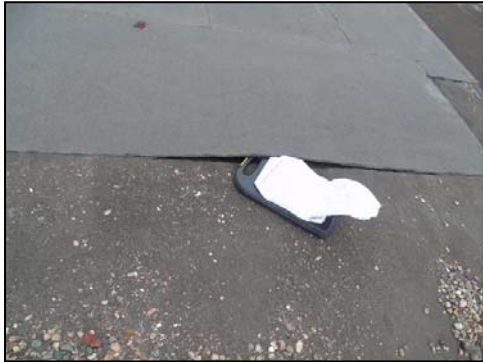
Defect Code:	3	Quantity:	Widespread	Priority:	Monitor
Description: Open lap in field membrane.					
Repair: Clean lap of all dirt and close seam. Overlay edge of affected seam with strip-in of new membrane of like material. Extend a minimum of 4" in all directions past seam edges and repair areas.

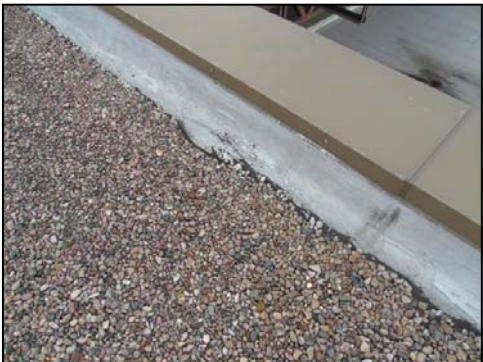
Defect Code:	11	Quantity:	Under 10 SF	Priority:	Monitor
Description: Blister in field membrane or flashing.					
Repair: Monitor blisters that are not broken. Repair any broken blisters or blisters in traffic areas or those applying stress to seams or flashings. Cut out blistered membrane and remove wet materials. Apply new membrane and extend a minimum of 6" on

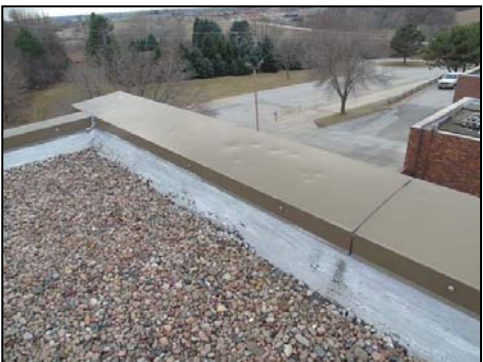
Defect Code:	23	Quantity:	Widespread	Priority:	Monitor
Description: Physical damage to membrane including cuts, holes, tears, scrapes, scuffs, or abrasions.					
Repair: Apply repair membrane over damaged area, extending repair material a minimum 6" past damage.

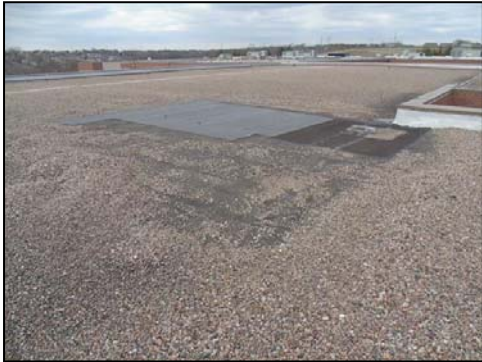
<b>Defect Code:</b>	<b>24</b>	<b>Quantity:</b>	<b>Widespread</b>	<b>Priority:</b>	<b>Monitor</b>
Description: Evidence of past problem and previous repair.					
Repair: Investigate for chronic leak problems and repair any areas that are suspect.

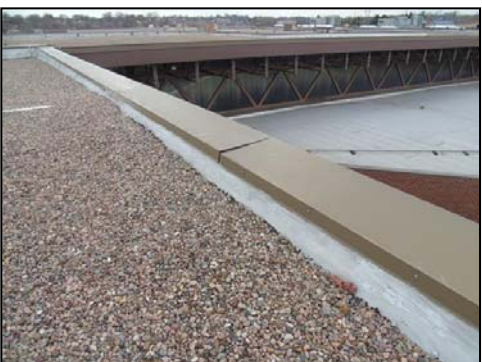
<b>Defect Code:</b>	<b>75</b>	<b>Quantity:</b>	<b>Under 10 LF</b>	<b>Priority:</b>	<b>First Year</b>
Description: Inadequate attachment of metal flashings.					
Repair: Reattach metal flashings a maximum of two EPDM washered fasteners per side of curb or attach a maximum of 12" O.C for flashings more than 24 " in length.

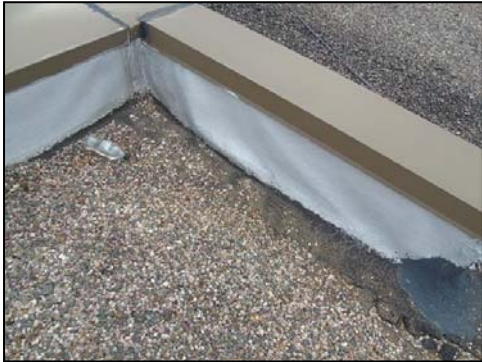
<b>Defect Code:</b>	<b>7</b>	<b>Quantity:</b>	<b>Random</b>	<b>Priority:</b>	<b>Monitor</b>
Description: Wrinkle in membrane.					
Repair: Cut out wrinkles and loose membrane. Apply new membrane of like material and plies to cover cuts and extend repairs a minimum of 6" in all directions past cut out areas.

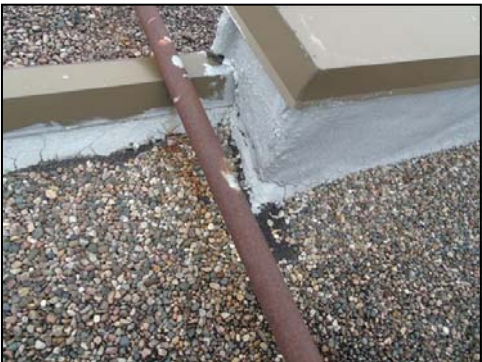
<b>Defect Code:</b>	<b>46</b>	<b>Quantity:</b>	<b>Under 10 LF</b>	<b>Priority:</b>	<b>First Year</b>
Description: Split in flashing					
Repair: Cut away loose flashing and clean and prime repair area. Apply strip in of like material centered over split extending a minimum of 4" in all directions past prepared area.

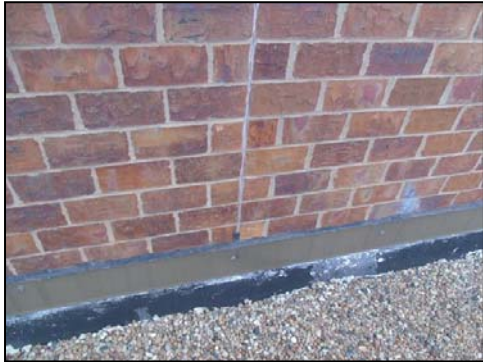
<b>Defect Code:</b>	<b>1</b>	<b>Quantity:</b>	<b>Widespread</b>	<b>Priority:</b>	<b>Monitor</b>
Description: Deteriorated or missing sealant at counterflashing, termination bar, sealant lip, metal flashing, expansion joint, etc.					
Repair: Clean loose sealant and dirt from all surfaces. Apply new polyurethane sealant and tool to shed water.

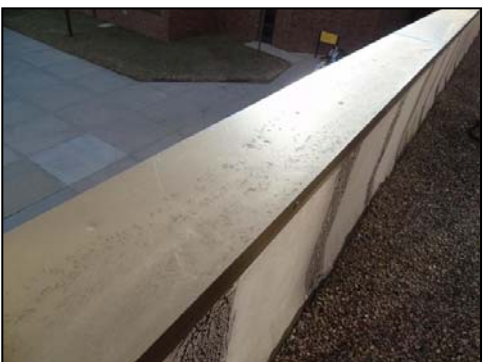
<b>Defect Code:</b>	<b>23</b>	<b>Quantity:</b>	<b>Widespread</b>	<b>Priority:</b>	<b>Monitor</b>
Description: Physical damage to membrane including cuts, holes, tears, scrapes, scuffs, or abrasions.					
Repair: Apply repair membrane over damaged area, extending repair material a minimum 6" past damage.

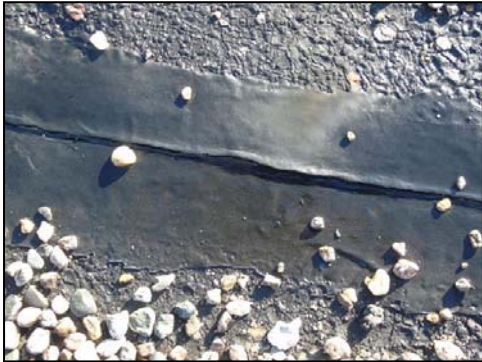
<b>Defect Code:</b>	<b>6</b>	<b>Quantity:</b>	<b>Random</b>	<b>Priority:</b>	<b>First Year</b>
Description: Split in membrane.					
Repair: Cut out splits and repair membrane with similar membrane material. Extend repair material a minimum of 6" in all directions past repair areas.

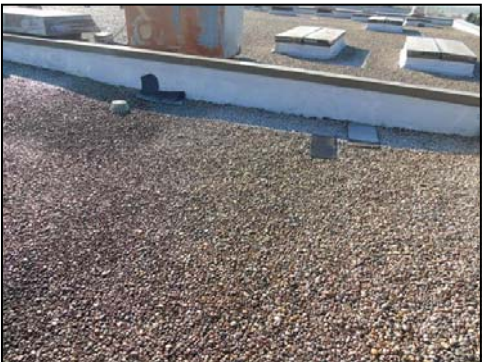
<b>Defect Code:</b>	<b>22</b>	<b>Quantity:</b>	<b>Random</b>	<b>Priority:</b>	<b>First Year</b>
Description: Debris, trash, construction materials, HVAC equipment, filters, motors, etc. on roof surface.					
Repair: Remove all trash and debris from roof. Clean and inspect surfaces and repair any damages to the membrane or flashings.

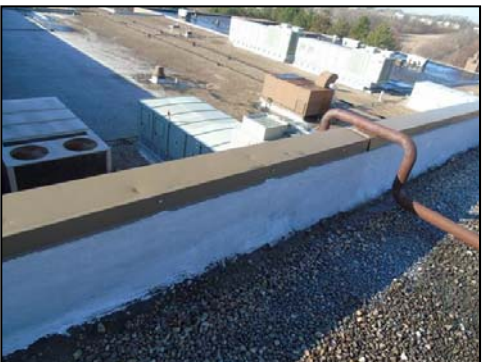
<b>Defect Code:</b>	<b>23</b>	<b>Quantity:</b>	<b>Widespread</b>	<b>Priority:</b>	<b>Monitor</b>
Description: Physical damage to membrane including cuts, holes, tears, scrapes, scuffs, or abrasions.					
Repair: Apply repair membrane over damaged area, extending repair material a minimum 6" past damage.

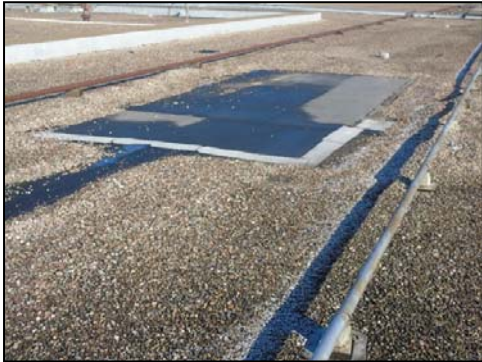
<b>Defect Code:</b>	<b>24</b>	<b>Quantity:</b>	<b>Random</b>	<b>Priority:</b>	<b>Monitor</b>
Description: Evidence of past problem and previous repair.					
Repair: Investigate for chronic leak problems and repair any areas that are suspect.

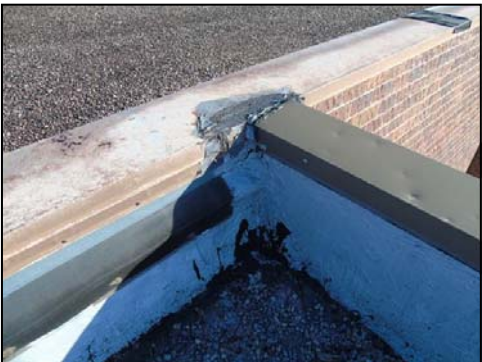
<b>Defect Code:</b>	<b>57</b>	<b>Quantity:</b>	<b>Under 10 LF</b>	<b>Priority:</b>	<b>First Year</b>
Description: Expansion joint deficiencies.					
Repair: Repair defects in rubber expansion joint or joint covers with two layers of flashing with the second layer being 3" larger in all directions than the first. Install flashing with manufacturer's recommended cleaners and primers.

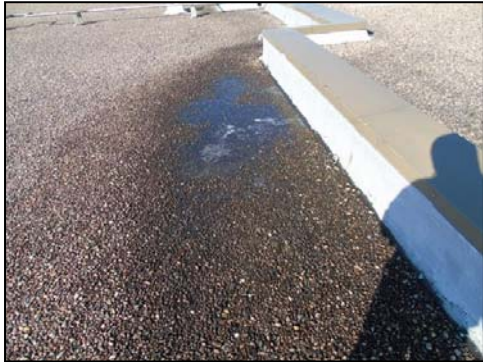
<b>Defect Code:</b>	<b>15</b>	<b>Quantity:</b>	<b>Random</b>	<b>Priority:</b>	<b>Monitor</b>
Description: Ponding of water.					
Repair: Monitor areas for severe or chronic ponding. Provide sacrificial membrane ply in ponded areas where existing membrane is deteriorated. Install additional drain or scupper including collectors and drain piping where ponding conditions are severe and chronic.

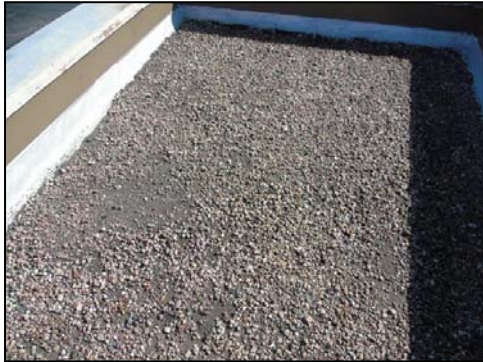
Defect Code:	8	Quantity:	Random	Priority:	Monitor
Description: Surface erosion.					
Repair: Prepare membrane surface by thoroughly cleaning and priming. Apply new surfacing of like materials to eroded areas. On gravel surfaced systems apply gravel in hot asphalt or recommended cold adhesive. Apply granulated fiberglass cap sheet or modified bitumen membrane on like systems. Apply coating system on smooth asphalt surfaces. Transition surfacing to provide for a smooth and neat finished appearance to match the existing surfacing.

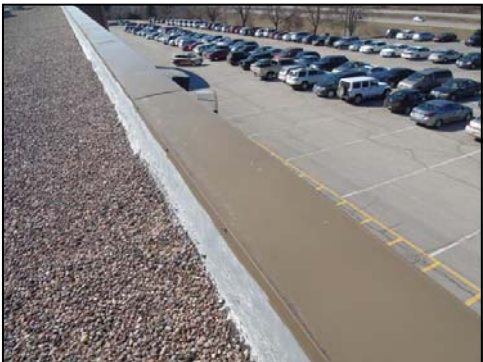
Defect Code:	23	Quantity:	Random	Priority:	Monitor
Description: Physical damage to membrane including cuts, holes, tears, scrapes, scuffs, or abrasions.					
Repair: Apply repair membrane over damaged area, extending repair material a minimum 6" past damage.

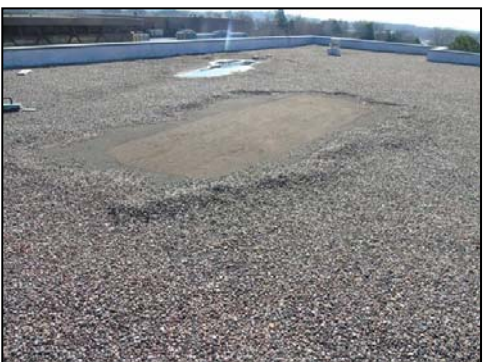
Defect Code:	24	Quantity:	Random	Priority:	Monitor
Description: Evidence of past problem and previous repair.					
Repair: Investigate for chronic leak problems and repair any areas that are suspect.

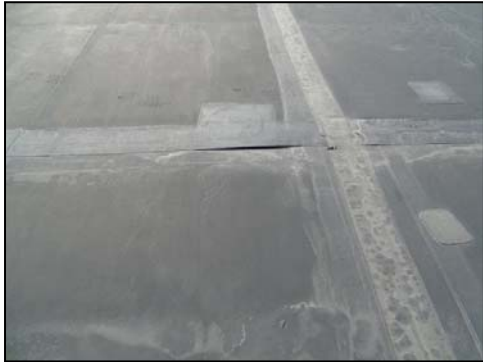
Defect Code:	3	Quantity:	Widespread	Priority:	Monitor
Description: Open lap in field membrane.					
Repair: Clean lap of all dirt and close seam. Overlay edge of affected seam with strip-in of new membrane of like material. Extend a minimum of 4" in all directions past seam edges and repair areas.

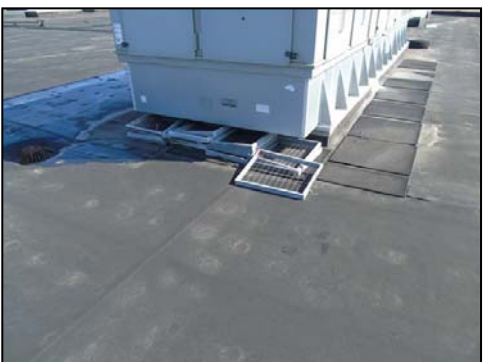
Defect Code:	22	Quantity:	Random	Priority:	Monitor
Description: Debris, trash, construction materials, HVAC equipment, filters, motors, etc. on roof surface.					
Repair: Remove all trash and debris from roof. Clean and inspect surfaces and repair any damages to the membrane or flashings.

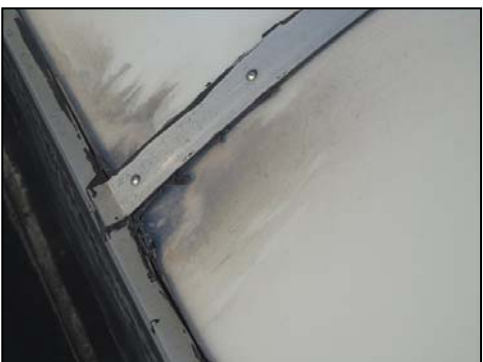
<b>Defect Code:</b>	<b>88</b>	<b>Quantity:</b>	<b>Widespread</b>	<b>Priority:</b>	<b>Monitor</b>
Description: Skylight defect/cracked/deteriorated					
Repair: Remove and replace affected components.

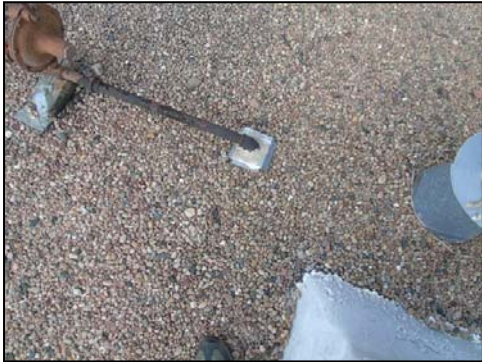
<b>Defect Code:</b>	<b>1</b>	<b>Quantity:</b>	<b>1</b>	<b>Priority:</b>	<b>Monitor</b>
Description: Deteriorated or missing sealant at counterflashing, termination bar, sealant lip, metal flashing, expansion joint, etc.					
Repair: Clean loose sealant and dirt from all surfaces. Apply new polyurethane sealant and tool to shed water.

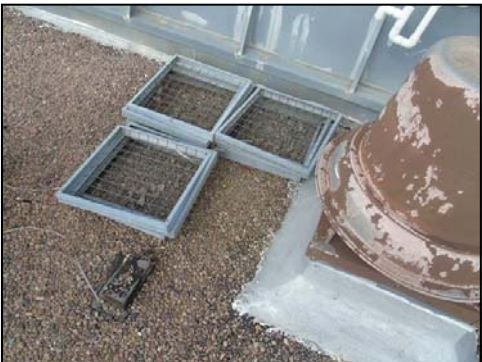
<b>Defect Code:</b>	<b>22</b>	<b>Quantity:</b>	<b>Random</b>	<b>Priority:</b>	<b>Monitor</b>
Description: Debris, trash, construction materials, HVAC equipment, filters, motors, etc. on roof surface.					
Repair: Remove all trash and debris from roof. Clean and inspect surfaces and repair any damages to the membrane or flashings.

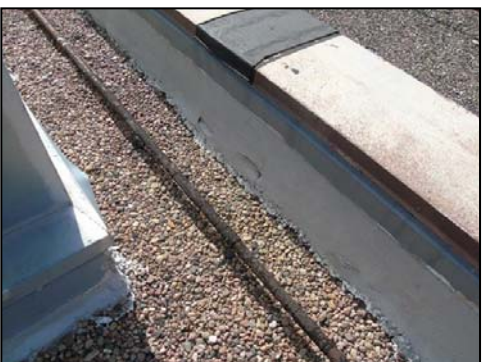
<b>Defect Code:</b>	<b>23</b>	<b>Quantity:</b>	<b>Under 10 SF</b>	<b>Priority:</b>	<b>First Year</b>
Description: Physical damage to membrane including cuts, holes, tears, scrapes, scuffs, or abrasions.					
Repair: Apply repair membrane over damaged area, extending repair material a minimum 6" past damage.

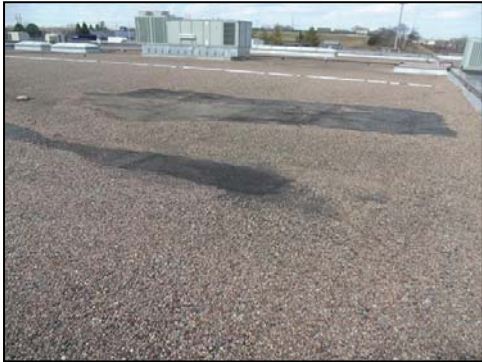
<b>Defect Code:</b>	<b>24</b>	<b>Quantity:</b>	<b>Random</b>	<b>Priority:</b>	<b>Monitor</b>
Description: Evidence of past problem and previous repair.					
Repair: Investigate for chronic leak problems and repair any areas that are suspect.

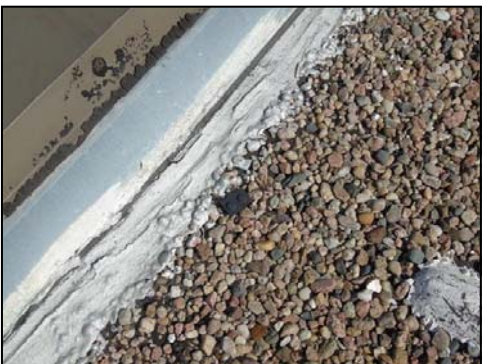
<b>Defect Code:</b>	<b>46</b>	<b>Quantity:</b>	<b>Random</b>	<b>Priority:</b>	<b>First Year</b>
Description: Split in flashing					
Repair: Cut away loose flashing and clean and prime repair area. Apply strip in of like material centered over split extending a minimum of 4" in all directions past prepared area.

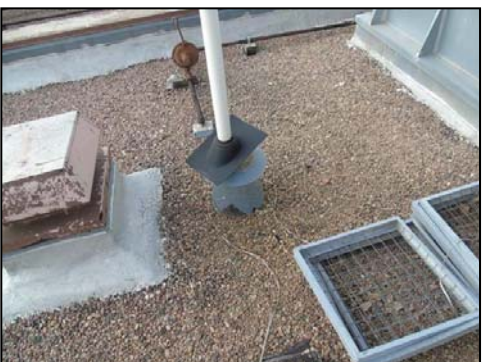
<b>Defect Code:</b>	<b>52</b>	<b>Quantity:</b>	<b>1</b>	<b>Priority:</b>	<b>Monitor</b>
Description: Missing rain cap, rain collar, or hood.					
Repair: Install rain cap, hood, or collar and secure and seal to pipe.

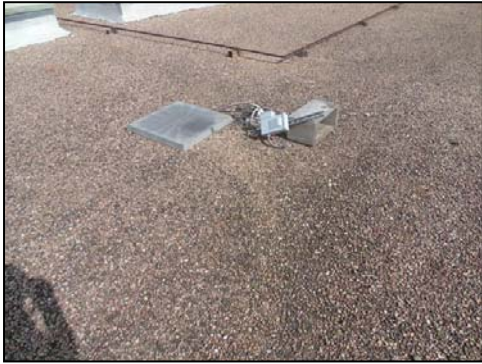
Defect Code:	56	Quantity:	2	Priority:	Monitor
Description: Abandoned and obsolete equipment.					
Repair: Monitor for leaks. Check systems are abandoned and disconnected and will not be used in the future. Remove abandoned equipment and repair deck at scheduled roof replacement.

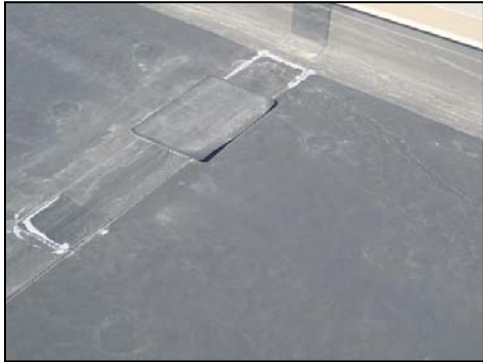
Defect Code:	3	Quantity:	Widespread	Priority:	Monitor
Description: Open lap in field membrane.					
Repair: Clean lap of all dirt and close seam. Overlay edge of affected seam with strip-in of new membrane of like material. Extend a minimum of 4" in all directions past seam edges and repair areas.

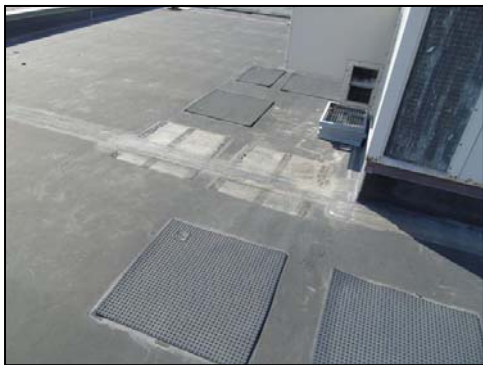
Defect Code:	21	Quantity:	Widespread	Priority:	Monitor
Description: Loose walkway pad or deteriorated paver.					
Repair: Reattach or reweld walkway pads. Provide new pads to replace damaged or missing pads. Replace deteriorated concrete pavers with pavers of like kind and weight to ensure a flush walking surface.

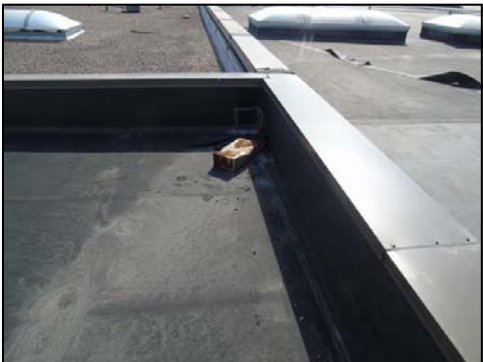
Defect Code:	22	Quantity:	Random	Priority:	Monitor
Description: Debris, trash, construction materials, HVAC equipment, filters, motors, etc. on roof surface.					
Repair: Remove all trash and debris from roof. Clean and inspect surfaces and repair any damages to the membrane or flashings.

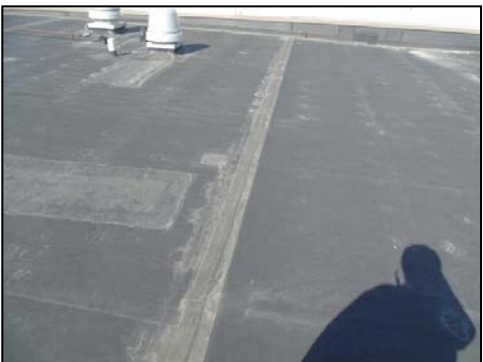
Defect Code:	24	Quantity:	Widespread	Priority:	Monitor
Description: Evidence of past problem and previous repair.					
Repair: Investigate for chronic leak problems and repair any areas that are suspect.

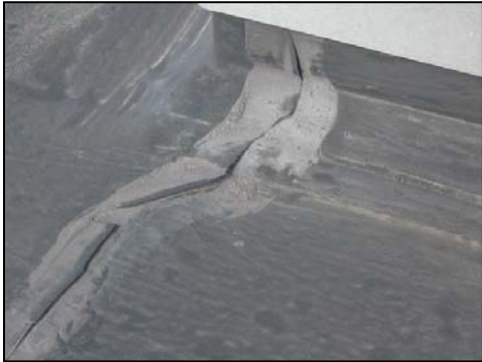
Defect Code:	45	Quantity:	Widespread	Priority:	Monitor
Description: Open flashing lap					
Repair: Open loose lap area and clean thoroughly. Prime and reseam or reweld lap per the manufacturer's requirements. Strip-in defective lap with minimum 6" wide membrane on single ply systems or 6" wide fabric and mastic three-course application on asphalt systems. Regranulate or coat flashing repairs.

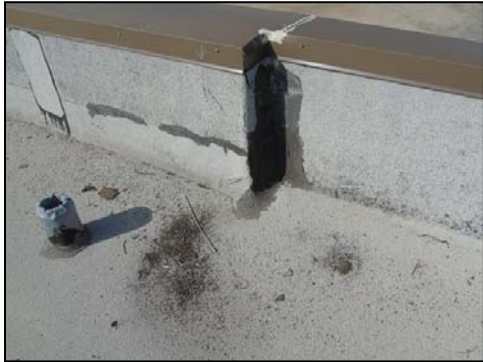
<b>Defect Code:</b>	<b>24</b>	<b>Quantity:</b>	<b>Random</b>	<b>Priority:</b>	<b>Monitor</b>
Description: Evidence of past problem and previous repair.					
Repair: Investigate for chronic leak problems and repair any areas that are suspect.

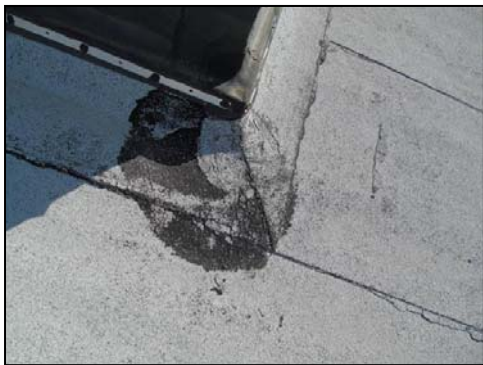
<b>Defect Code:</b>	<b>45</b>	<b>Quantity:</b>	<b>Under 10 LF</b>	<b>Priority:</b>	<b>First Year</b>
Description: Open flashing lap					
Repair: Open loose lap area and clean thoroughly. Prime and reseam or reweld lap per the manufacturer's requirements. Strip-in defective lap with mimum 6" wide membrane on single ply systems or 6" wide fabric and mastic three-course application on asphalt systems. Regranulate or coat flashing repairs.

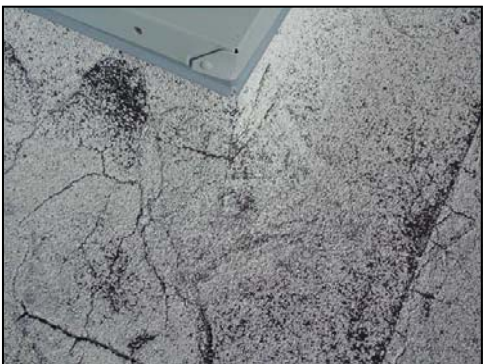
<b>Defect Code:</b>	<b>46</b>	<b>Quantity:</b>	<b>Under 10 LF</b>	<b>Priority:</b>	<b>First Year</b>
Description: Split in flashing					
Repair: Cut away loose flashing and clean and prime repair area. Apply strip in of like material centered over split extending a minimum of 4" in all directions past prepared area.

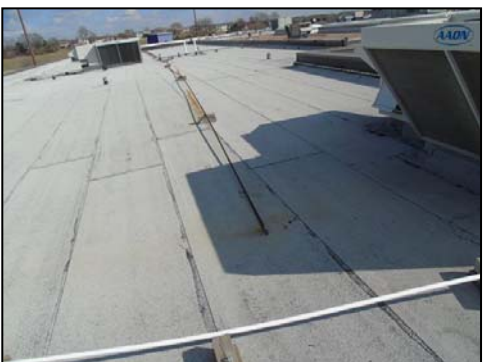
<b>Defect Code:</b>	<b>81</b>	<b>Quantity:</b>	<b>Widespread</b>	<b>Priority:</b>	<b>First Year</b>
Description: Displaced antenna, sign, bracing, support, strap, etc.					
Repair: Reattach equipment and repair damages to membrane and flashings.

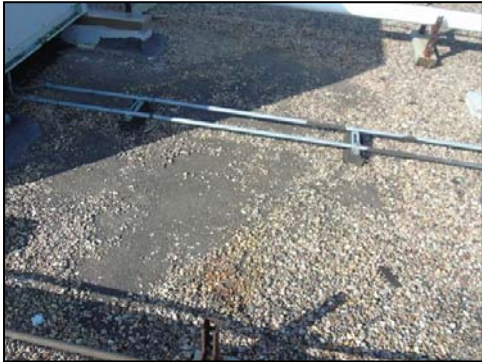
<b>Defect Code:</b>	<b>8</b>	<b>Quantity:</b>	<b>Random</b>	<b>Priority:</b>	<b>Monitor</b>
Description: Surface erosion.					
Repair: Prepare membrane surface by thoroughly cleaning and priming. Apply new surfacing of like materials to eroded areas. On gravel surfaced systems apply gravel in hot asphalt or recommended cold adhesive. Apply granulated fiberglass cap sheet or modified bitumen membrane on like systems. Apply coating system on smooth asphalt surfaces. Transition surfacing to provide for a smooth and neat finished appearance to match the existing surfacing.

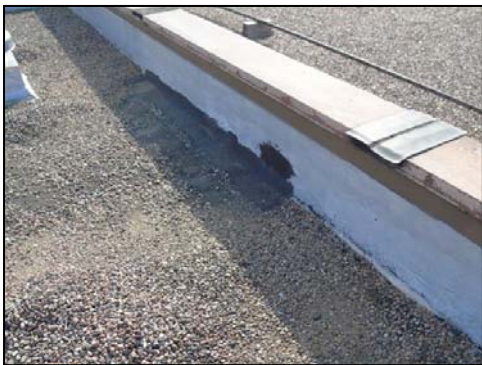
<b>Defect Code:</b>	<b>24</b>	<b>Quantity:</b>	<b>Random</b>	<b>Priority:</b>	<b>Monitor</b>
Description: Evidence of past problem and previous repair.					
Repair: Investigate for chronic leak problems and repair any areas that are suspect.

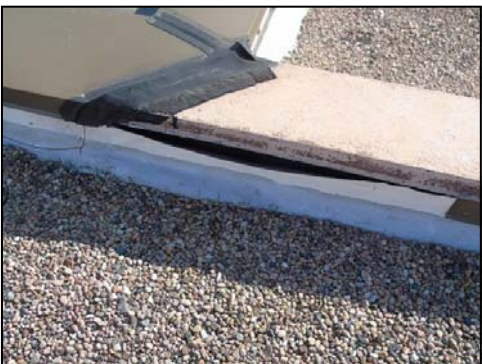
<b>Defect Code:</b>	<b>45</b>	<b>Quantity:</b>	<b>Under 10 LF</b>	<b>Priority:</b>	<b>First Year</b>
Description: Open flashing lap					
Repair: Open loose lap area and clean thoroughly. Prime and reseat or reweld lap per the manufacturer's requirements. Strip-in defective lap with mimum 6" wide membrane on single ply systems or 6" wide fabric and mastic three-course application on asphalt systems. Regranulate or coat flashing repairs.

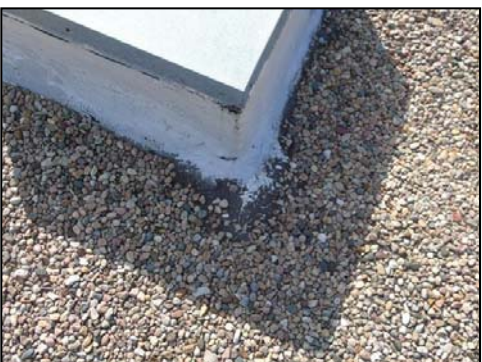
<b>Defect Code:</b>	<b>46</b>	<b>Quantity:</b>	<b>Random</b>	<b>Priority:</b>	<b>First Year</b>
Description: Split in flashing					
Repair: Cut away loose flashing and clean and prime repair area. Apply strip in of like material centered over split extending a minimum of 4" in all directions past prepared area.

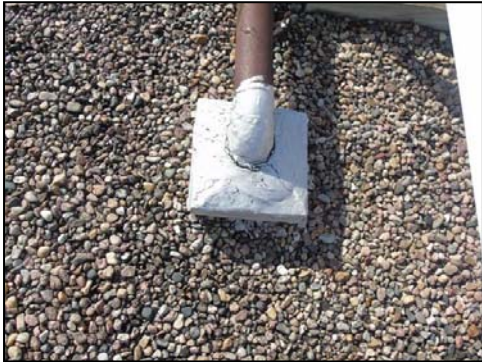
<b>Defect Code:</b>	<b>55</b>	<b>Quantity:</b>	<b>1</b>	<b>Priority:</b>	<b>First Year</b>
Description: Deteriorated or shrunken pitch pan filler.					
Repair: Clean pocket and penetrations of all dirt, insulation, and other materials and debris. Install manufacturer's recommended sealant in prepared pitch pan.

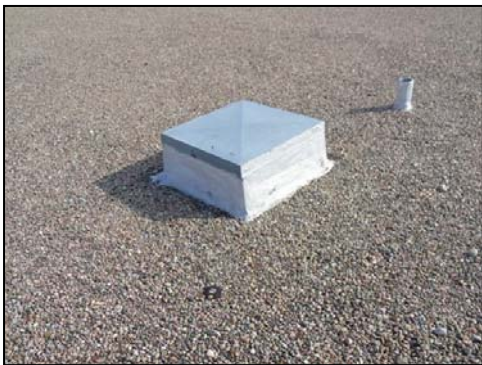
<b>Defect Code:</b>	<b>56</b>	<b>Quantity:</b>	<b>1</b>	<b>Priority:</b>	<b>Monitor</b>
Description: Abandoned and obsolete equipment.					
Repair: Monitor for leaks. Check systems are abandoned and disconnected and will not be used in the future. Remove abandoned equipment and repair deck at scheduled roof replacement.

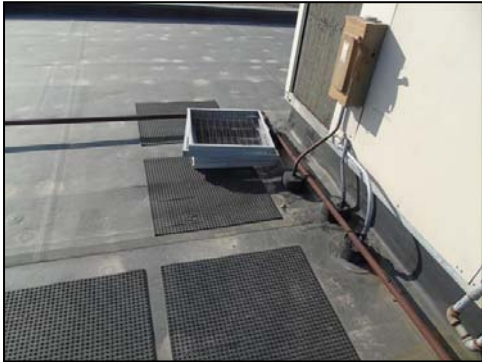
<b>Defect Code:</b>	<b>21</b>	<b>Quantity:</b>	<b>Random</b>	<b>Priority:</b>	<b>First Year</b>
Description: Loose walkway pad or deteriorated paver.					
Repair: Readhere or reweld walkway pads. Provide new pads to replace damaged or missing pads. Replace deteriorated concrete pavers with pavers of like kind and weight to ensure a flush walking surface.

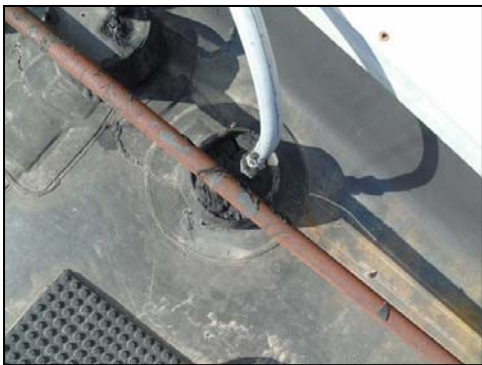
<b>Defect Code:</b>	<b>55</b>	<b>Quantity:</b>	<b>1</b>	<b>Priority:</b>	<b>First Year</b>
Description: Deteriorated or shrunken pitch pan filler.					
Repair: Clean pocket and penetrations of all dirt, insulation, and other materials and debris. Install manufacturer's recommended sealant in prepared pitch pan.

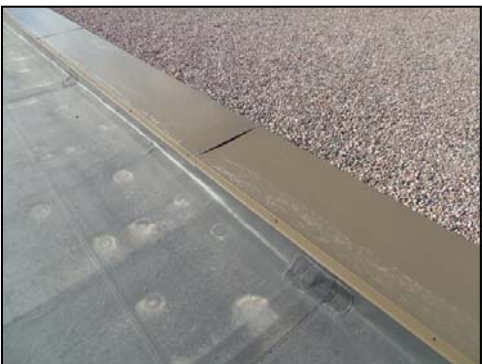
<b>Defect Code:</b>	<b>71</b>	<b>Quantity:</b>	<b>Random</b>	<b>Priority:</b>	<b>Monitor</b>
Description: Open or missing joint cover.					
Repair: Replace joint covers that are open or missing with matching joint covers and sealant.

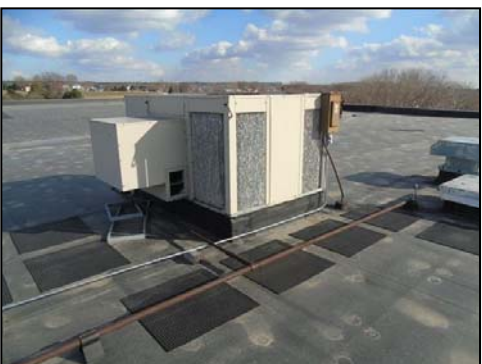
<b>Defect Code:</b>	<b>87</b>	<b>Quantity:</b>	<b>2</b>	<b>Priority:</b>	<b>Monitor</b>
Description: Mechanical defect					
Repair: Repair mechanical defect. Replace or reinstall missing access doors and panels. Reseal rooftop unit, pans, ducts, curbs, etc.
