# Roof Inspection Report

Prepared for:

Prepared by:

West High School  
1501 Thurston Avenue  
Bellevue, NE 68123

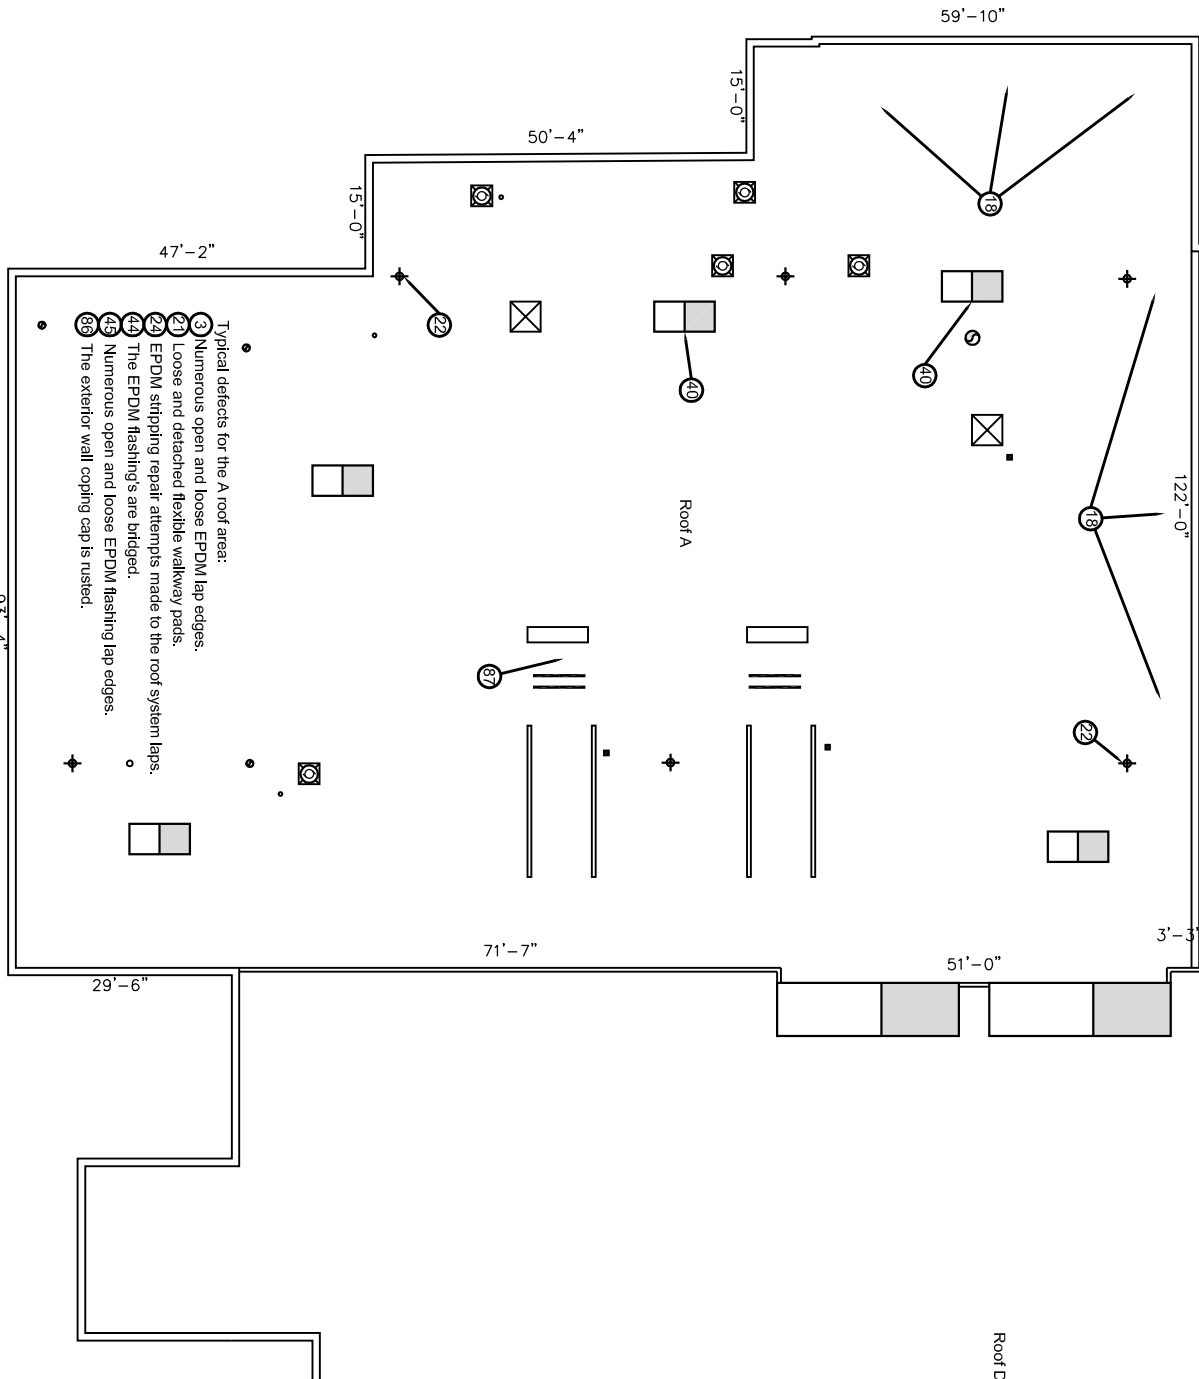
- Typical defects for the A roof area:
- 3 Numerous open and loose EPDM lap edges.
  - 21 Loose and detached flexible walkway pads.
  - 24 EPDM stripping repair attempts made to the roof system laps.
  - 47 The EPDM flashings are bridged.
  - 49 Numerous open and loose EPDM flashing lap edges.
  - 89 The exterior wall coping cap is rusted.

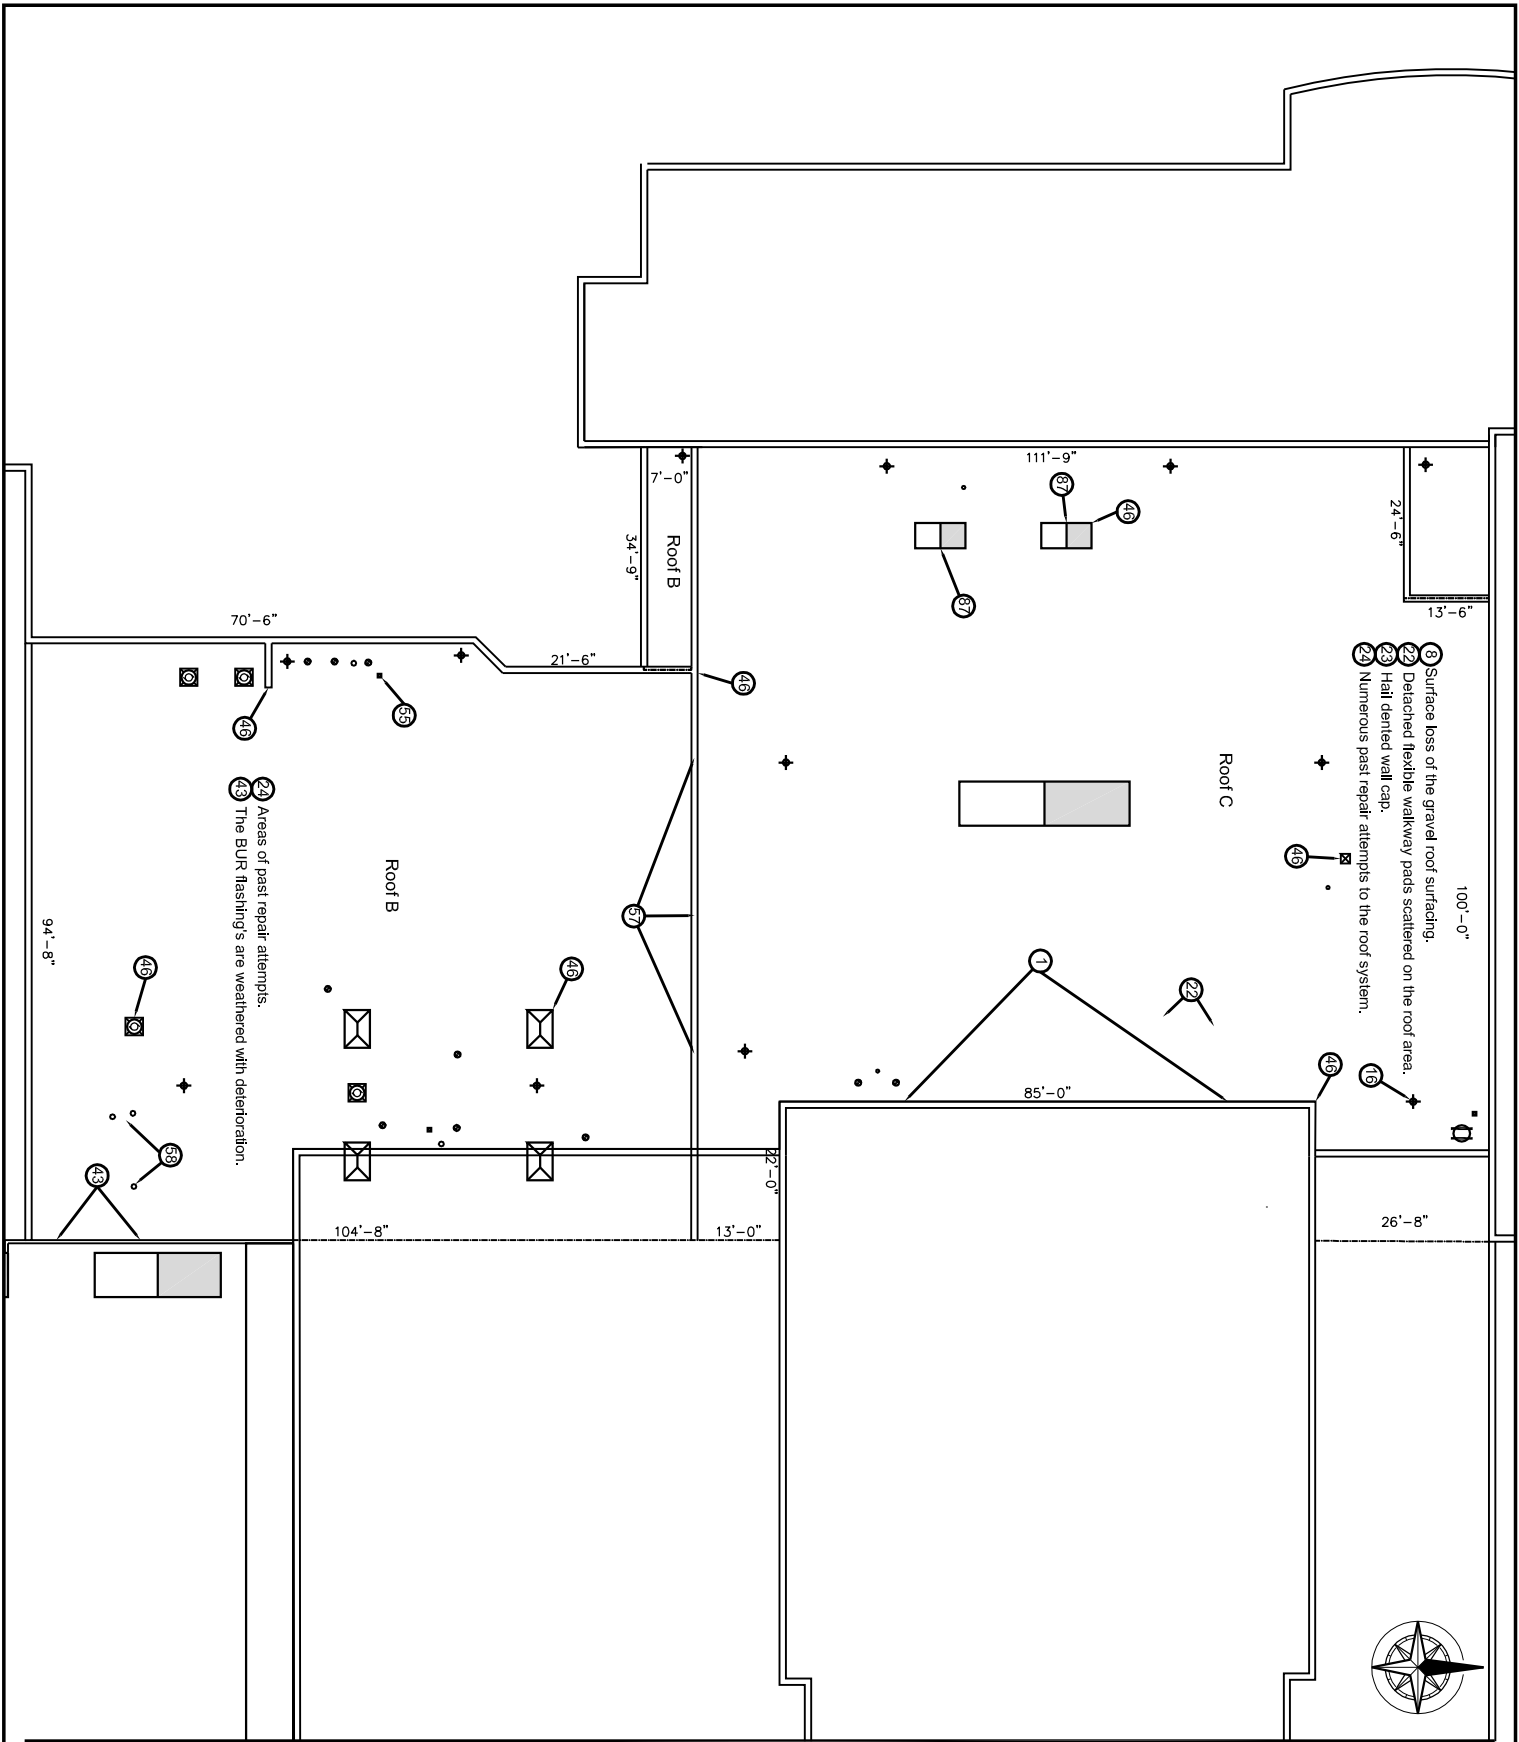
**Sheet Title:**  
**B&C-Roof Plan**

- ① Surface loss of the gravel roof surfacing.
- ② Detached flexible walkway pads scattered on the roof area.
- ③ Hail denied wall cap.
- ④ Numerous past repair attempts to the roof system.

⑤ Areas of past repair attempts. The BUR flashings are weathered with deterioration.

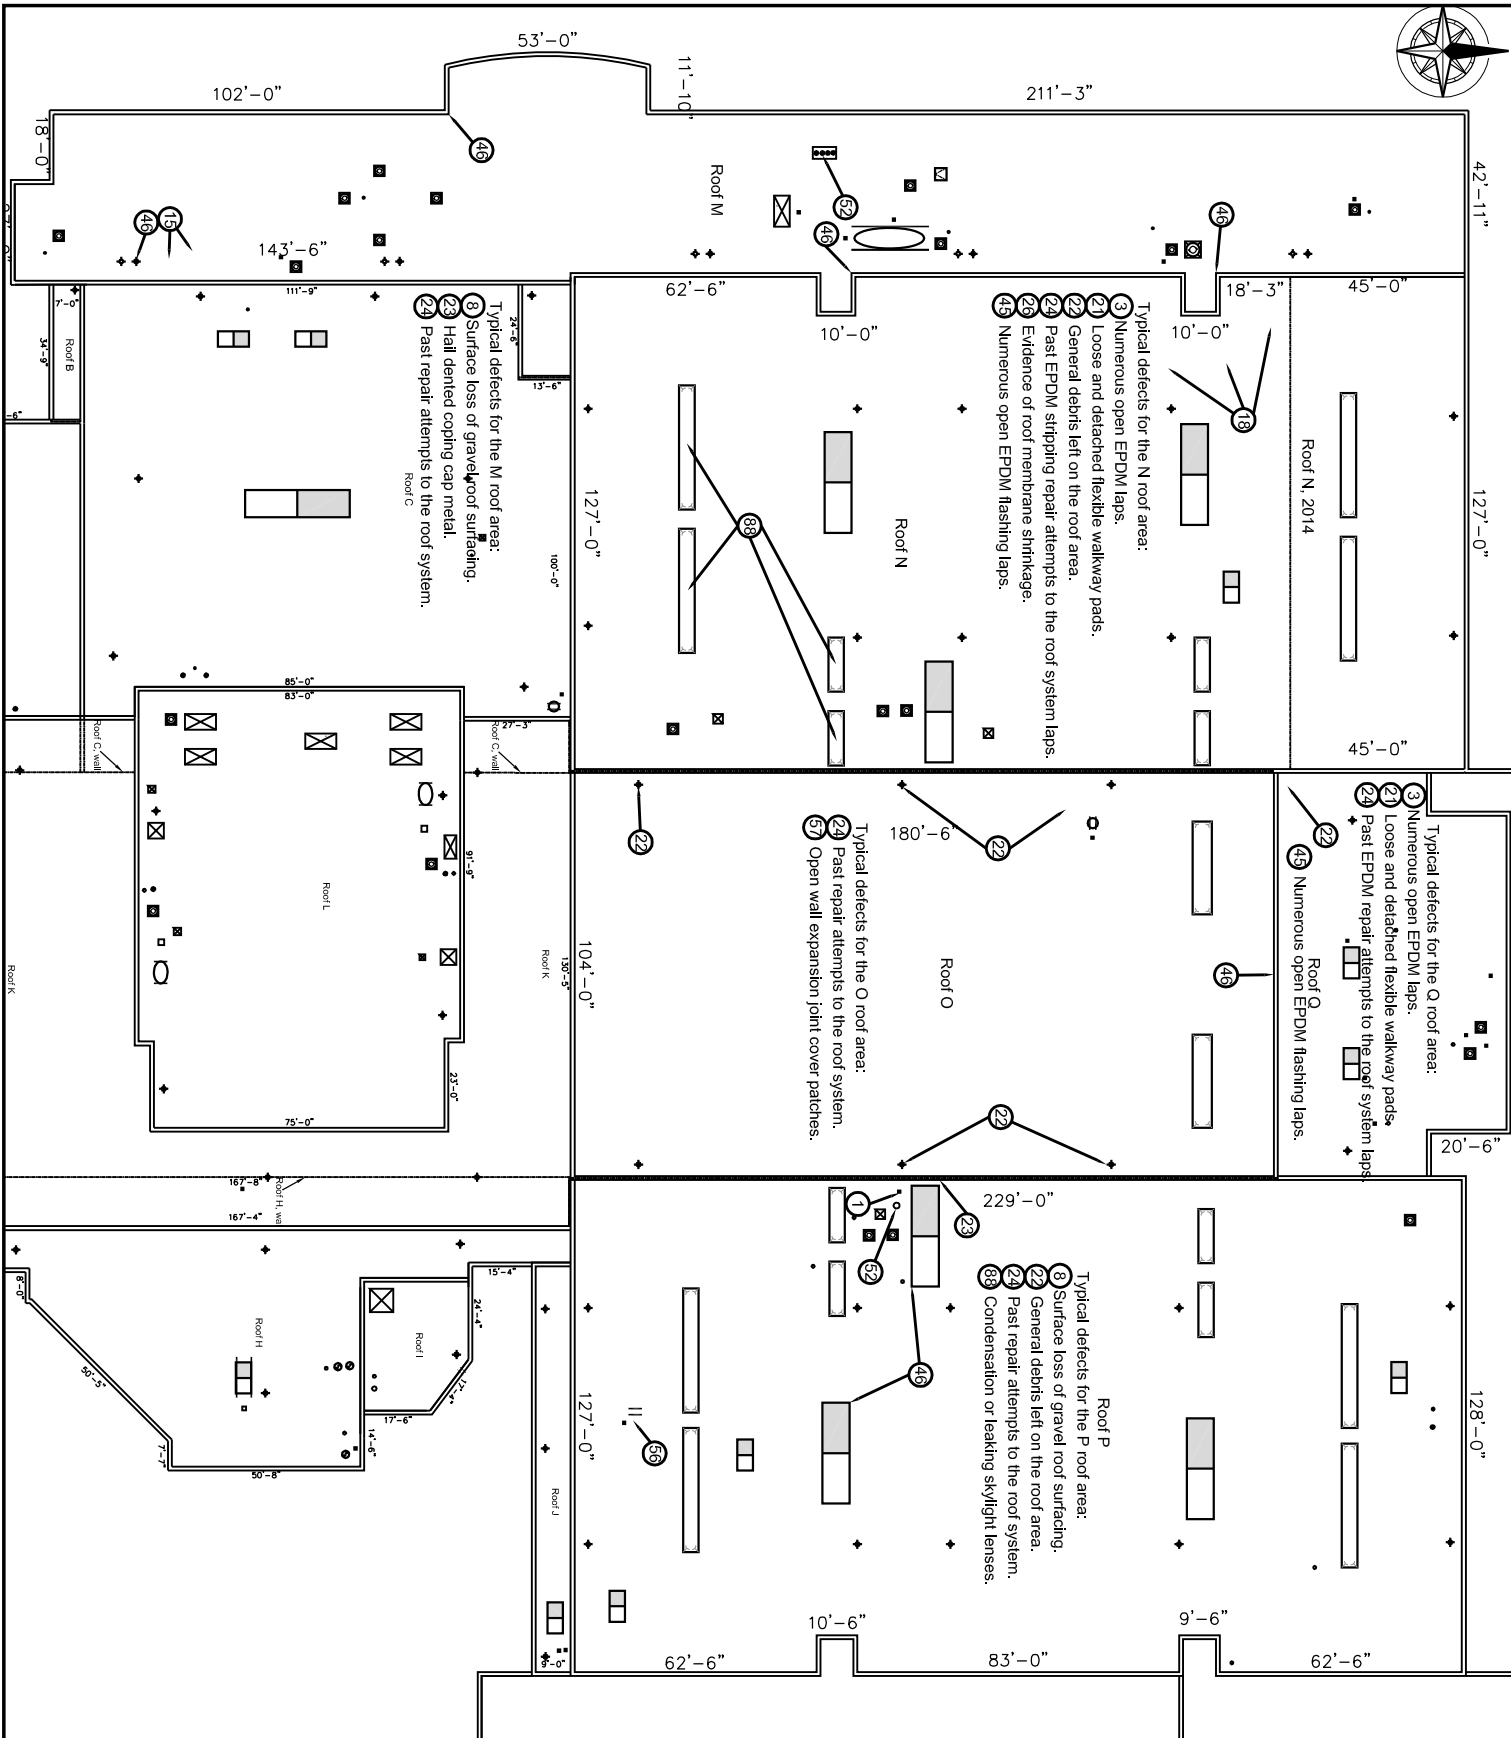
Typical defects for the M roof area:  
 18 Surface loss of gravel/roof surfacing.  
 19 Hall dented coping cap metal.  
 20 Past repair attempts to the roof system.

Typical defects for the N roof area:  
 21 Numerous open EPDM laps.  
 22 Loose and detached flexible walkway pads.  
 23 General debris left on the roof area.  
 24 Past EPDM stripping repair attempts to the roof system laps.  
 25 Evidence of roof membrane shrinkage.  
 26 Numerous open EPDM flashing laps.

Typical defects for the O roof area:  
 27 Past repair attempts to the roof system.  
 28 Open wall expansion joint cover patches.

Typical defects for the Q roof area:  
 29 Numerous open EPDM laps.  
 30 Loose and detached flexible walkway pads.  
 31 Past EPDM repair attempts to the roof system laps.  
 32 Numerous open EPDM flashing laps.

Typical defects for the P roof area:  
 33 Surface loss of gravel roof surfacing.  
 34 General debris left on the roof area.  
 35 Past repair attempts to the roof system.  
 36 Condensation or leaking skylight lenses.

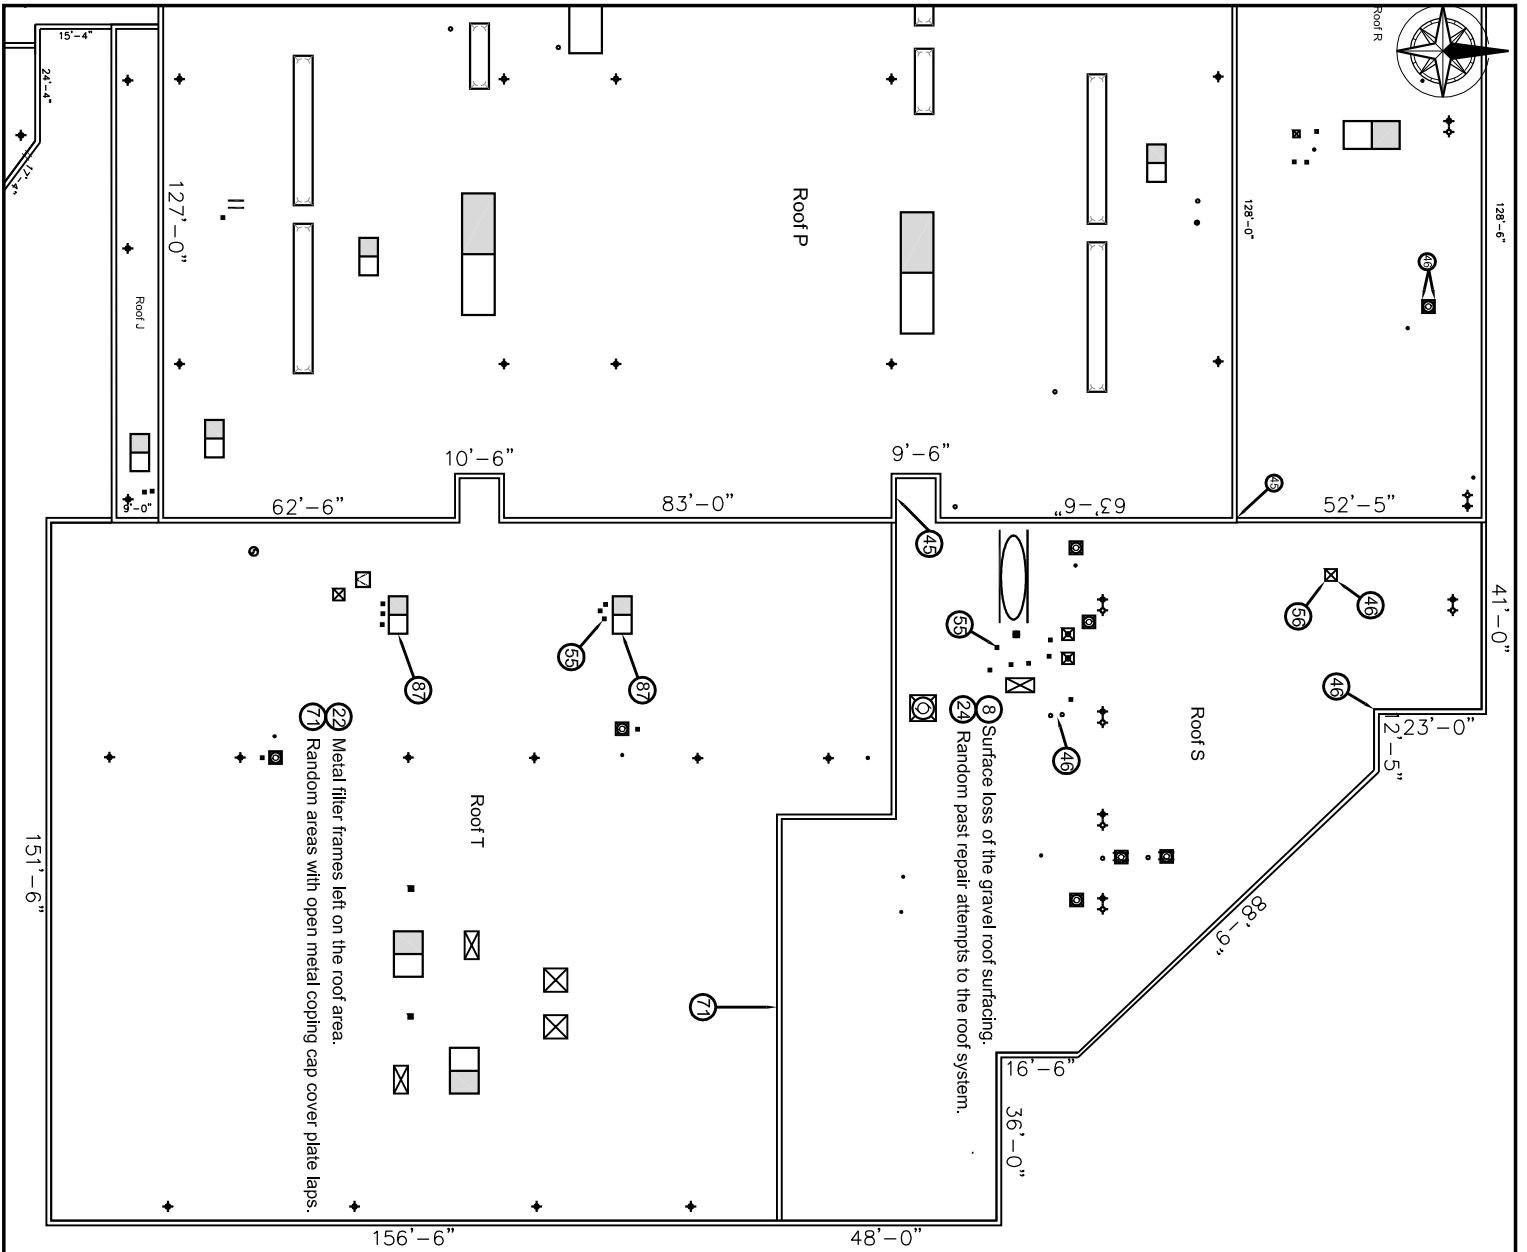
72 Metal filter frames left on the roof area.  
 71 Random areas with open metal coping cap cover plate laps.

8 Surface loss of the gravel roof surfacing.  
 29 Random past repair attempts to the roof system.
