# Roof Inspection Report

Bellevue School Transport  
2824 Arboretum Drive  
Bellevue, NE 68005

Date	Inspection Type	Inspecting Company	Inspector
Apr 05, 2017	Phase 1 Roof Inspection	Roofing Solutions, Inc.	Garry Hendrickson

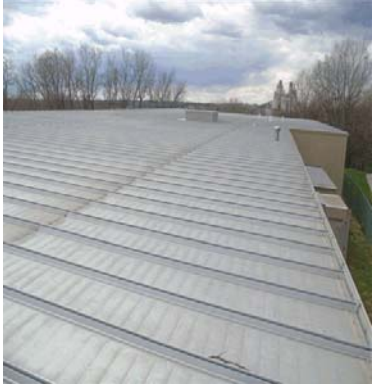
Roof A A 2005	20,045 sq. ft. 24 ft.	Standing Seam Sheet Metal Roofing	Good 71 8(Yrs)	\$160,360.00

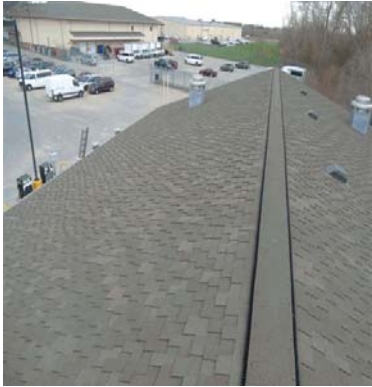
Roof B B 2005	3,460 sq. ft. 16 ft.	Asphalt Shingles	Good 66 6(Yrs)	\$20,760.00
<b>23,505</b>					<b>\$181,120.00</b>
*RCI Rating 0 -100 where 100 is excellent

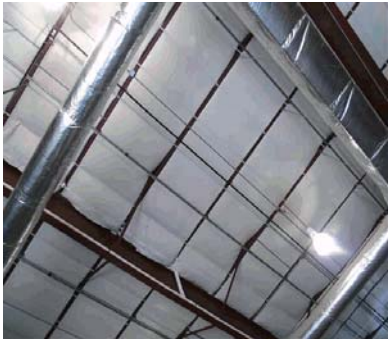
Apr 05, 2017	Deck Underside

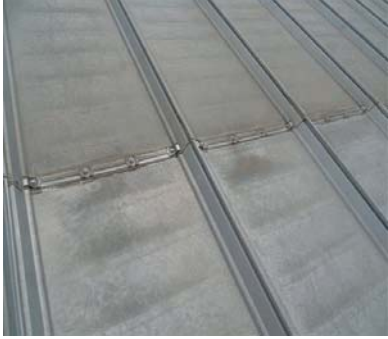
Apr 05, 2017	Membrane
