Roof Inspection Report

Bellevue Welcome Center
2600 Arboretum Drive
Bellevue, NE 68005

Date	Inspection Type	Inspecting Company	Inspector
Apr 06, 2017	Phase 1 Roof Inspection	Roofing Solutions, Inc.	Garry Hendrickson

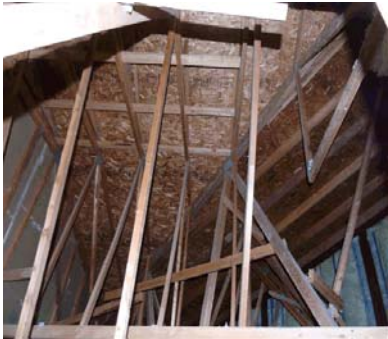
No core cut was performed. An under view of the structure revealed wood trusses with an OSB plywood decking and roofing layers were determined at an eave edge. There is one (1) layer of ice & water shield and the membrane is a laminated, asphalt shingle.

Apr 06, 2017	Deck Underside

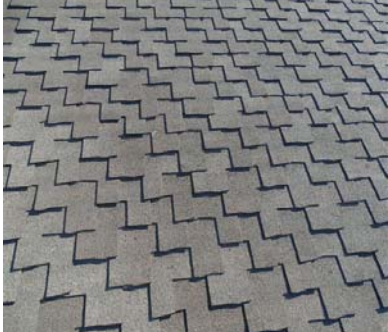
Apr 06, 2017	Membrane
