Roof Inspection Report

Fairview Elementary
14110 Tregaron Drive
Bellevue, NE 68123

Fairview Elementary_Bellevue, NE
Ph 1 Inspection Project_Roof A_2017-03-08

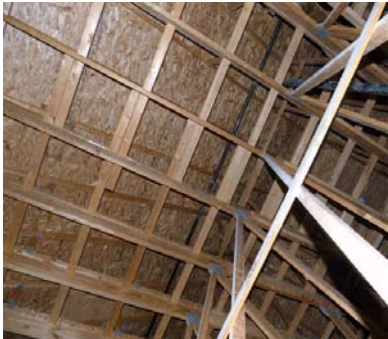
Mar 08, 2017	Deck Underside

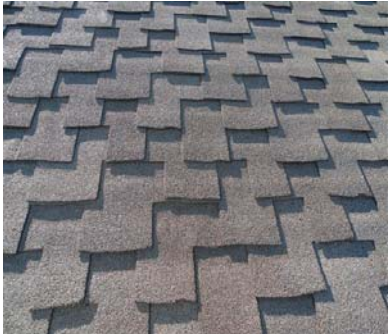
Mar 08, 2017	Membrane
