Roof Inspection Report

Leonard Lawrence Elementary
13204 S. 29th Street
Bellevue, NE 68123

Leonard Lawrence Elementary_Bellevue, NE
Ph 1 Roof Inspection_Roof A_2017-02-28

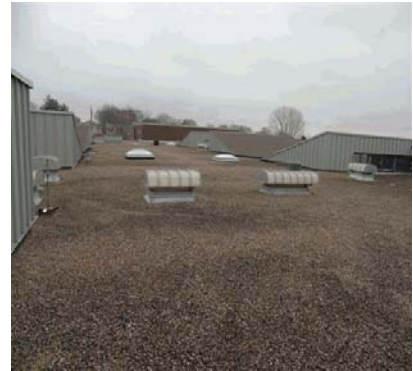
**Drainage and Leak
Details:** Roof Section A slopes from a central ridge line towards the north and south and drains to six (6) primary roof drains. There are also two (2) valley areas which drain to scuppers and an additional scupper on the north side, by the main entry to the facility.

RSI's contact for this facility reported scattered active leaks, most of which were reported to be below this roof section.

- Deteriorated or split caulking observed on top of the perimeter wall counter flashing and in the brick wall expansion joints
- Random areas with surface loss of the gravel roof surfacing
- Caulking repair attempts observed to the window seals
- One (1) repair attempt to a crack in the gym brick wall
- Numerous areas with repair attempts to the BUR system
- Random areas with low flashing height
- Split BUR flashing corners observed
- The BUR flashings are wrinkled and/or racked at the corners
- One (1) loose vent cover observed
- Poor transition flashings on the bottom ends of the shingle roof areas
- Deteriorating seals observed on the windows installed above the roof system

Overall, the roof system is in poor condition due to reported leak issues and above referenced defects. Given the observed conditions, it is our opinion comprehensive repairs in an effort to extend the life of the system would be neither feasible nor cost effective. We recommend the roof be replaced, pending the outcome of an infrared scan.

Budget Year	Activity Type	Action Item ?	Allocation	Urgency	Quotation \$
2017	Infrared Scan	Yes	Expense	High	\$2,000
RSI recommends an infrared scan be performed to locate any wet insulation.					
2017	Retrofit	Yes	Capital	High	\$200,900
<p>RSI recommends the installation of a new twenty (20) year design life retrofit roof system. We further recommend installation of new perimeter metal and projection details per the SMACNA Architectural Sheet Metal Manual.</p> <p><i>*Please Note: Costs associated with repairs and/or replacement of window units or seals are not included in this budget estimate.</i></p> <p><i>*Please Note: Due to extensive past repair attempts and reported past leak issues at this facility, this roof system may have to be completely removed, which could significantly increase the estimated replacement cost for this roof section.</i></p>					
					\$202,900

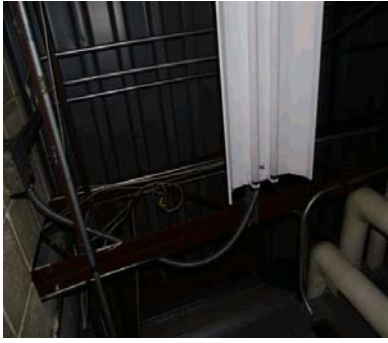
Feb 28, 2017	Deck Underside

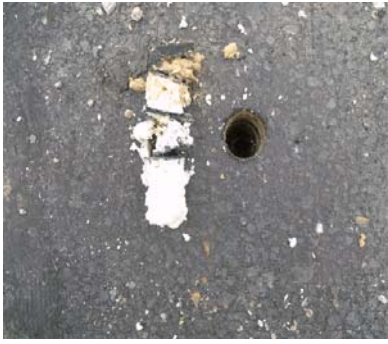
Feb 28, 2017	Core cut #1

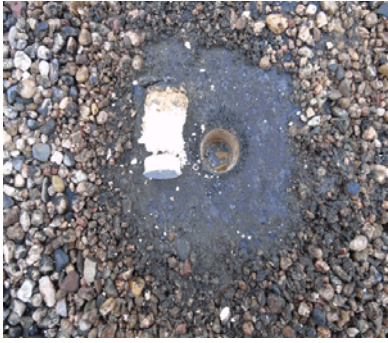
Feb 28, 2017	Core cut #2

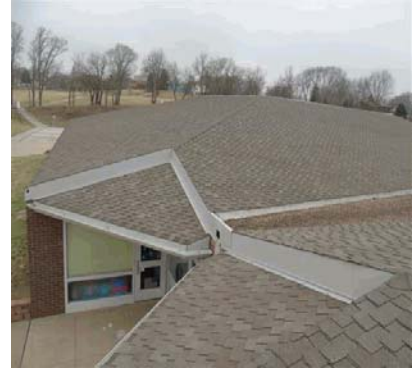
Although there were no reported leaks specific to this roof section, the poor condition of the shingle membrane indicates that roof leaks are probable.

- Numerous splits in the shingle membrane observed
- Random areas with deteriorated shingles observed along the eave edges
- Numerous past repair attempts observed to shingle roof, many have split through the roof mastic
- Random areas with broken or missing shingles observed near the eave edges
- Random areas with loose anchors or bowed up top edge metal flashing

Overall, the roof system is in poor condition due to the above listed defects and poor condition of the shingle membrane. Given the observed conditions, it is our opinion comprehensive repairs in an effort to extend the life of the system would be neither feasible nor cost effective. We recommend the roof be replaced. There was no warranty information available for this roof section at the time of inspection.

RSI recommends the installation of a new twenty (20) year design life roof system. We further recommend the replacement of all perimeter coping cap and projection details per SMACNA Architectural Sheet Metal Manual.

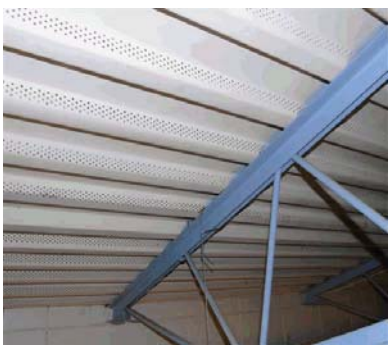
Feb 28, 2017	Deck Underside

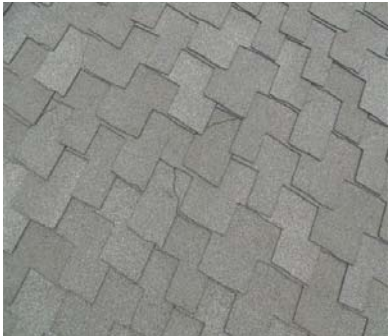
Feb 28, 2017	Membrane

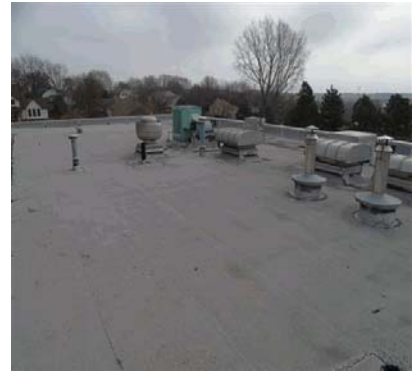
- Standing water observed in front of two (2) scuppers
- Random areas with past roof mastic repair attempts to the roof system
- Random areas with split flashing seals around the pipe penetration and pitch pocket flashings

Overall, the roof system is in good working condition. With the aforementioned defects addressed, in addition to routine maintenance and regular inspection, the roof system should remain effective for the duration of its assessed service life. There was no warranty information available for this roof section at the time of inspection.

Budget Year	Activity Type	Action Item ?	Allocation	Urgency	Quotation \$
2017	Repair	Yes	Expense	High	\$750
RSI recommends repairs be completed in accordance with the attached deficiency list.					
					\$750

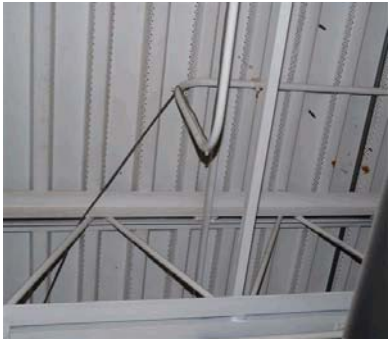
Feb 28, 2017	Deck Underside

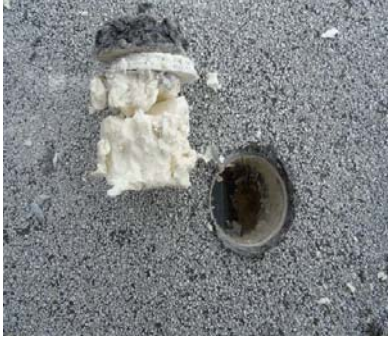
Feb 28, 2017	Roof System Core

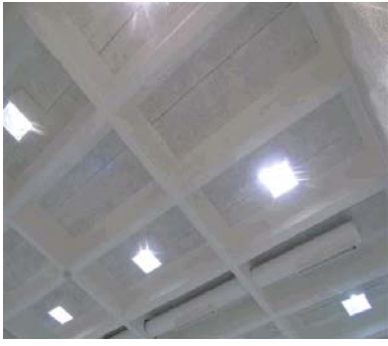
Feb 28, 2017	Deck Underside

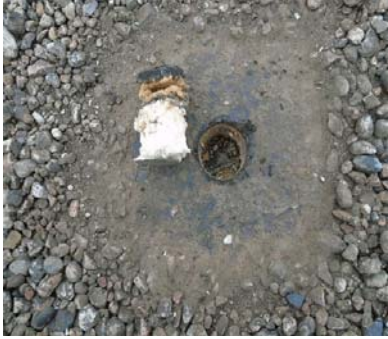
Feb 28, 2017	Roof System Core

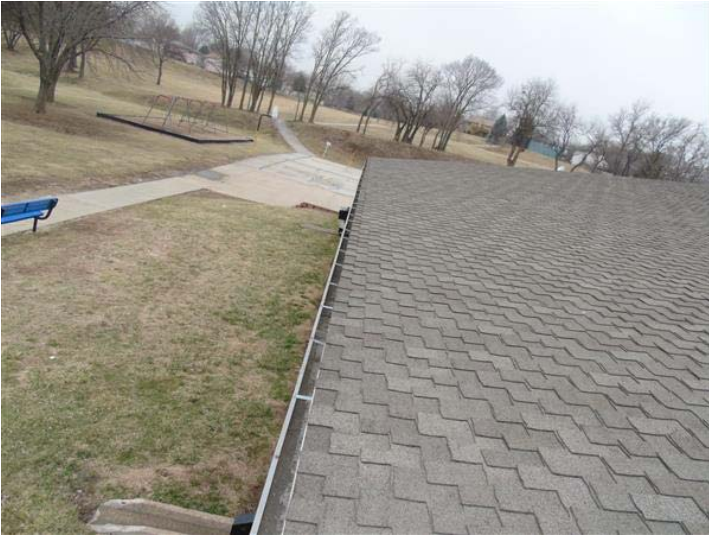
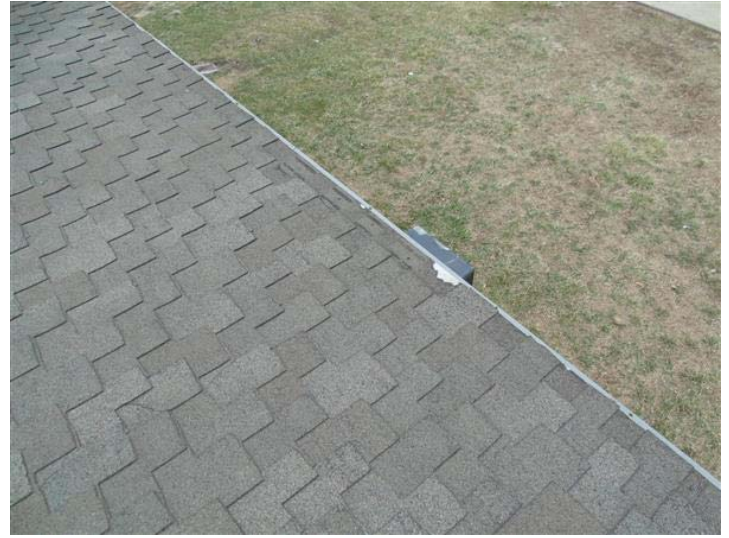
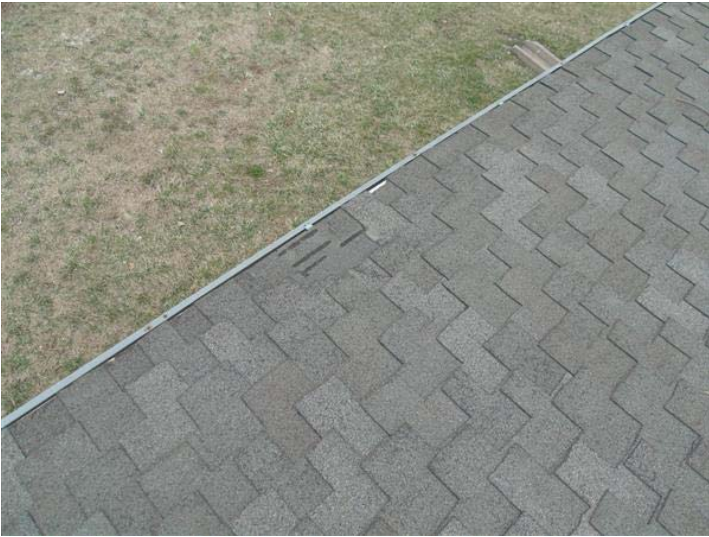
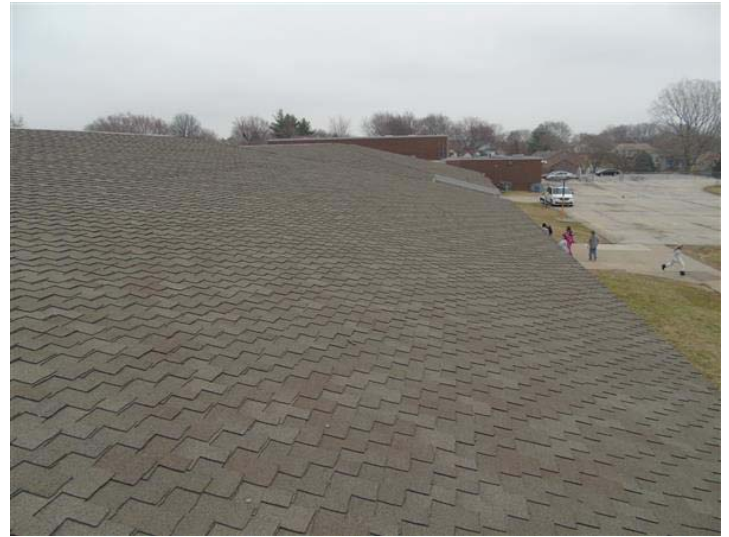
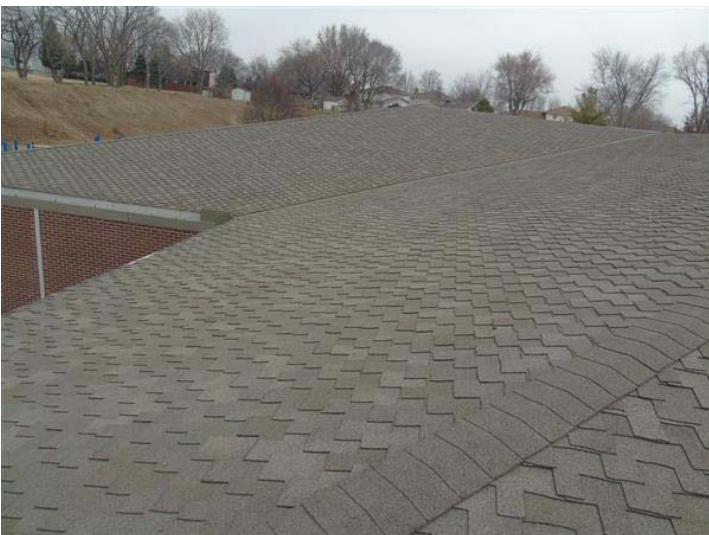
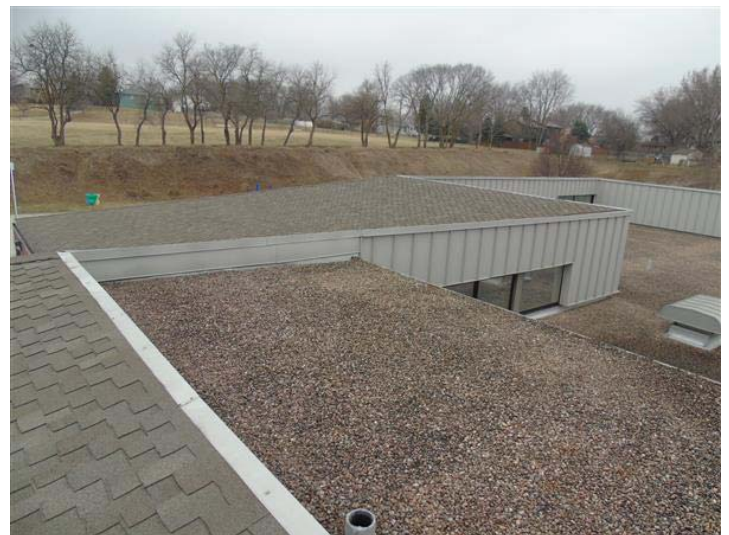
Leonard Lawrence Elementary_Bellevue, NE
Ph 1 Roof Inspection_Roof B_2017-02-28

- Typical defects for the B roof areas:**
- 6 Numerous areas with split shingles.
 - 9 Random areas with deteriorated shingles along the eave edges.
 - 24 Numerous areas with past repair attempts to the roof system, some of which are splitting through mastic.
 - 29 Random areas with broken and missing shingles near the eave edges.
 - 75 Random areas with loose anchors and bowed metal flashings along the top edge flashing.
