Roof Inspection Report

Lewis & Clark Middle School
13502 S. 38th Street
Bellevue, NE 68123

Lewis & Clark Middle School_Bellevue, NE
Ph 1 Roof Inspection_Roof A-1_2017-03-28

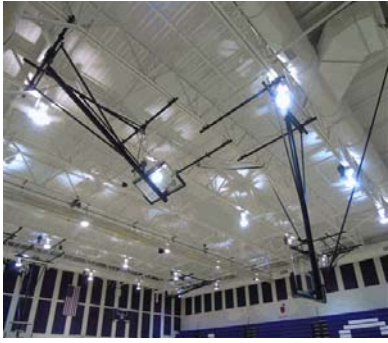
Mar 28, 2017	Deck Underside

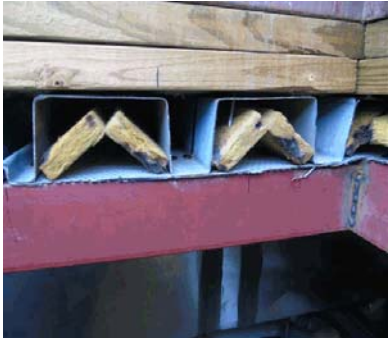
Mar 28, 2017	Roof Construction

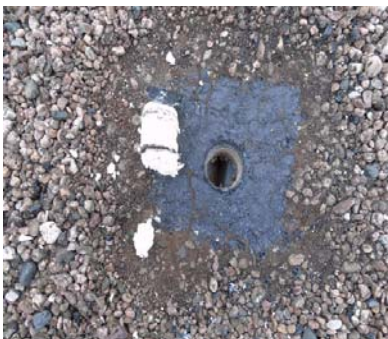
Mar 28, 2017	Roof System Core

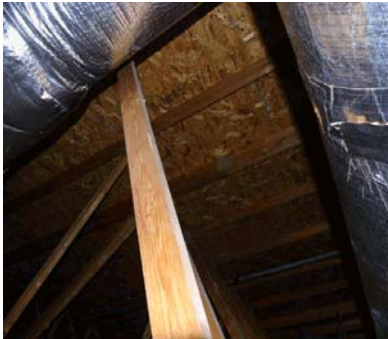
Mar 28, 2017	Deck Underside

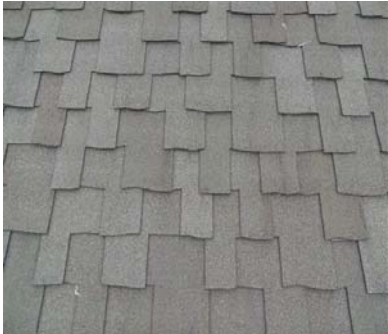
Mar 28, 2017	Membrane

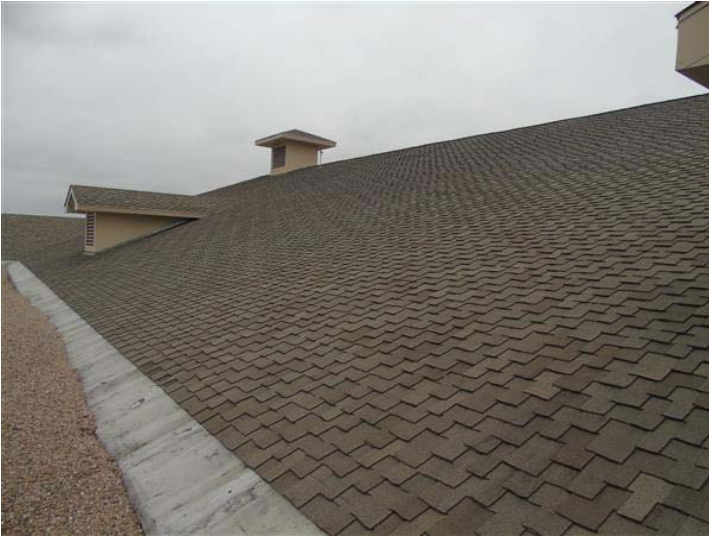
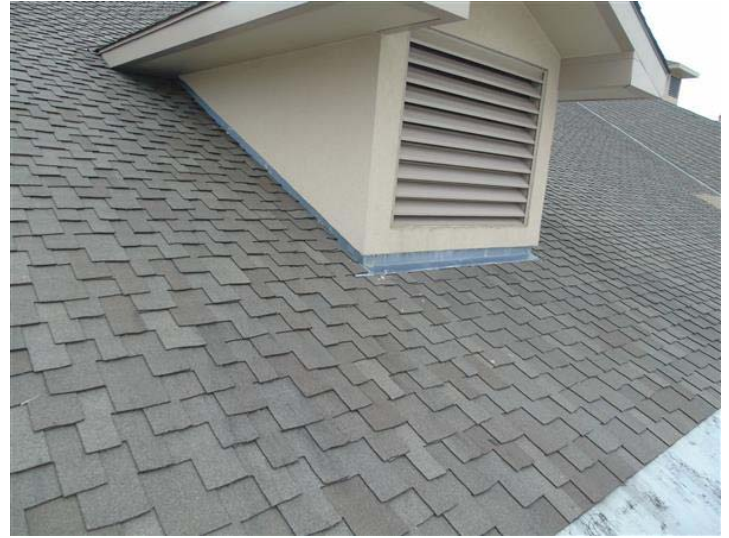
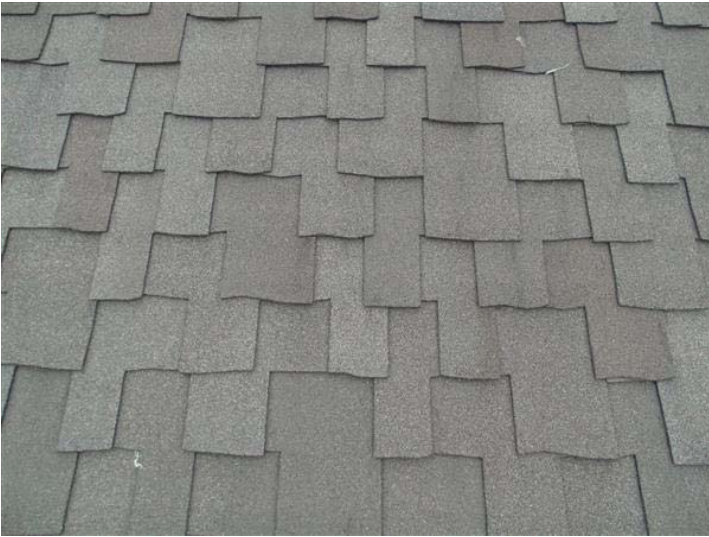
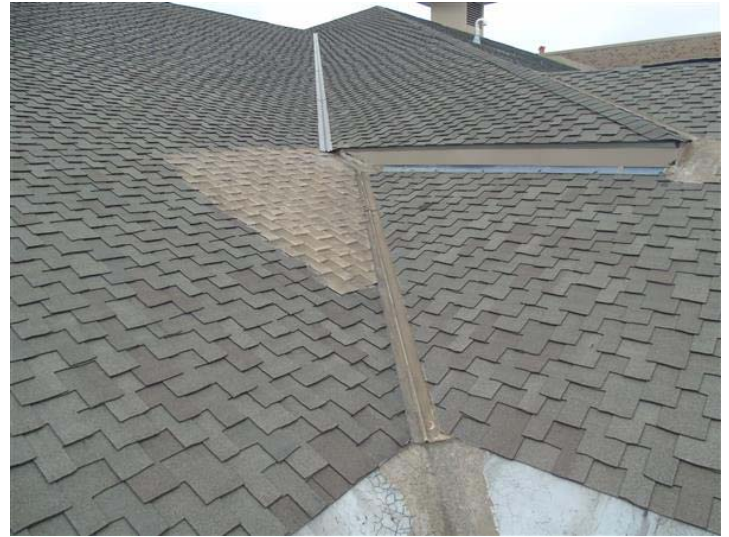
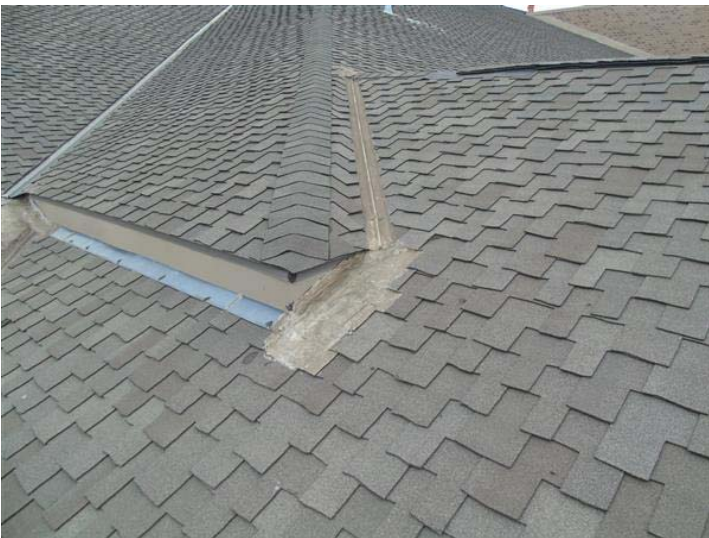
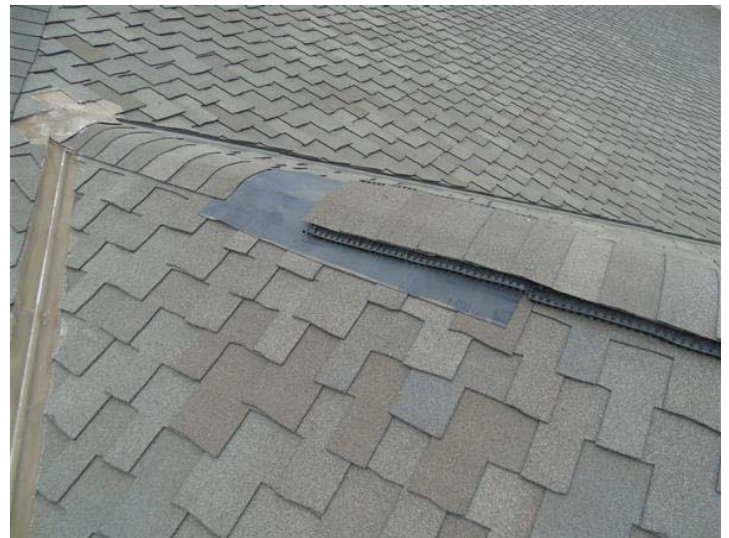
Lewis & Clark Middle School_Bellevue, NE
Ph 1 Roof Inspection_Roof B_2017-03-28

- Typical defects for the B roof area:
- 24 Random roof mastic repair attempts.
 - 29 Random torn shingles.
 - 58 Missing tin shingles on the dormer rake edge flashings.
 - 59 Missing starter row of shingles on the dormer roofs.
 - 59 Random areas where the shingles do not appear to be properly offset.
