Roof Inspection Report

Lied Activity Center
2700 Arboretum Drive
Bellevue, NE 68005

Lied Activity Center_Bellevue, NE
Ph 1 Roof Inspection_Roof A_2017-02-28

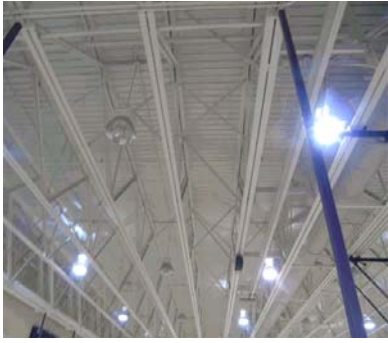
Feb 28, 2017	Deck Underside

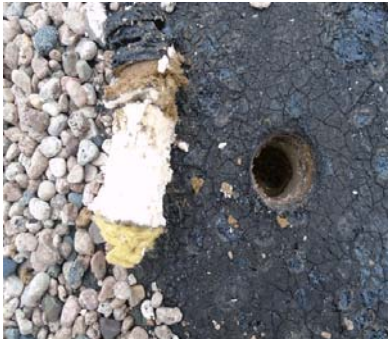
Feb 28, 2017	Roof System Core

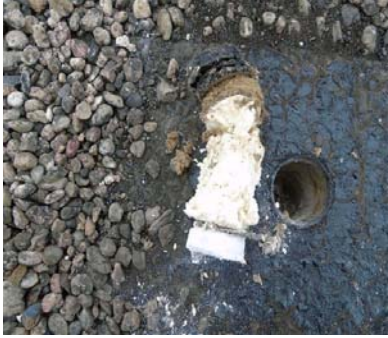
Feb 28, 2017	Roof System Core
