Roof Inspection Report

Twin Ridge Elementary
1400 Sunbury Drive
Bellevue, NE 68005

Date of Last Inspection: Mar 17, 2017

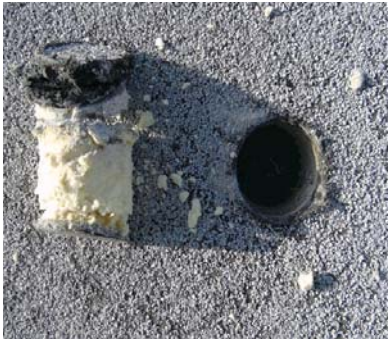
Mar 17, 2017	Roof System Core

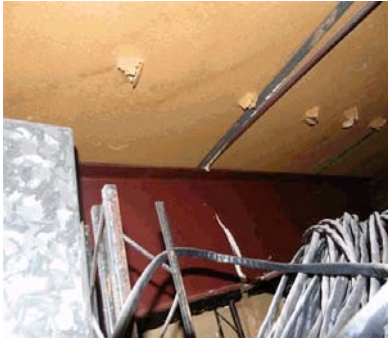
Mar 17, 2017	Deck Underside

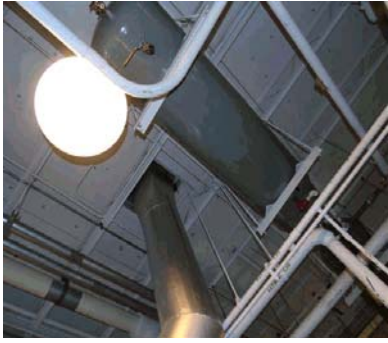
Mar 17, 2017	Deck Underside #2

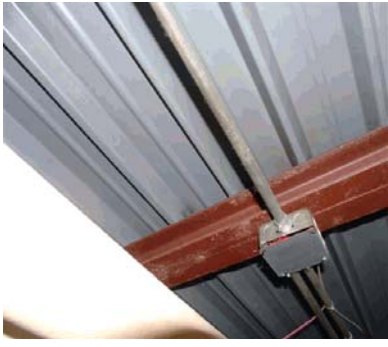
Mar 17, 2017	Deck Underside

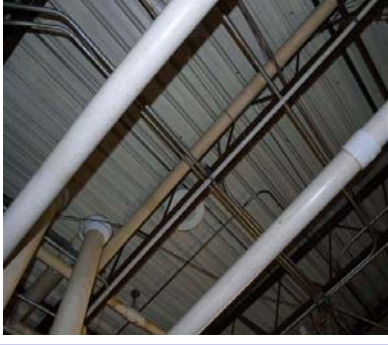
Mar 17, 2017	Deck Underside #2

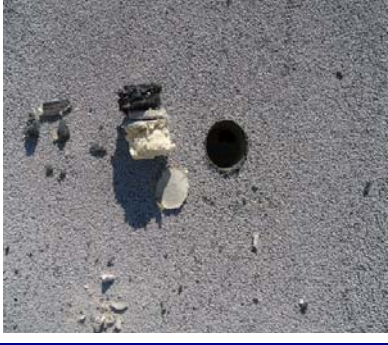
Mar 17, 2017	Core cut #1

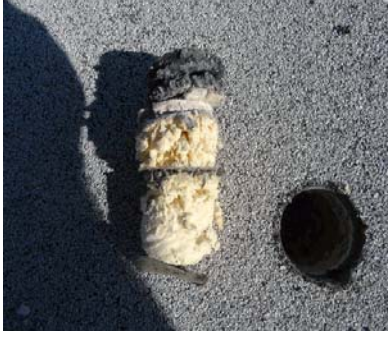
Mar 17, 2017	Core cut #2

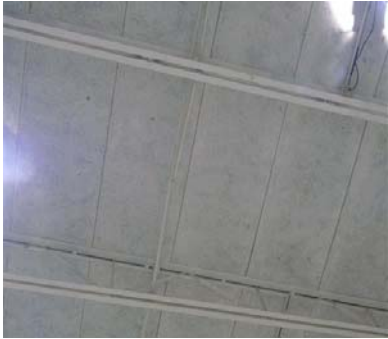
Mar 17, 2017	Deck Underside

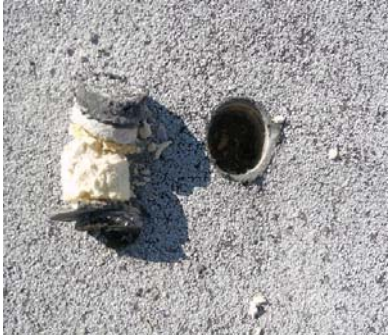
Mar 17, 2017	Roof System Core

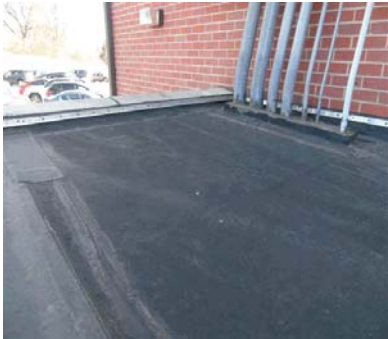
Mar 17, 2017	Membrane

- One (1) reported past leak issue at a corner of the building
- EPDM repair attempts observed near the reported leak location

Overall, the roof system is in poor condition due to its age. The EPDM membrane has surpassed its design service life by approximately five (5) years. RSI recommends the roof system be replaced with a new twenty (20) year design life roof system.

RSI recommends the installation of a new twenty (20) year design life roof system. We further recommend installation of new perimeter metal and projection details per the SMACNA Architectural Sheet Metal Manual.

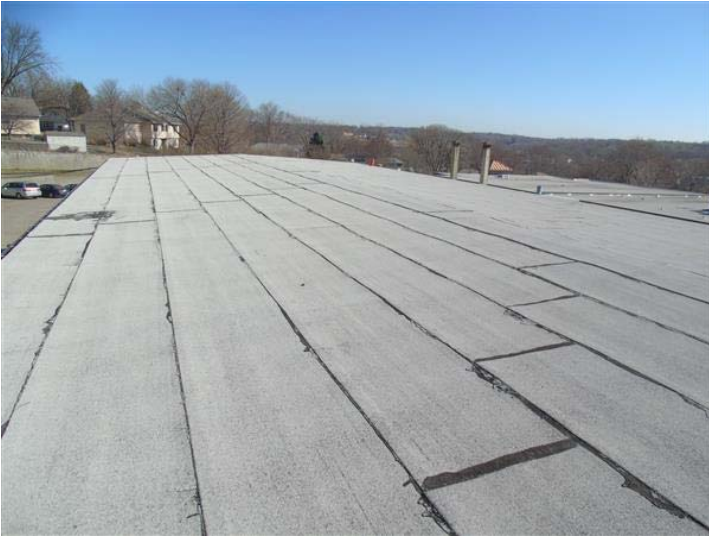
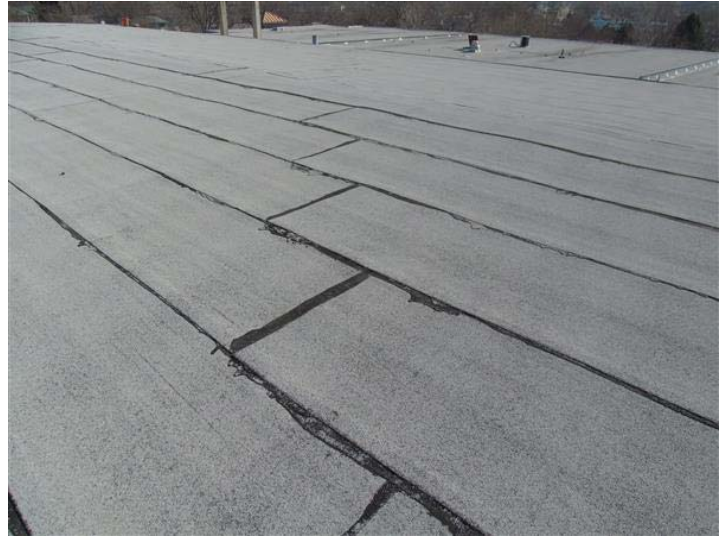
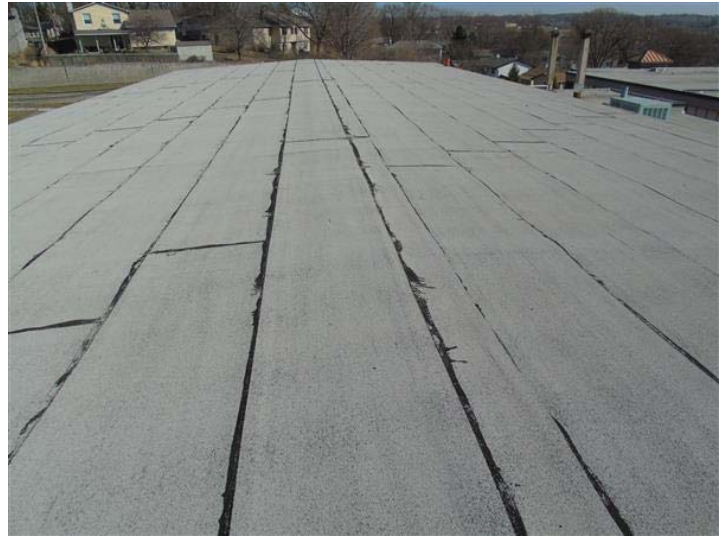
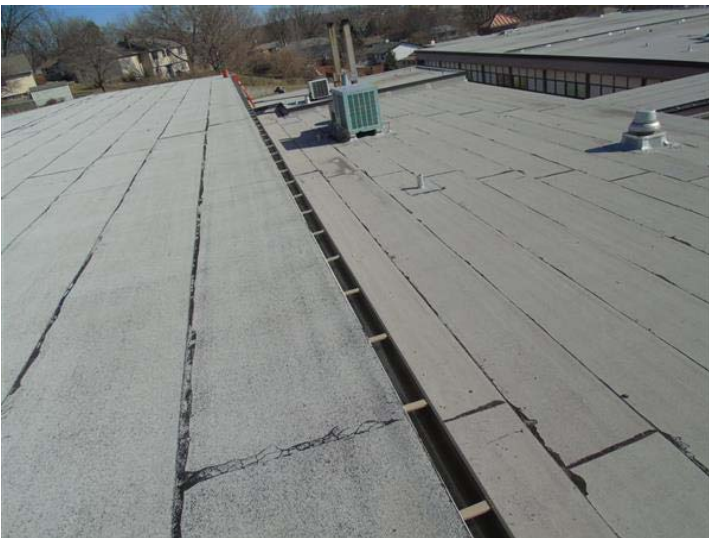
Twin Ridge Elementary_Bellevue, NE
Ph 1 Roof Inspection_Roof C_2017-03-17

Typical defects for the C roof area:
 (5) Random ridges in the roof membrane plies.
 (45) Numerous open modified bitumen laps in the gutter edge stripping laps.
