# Roof Inspection Report

Two Springs Elementary  
3001 Spring Boulevard  
Bellevue, NE 68123

Date	Inspection Type	Inspecting Company	Inspector
Mar 09, 2017	Phase 1 Roof Inspection	Roofing Solutions, Inc.	Garry Hendrickson

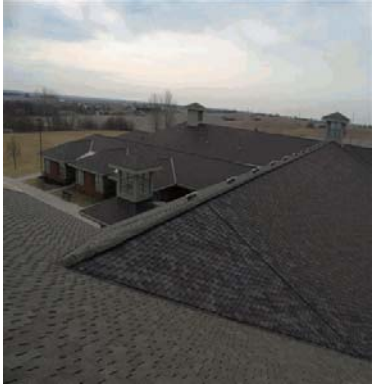
Roof Section A A 1996	67,936 sq. ft. 12 ft.	Asphalt Shingles	Poor 33 2(Yrs)	\$305,712.00

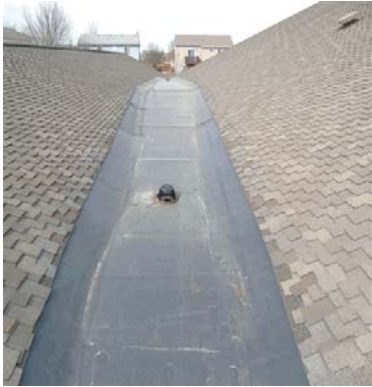
Roof Section B B 2016	3,936 sq. ft. 12 ft.	(EPDM) Ethylene-Propyl ene-Diene-Mon omer Roofing	Very Good 85 19(Yrs)	\$59,040.00
<b>71,872</b>					<b>\$364,752.00</b>
*RCI Rating 0 -100 where 100 is excellent

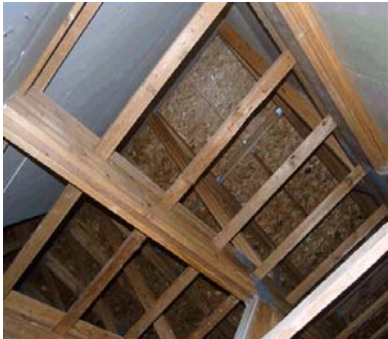
Mar 09, 2017	Deck Underside
