# Roof Inspection Report

## Project Location

Wake Robin School  
700 Lincoln Road  
Bellevue, NE 68005

Date	Inspection Type	Inspecting Company	Inspector
Mar 22, 2017	Phase 1 Roof Inspection	Roofing Solutions, Inc.	Garry Hendrickson

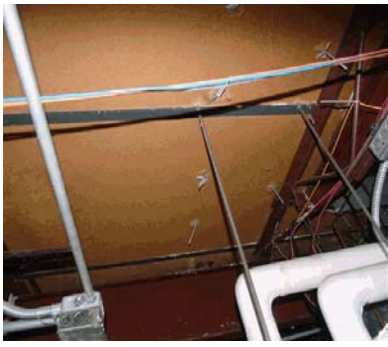
Mar 22, 2017	Deck Underside

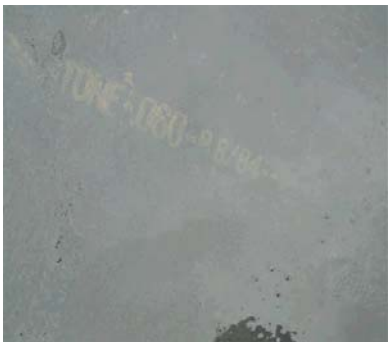
Mar 22, 2017	Membrane stamp

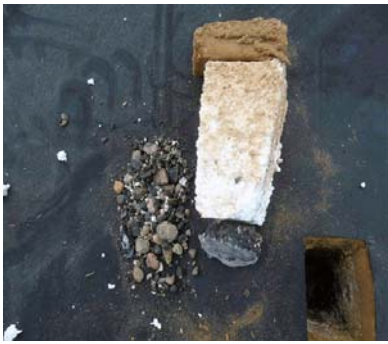
One (1) sample was taken on the 1964 construction portion of the roof area, which revealed two (2) roof systems in place. The deck is a poured in place gypsum decking. The original roof system consists of a multiply BUR system with a gravel surfacing. That roof system was later covered with an air-expanded polystyrene insulation board, which appears to be part of a tapered insulation system, and one (1) layer of 1" wood fiber cover board. The membrane is a fully-adhered, .060 mil Firestone EPDM. The wood fiber cover board was deteriorated at the core cut location. An under view of the 1969 addition to the building revealed the same type of form board used as the 1964 constructed area. The cover board appears to have been attached used toggle bolts through the gypsum decking.

Mar 22, 2017	Roof System Core

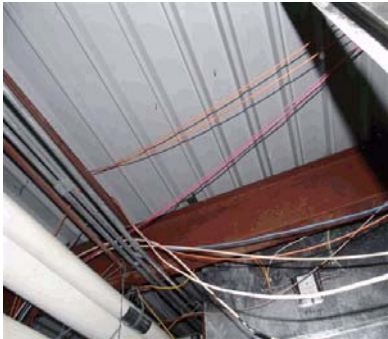
Mar 22, 2017	Deck Underside

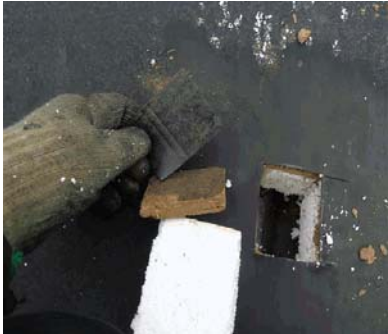
One (1) core sample was taken on the B-2 roof area, which is part of the 1992 addition portion of the roof area. The deck is a factory primed steel decking. The insulation is air-expanded polystyrene insulation, which appears to be part of a tapered insulation system, with one (1) layer of 1/2" wood fiber cover board. The membrane is a fully-adhered, .060 mil Firestone EPDM. The wood fiber cover board was deteriorated at the core cut location. An under view of the 1974 addition to the building revealed the same type of steel decking. Due to age difference of the 1974 addition, there may be an addition roof system in place on that portion of the roof area.

Mar 22, 2017	Roof System Core

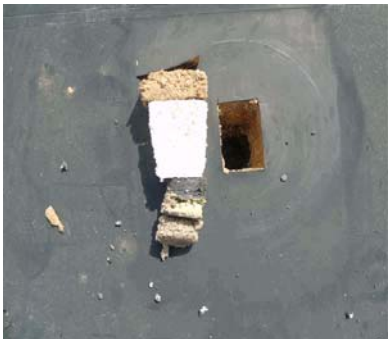
Mar 22, 2017	Core cut #2

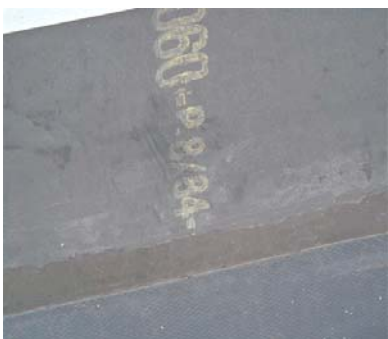
Mar 22, 2017	Membrane stamp

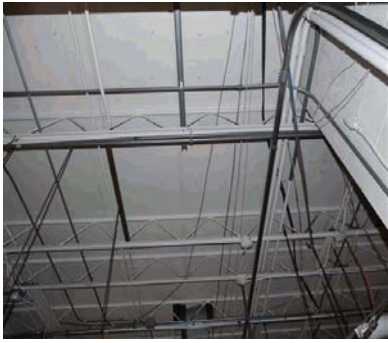
Mar 22, 2017	Deck Underside

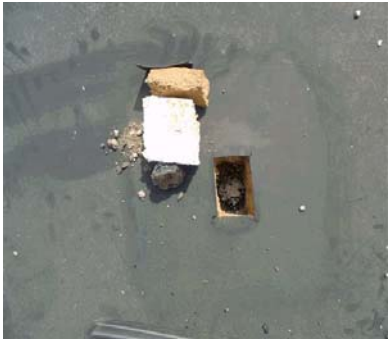
One (1) core sample revealed two (2) roof systems in place. The deck is a poured in place gypsum decking. The original roof system consists of a multiply BUR system with a gravel surfacing. That roof system was later covered with an air-expanded polystyrene insulation, which appears to be part of a tapered insulation system, and one (1) layer of 1" wood fiber cover board. The membrane is a fully-adhered, .060 mil Firestone EPDM. The wood fiber cover board was deteriorated at the core cut location.

Mar 22, 2017	Roof System Core

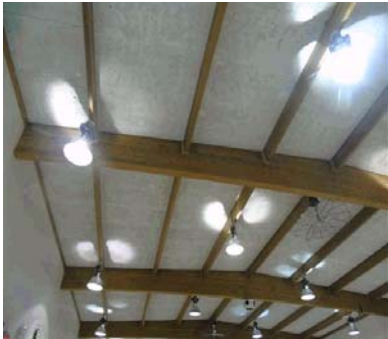
Mar 22, 2017	Deck Underside

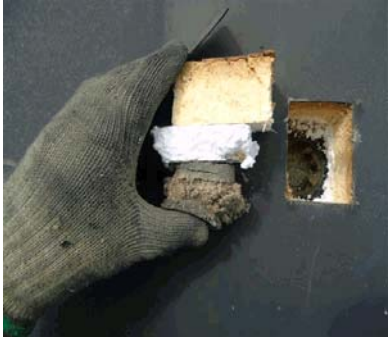
Mar 22, 2017	Roof System Core
